# A Strategic Electrical Safety Pre-Plan

# Initial Planning for Site-Wide Consolidation and Prioritization of Electrical Safety and Compliance Issues

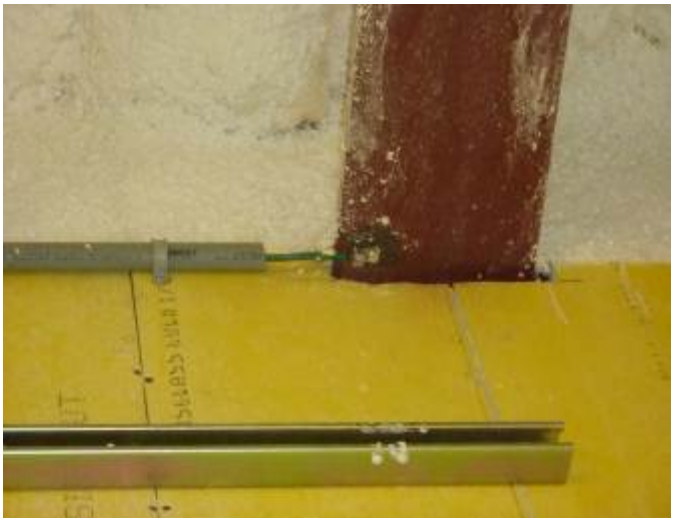
Picture A2. Panel schedule complete and accurate.

Picture A3. Working clearance observed.

Picture A4. Proper grounding of Separately Derived System.

Picture A5. Conduit compliantly supported.

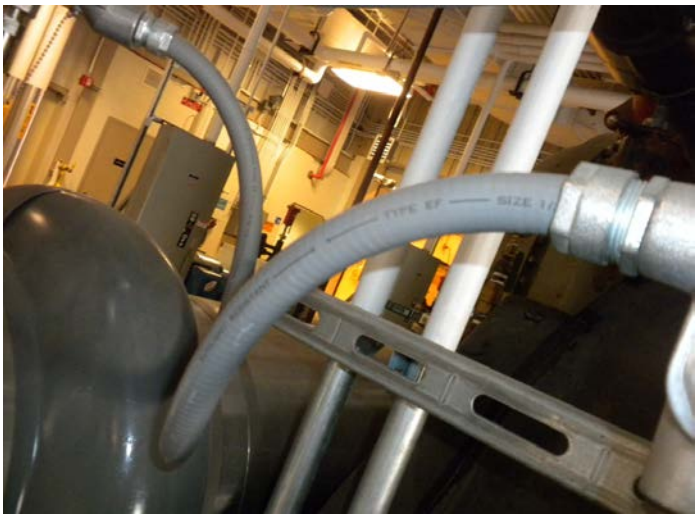
Picture B1. Liquidtight Flexible Metal Conduit does not comply with NEC 350.6 since it is not listed by NRTL.

Picture B2. Does not comply with NEC 300.11(B) and 350.30. Raceway supporting other cables and conduit not supported within 12” of box.
