CLOSEOUT REPORT
BROOKHAVEN NATIONAL LABORATORY
OPERABLE UNIT I AREA OF CONCERN (AOC) 10
WASTE CONCENTRATION FACILITY

September 2005

WESTON SOLUTIONS, INC.
205 Campus Drive
Edison, NJ 08837

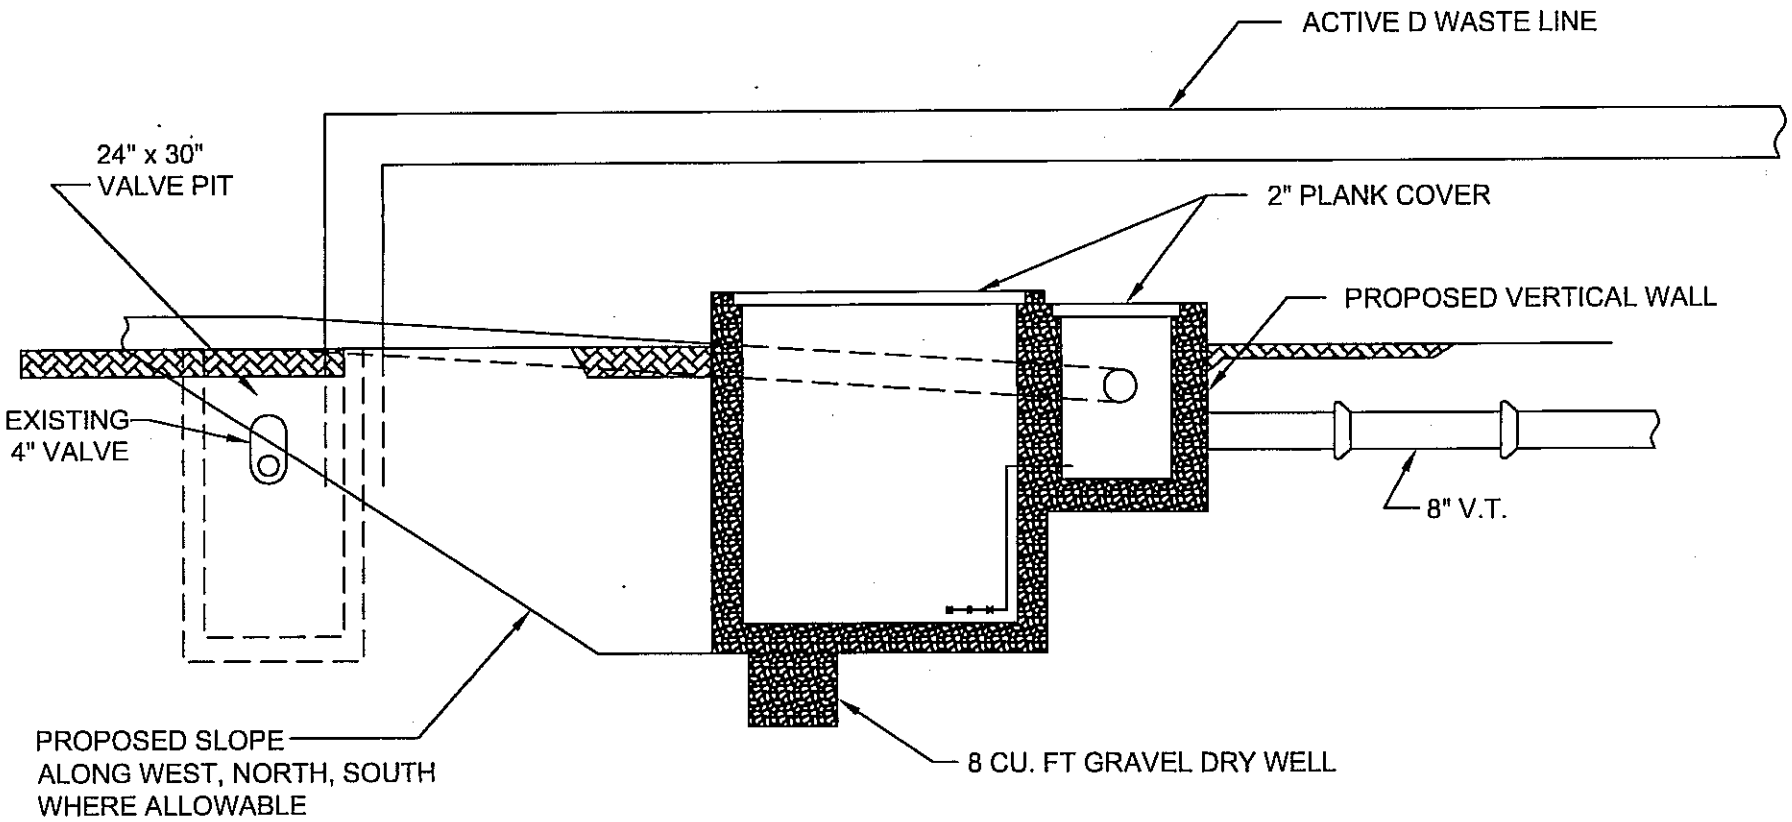
WESTON SOLUTIONS	PROJECT: Building 811 Close-Out Report	TITLE: D-WASTE VAULT EXCAVATION CROSS SECTION
DATE: 4-18-05	CLIENT NAME: Brookhaven National Labs	
FIGURE #: 3-1

The D-Waste vault was demolished beginning on 18 January 2005. Prior to demolition, BNL removed the active D-Waste Lines from service. Lines were supported and approximately eight feet of the D Waste Lines were removed from service. Disposal of vault contents is discussed in Section 3.6.5. A cross section drawing depicting the D Tank Vault excavation is provided in Figure 3-1. The D-Waste lines and other surface utilities were supported prior to the commencement of demolition activities through the use of shoring posts on the northern and southern ends of the exposed piping.

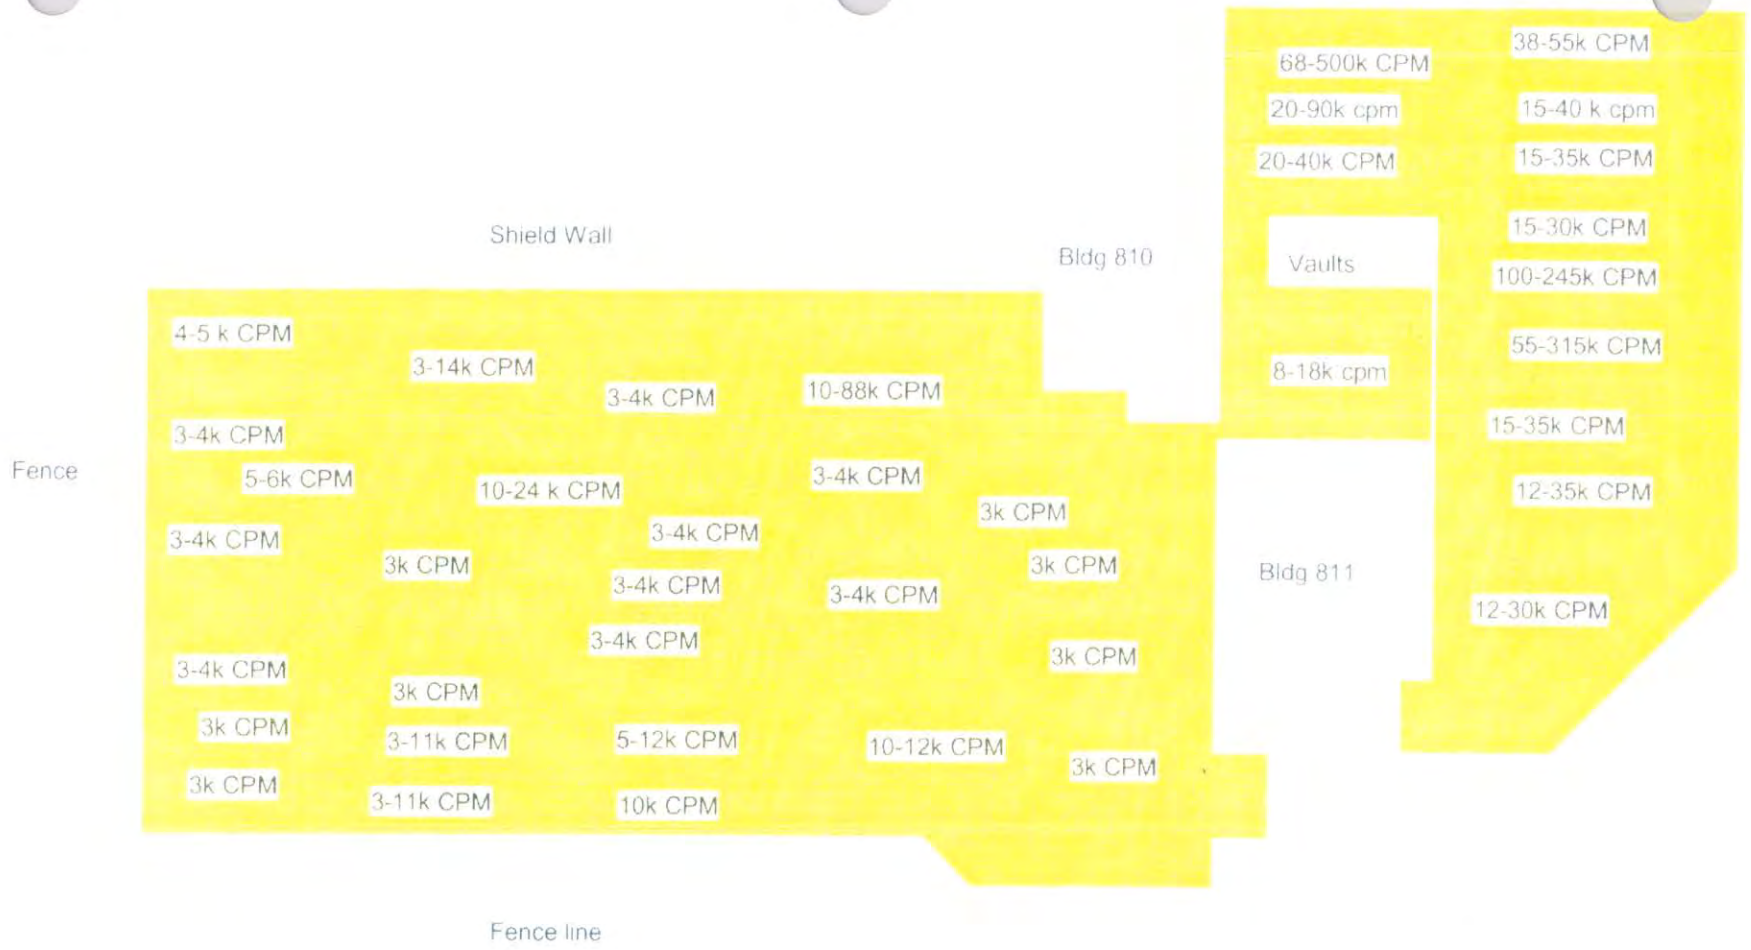
WESTON SOLUTIONS	PROJECT: BUILDING 811 REMEDIATION	TITLE: PRE-EXCAVATION WALKOVER SURVEY RESULTS
DATE: June 20, 2005	CLIENT NAME: BROOKHAVEN NATIONAL LAB	
FIGURE #: 3-2

Summary of initial Survey results for 811 area prior to remediation activities
All measurements performed using Ludlum model 2221 (2"x2" NaI)
All measurements recorded approximately 1-2" above soil
Some areas contain overburden material

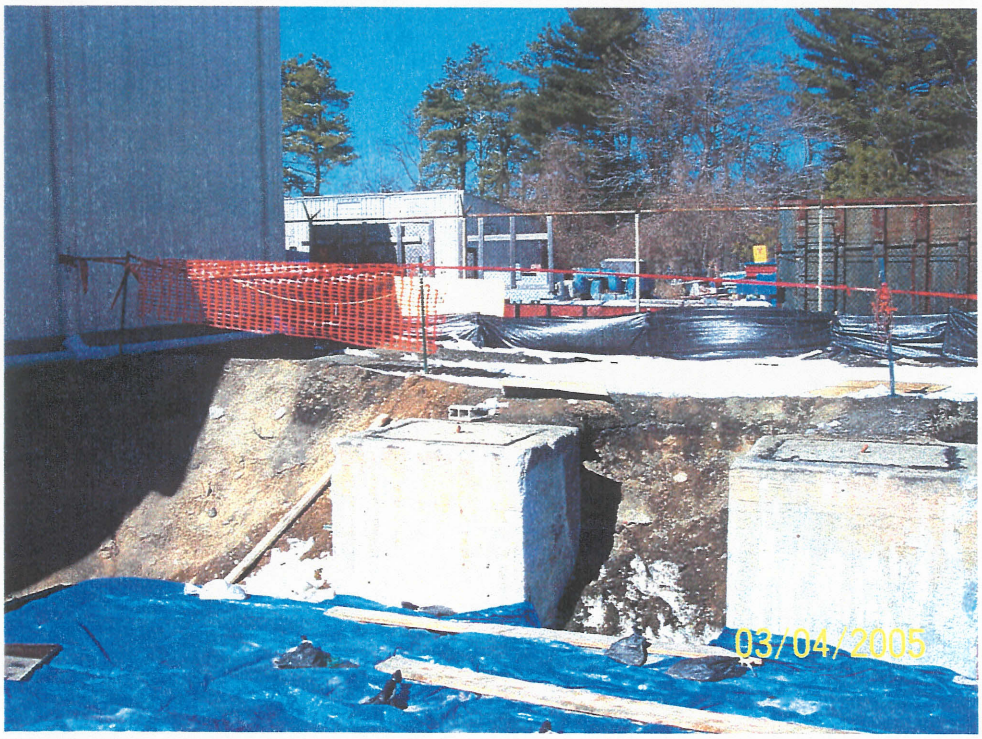
Photo 15: Valve pits were exposed in preparation for remediation

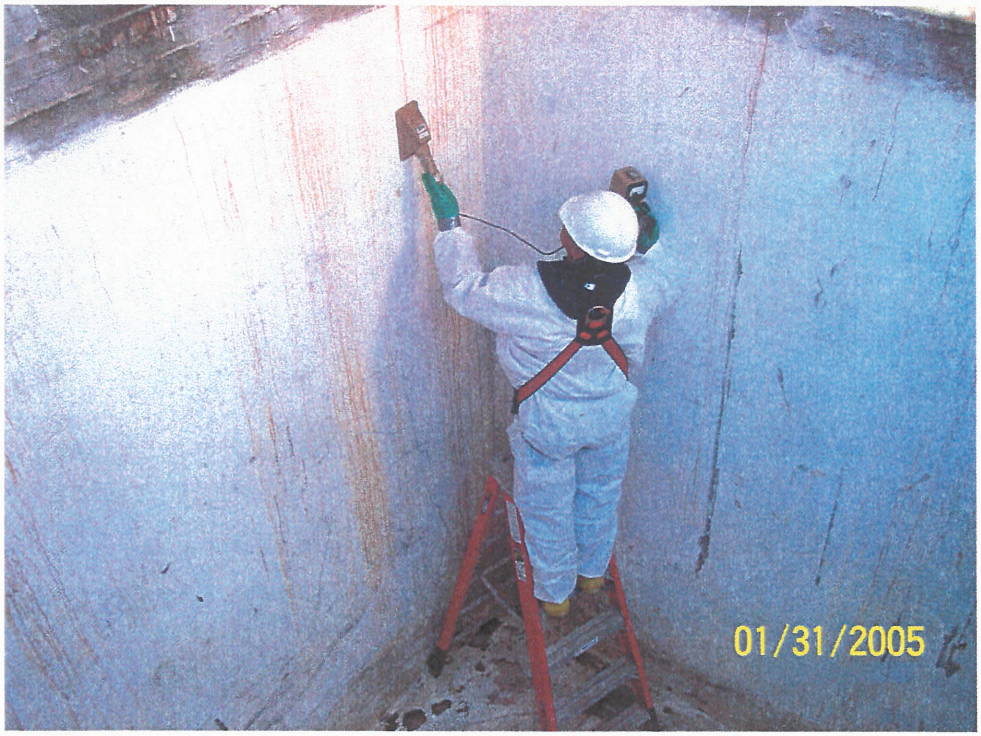
Photo 17: Vault walls are surveyed for radioactive contamination after clean-out

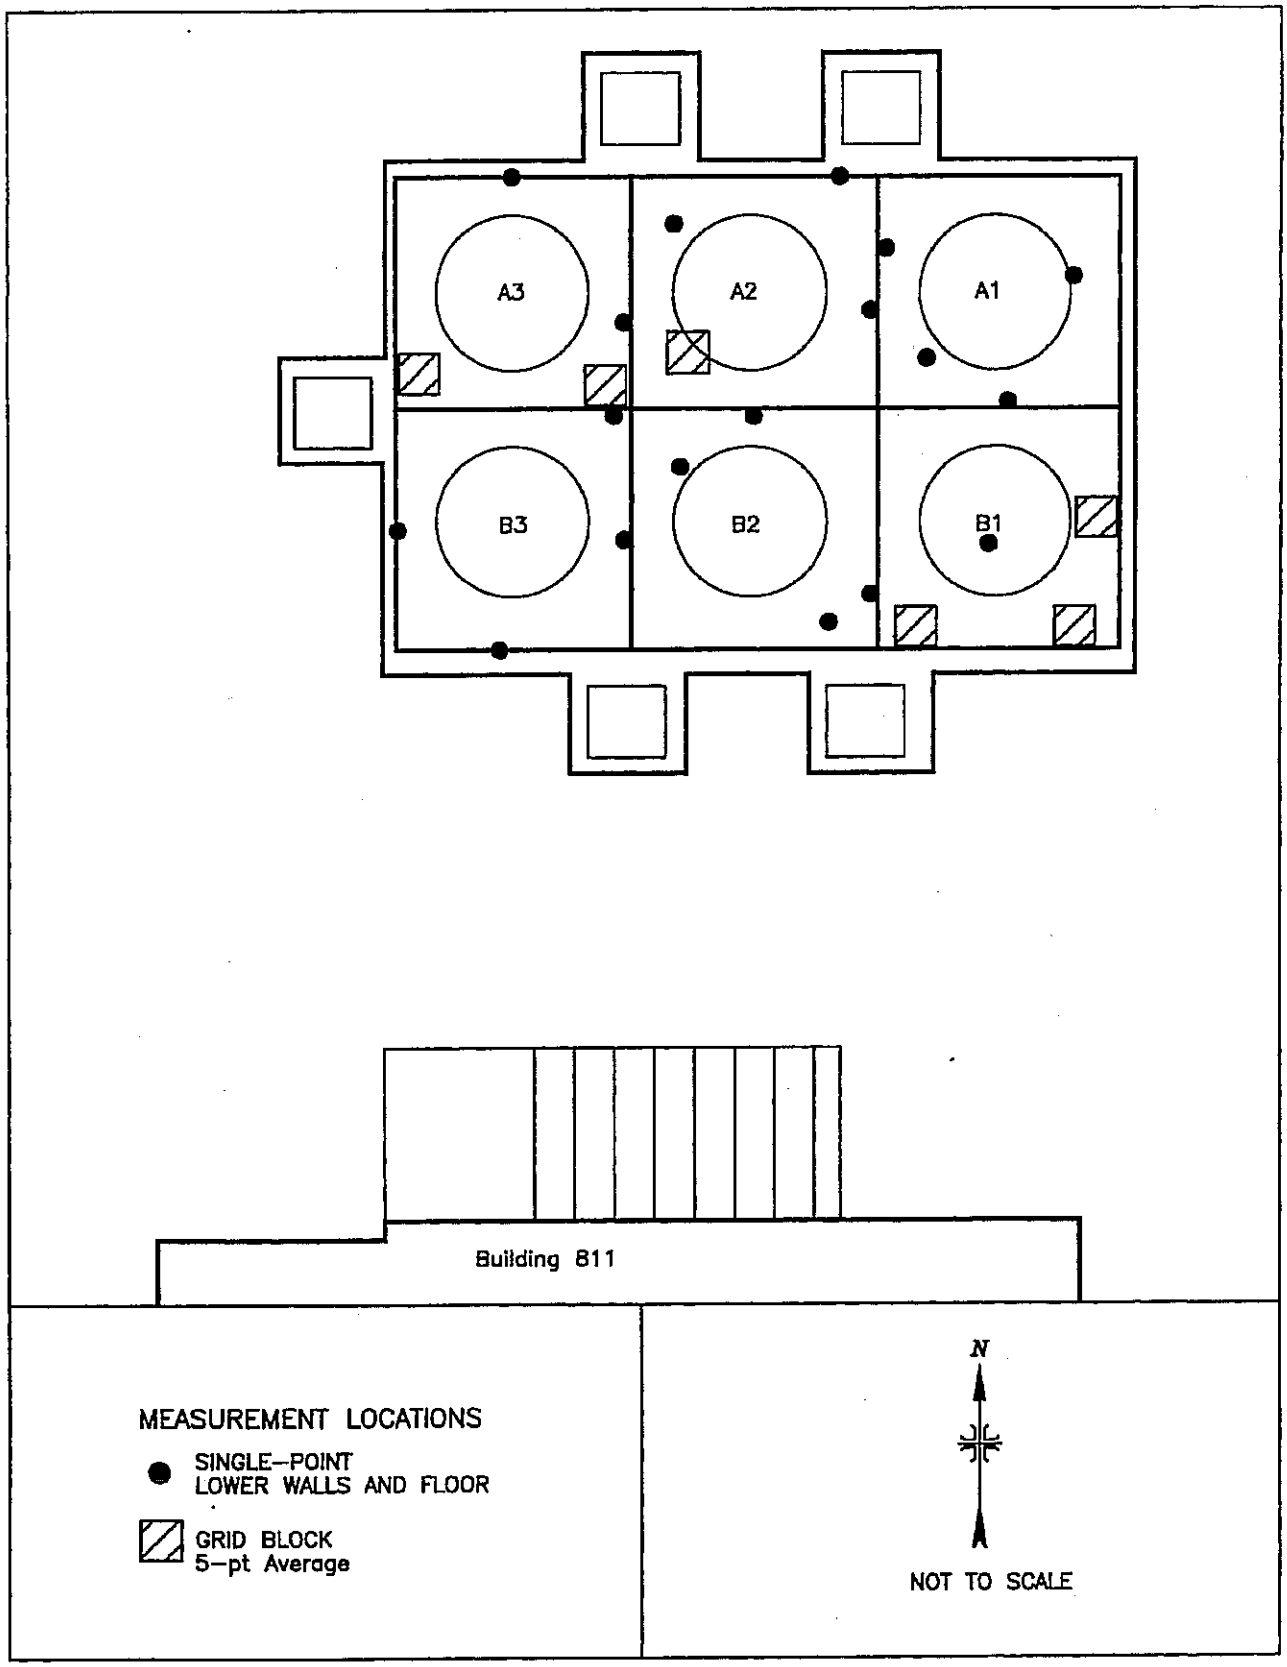
FIGURE 3: Waste Concentration Facility 811 A and B Vaults – Measurement Locations

Total surface activity measurements for alpha and alpha plus beta radiation were performed in at least four locations within each vault at the highest activity readings identified by scans. Additional measurements were also performed at judgmentally selected locations where elevated direct radiation was identified. When determined appropriate, a five-point measurement was made in the contiguous 1 m^2 area surrounding the location of elevated direct radiation to determine area average activity levels. Surface activity measurements were performed using gas proportional detectors coupled to ratemeter-scalers. Direct measurement locations within the vaults are shown in Figure 3.

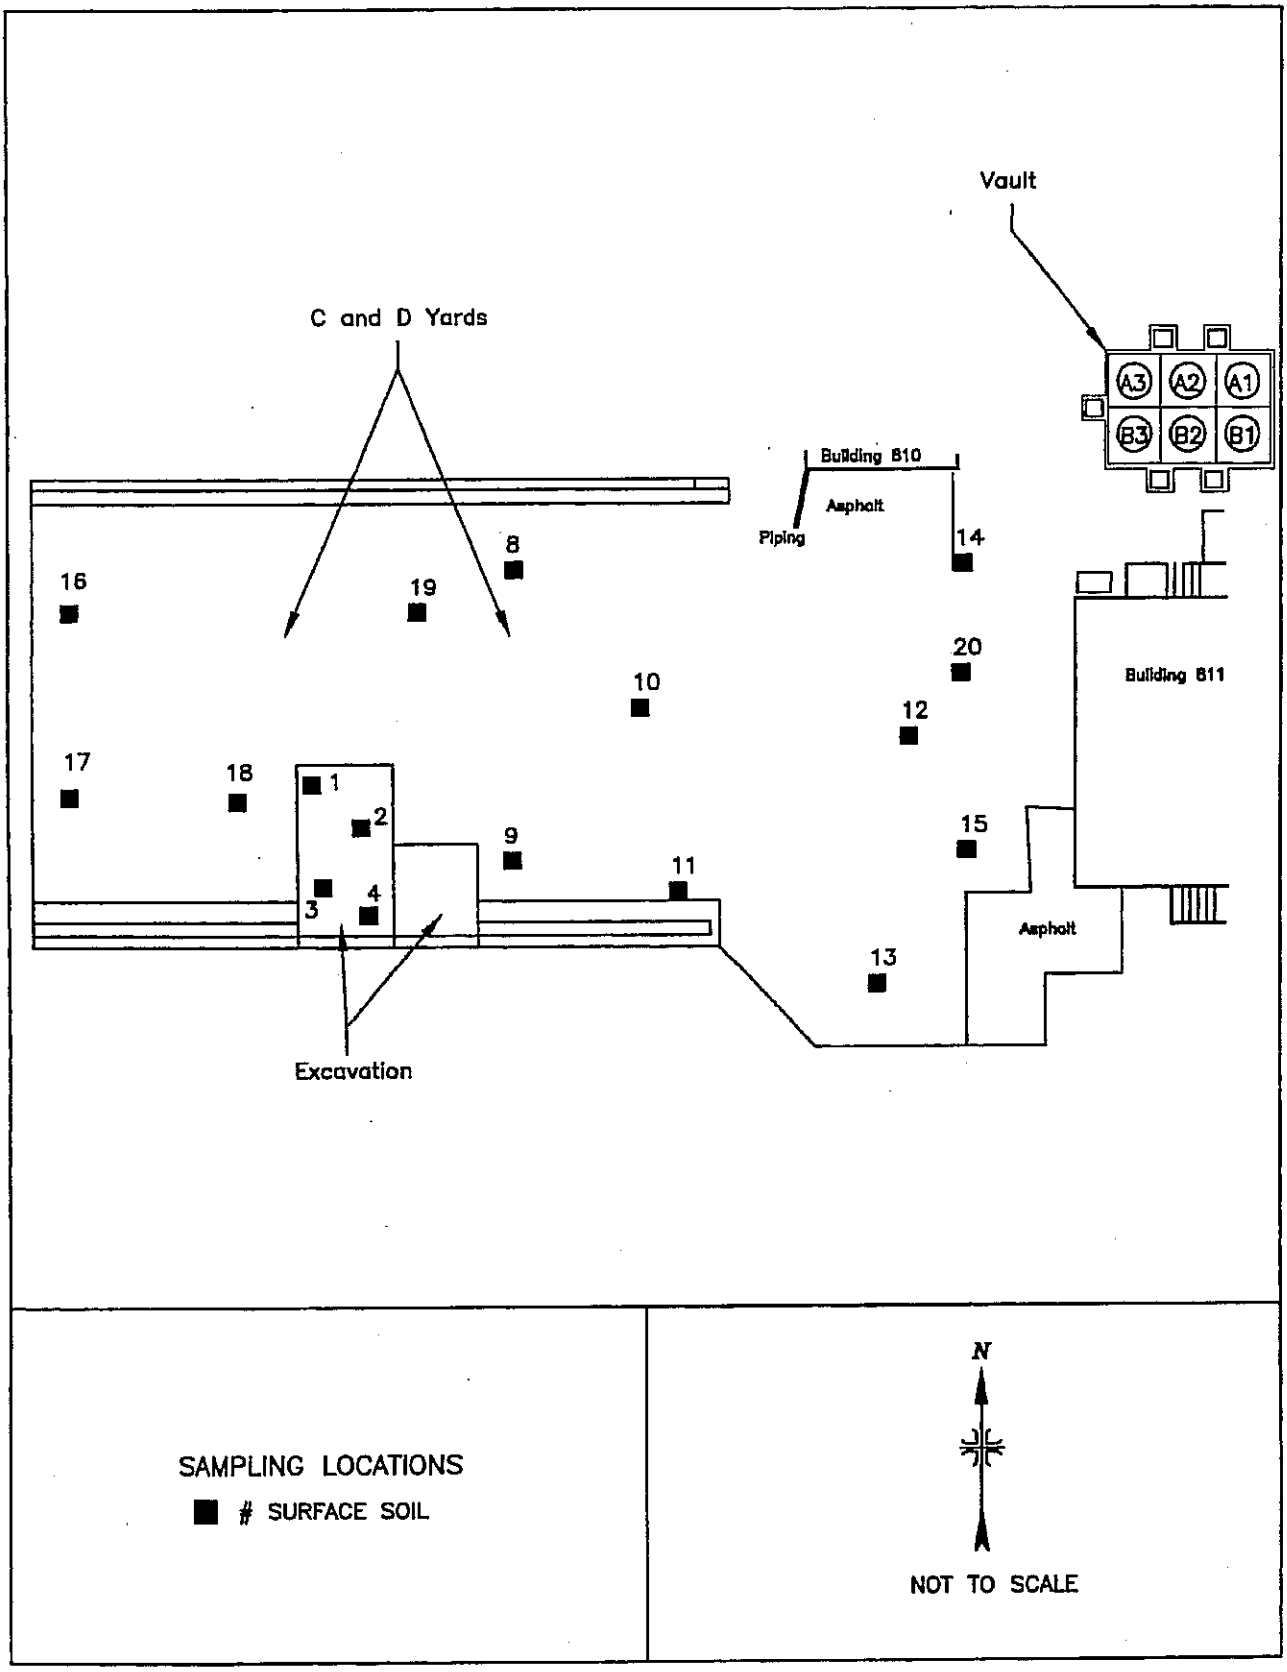
FIGURE 4: Waste Concentration Facility 811 C and D Yards – Sampling Locations

During the third and final survey effort by ESSAP the C and D Yards were rescanned. A few locations of elevated radiation were found. These were immediately removed by the contractor prior to ESSAP sampling. In an area between the 810 and 811 Building, it was difficult to discern whether the activity was from the soil or a contribution from the existing piping in the area or waste materials from the remedial operation in the A and B Yard that were stored nearby. A location was marked in the area for soil sampling.
