Brookhaven Graphite Research Reactor Decommissioning Project

DRAFT CANAL AND WATER TREATMENT HOUSES, EQUIPMENT, AND ASSOCIATED SOILS COMPLETION REPORT

April 15, 2002

BGRR-048, Rev. C
April 15, 2002

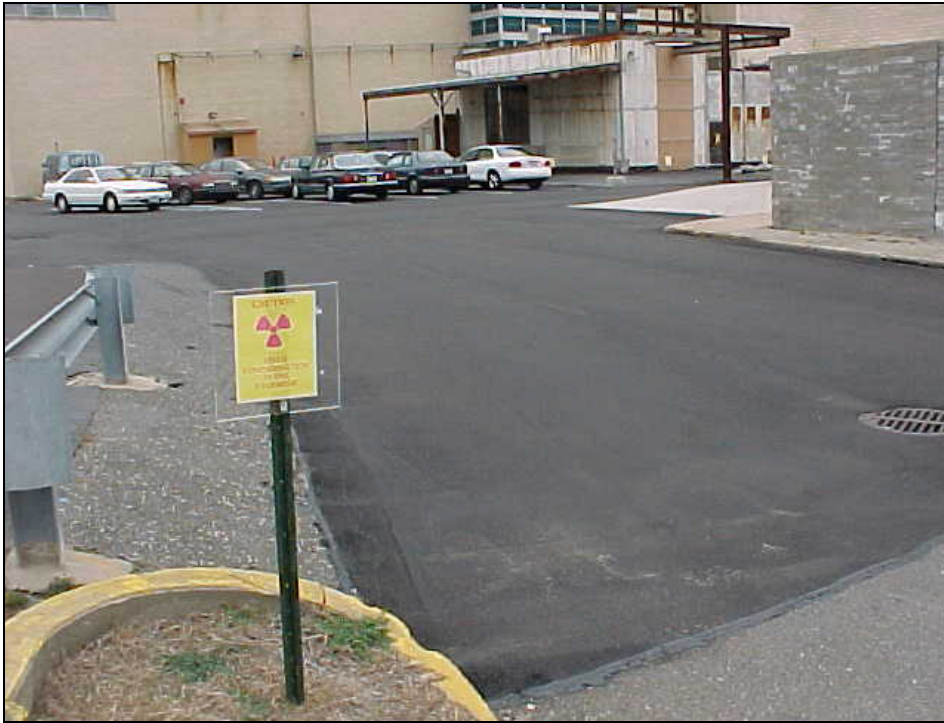
Figure 4. South Soils Area of the Canal Removal Action

Figure 4 shows the soils area south of the Canal from which several below-grade piping lines and four concrete vaults were removed. A new storm drain system was installed to separate it from the buildings 703 and 801 drains. The new storm drain flows through the catch basin seen on the far right side of the picture.

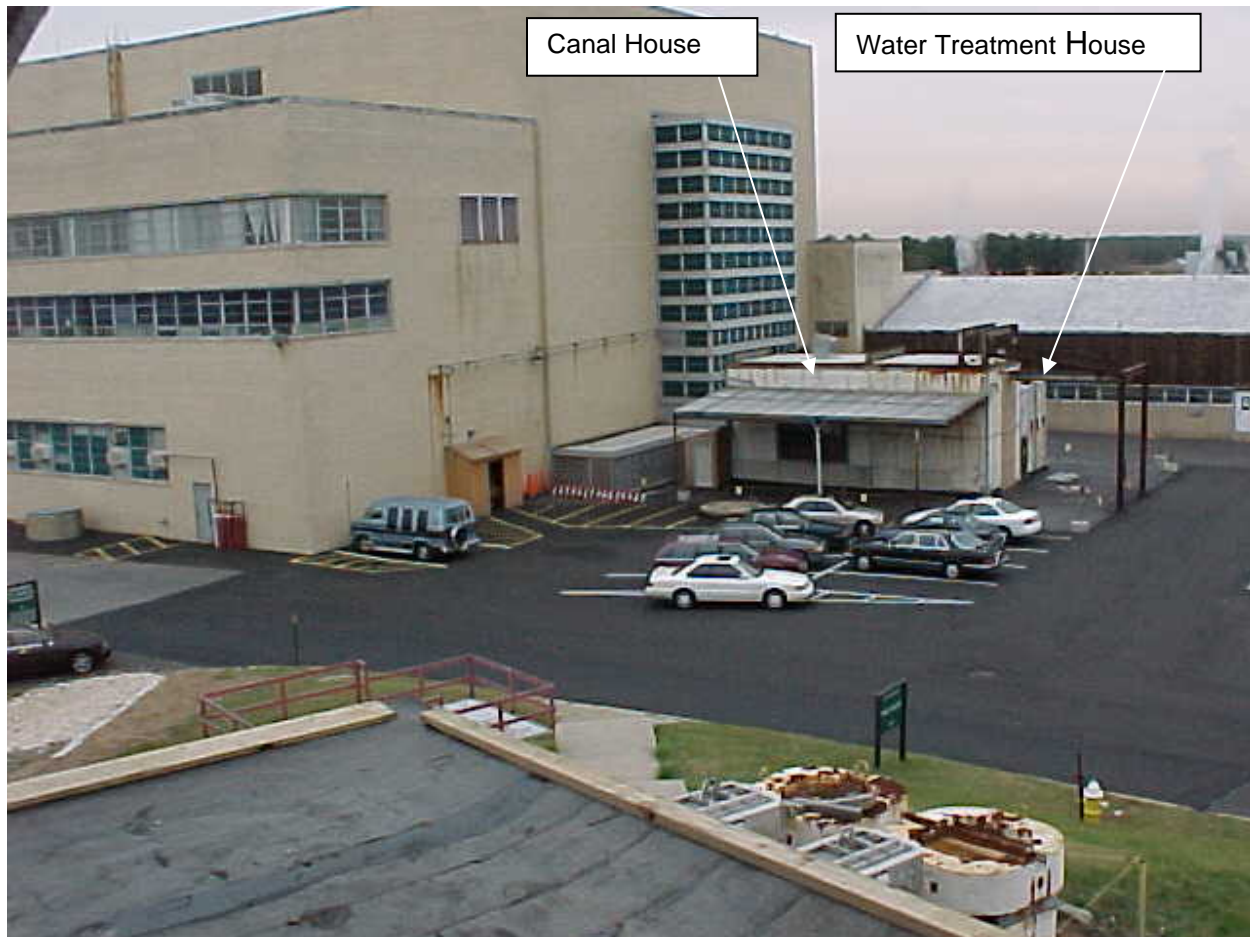
View of the Canal and Water Treatment House and the associated soils area before work began. The Canal House was constructed of a steel frame with "cemestos" siding (a concrete-asbestos containing material) a flat built-up roof, and a cemestos south pad awning. The main floor of the Canal House had a 4-foot by 14-foot opening that was used to raise and lower equipment and wastes from the Canal area (approximately 9 feet below grade level elevation of 109 feet).

The Water Treatment House was an addition to the Canal House and was connected to the north wall of the Canal structure. It was constructed of concrete blocks, with a built-up roof and its foundation was a slab of concrete.

A concrete pad area extended around the Canal and Water Treatment structures. It was covered with a heavy plastic membrane and filled with crushed stone. A layer of asphalt was placed over the stone to control drainage for the area.

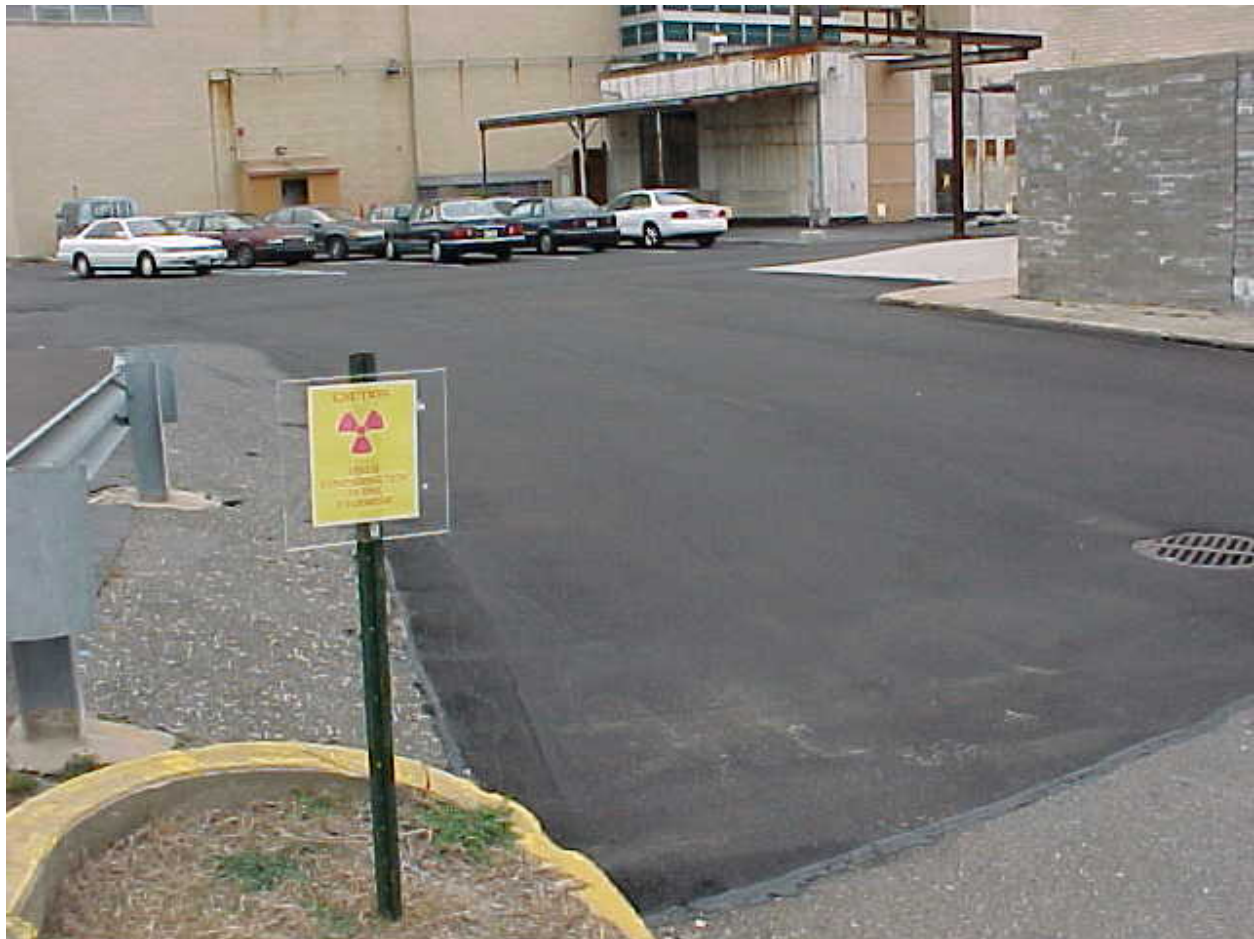
Spots under the asphalt layer of the paved area were known to be contaminated. There were several piping systems below grade that were removed during the execution of the Canal work. Among the items removed were the Canal discharge line, the reactor's pneumatic transfer lines, one section of an existing storm drain that was known to be contaminated, the rod storage vault, and three low-level radioactive waste storage vaults located on the south side of the Canal.

To remove the old storm-drain system the existing storm drains first had to be rerouted and a new system installed.

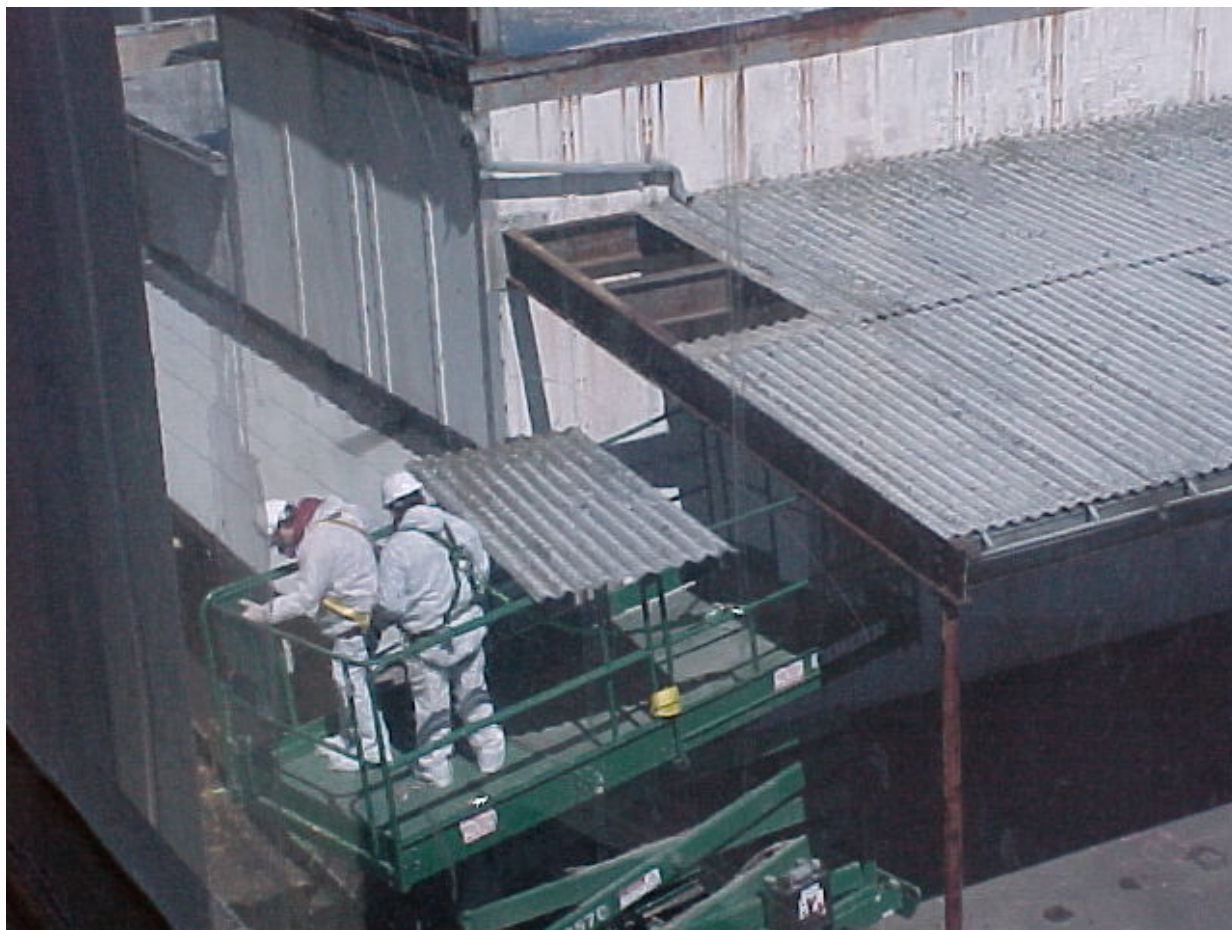
Asbestos workers on a manlift, removing awning panels. Each panel contained asbestos, requiring piece-by-piece removal, rather than allowing the material to fall and shatter.

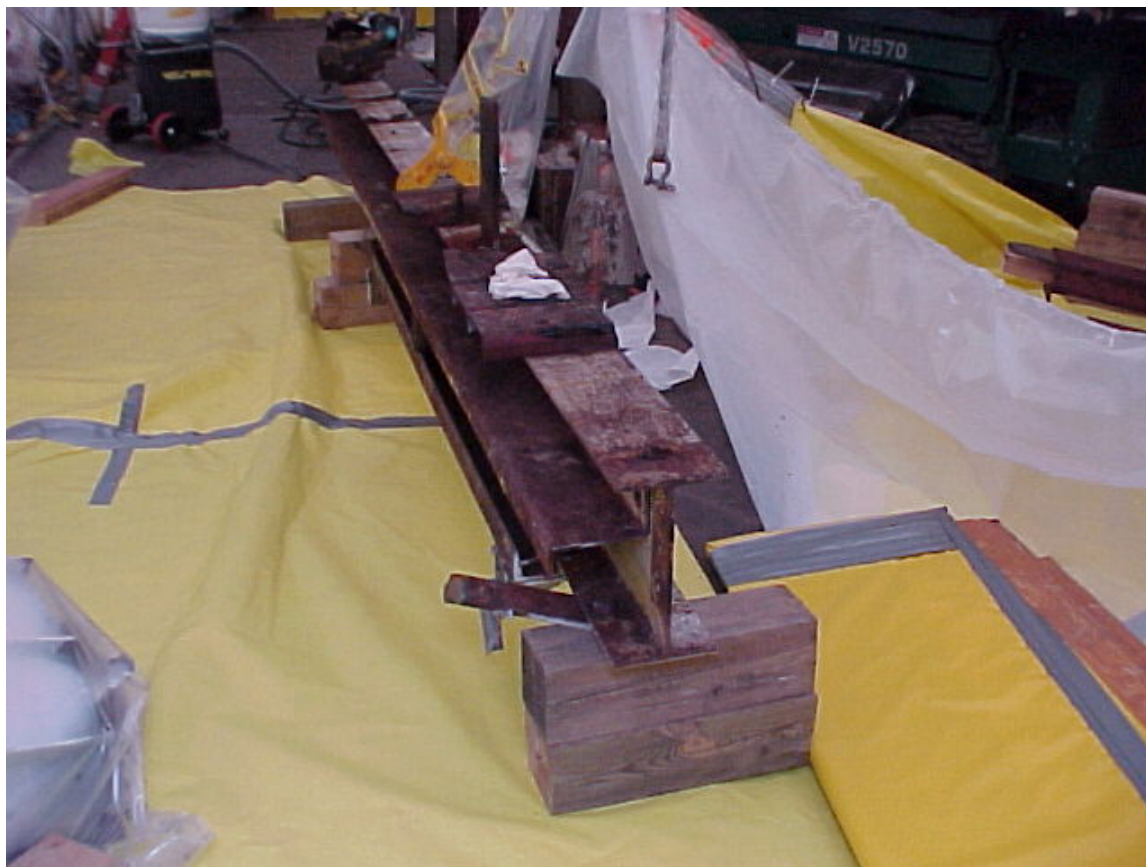
This is the first beam of the steel framing of the Canal House staged to be reduced in size for packaging and disposal. The Canal House was disassembled -- rather than demolished -- because demolition would have made control of the hazardous asbestos-containing material siding more difficult. The asbestos would have become friable, requiring workers to take additional precautions.

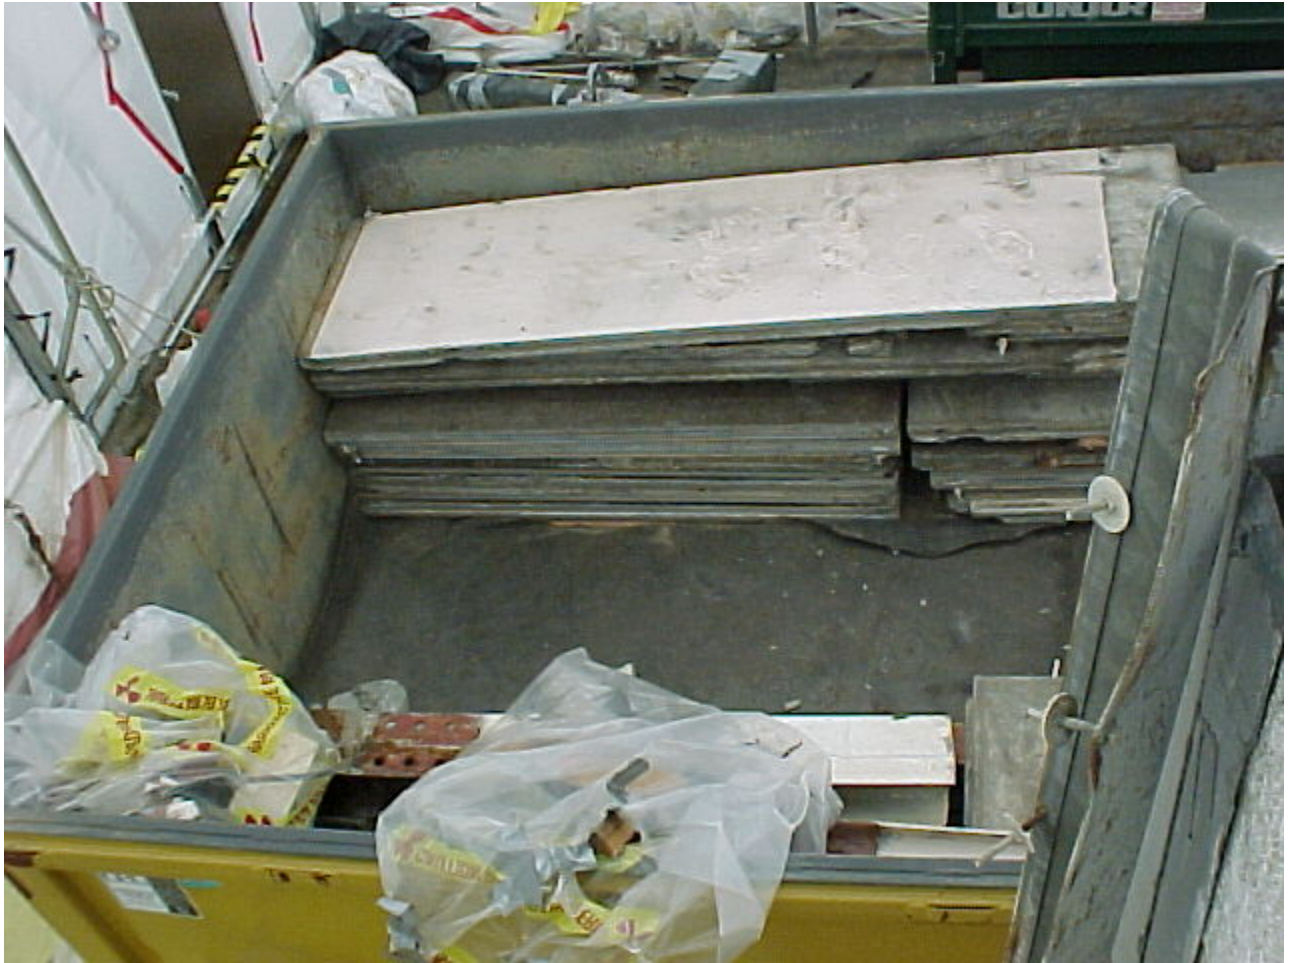
Asbestos-containing roof slabs were packaged for disposal.

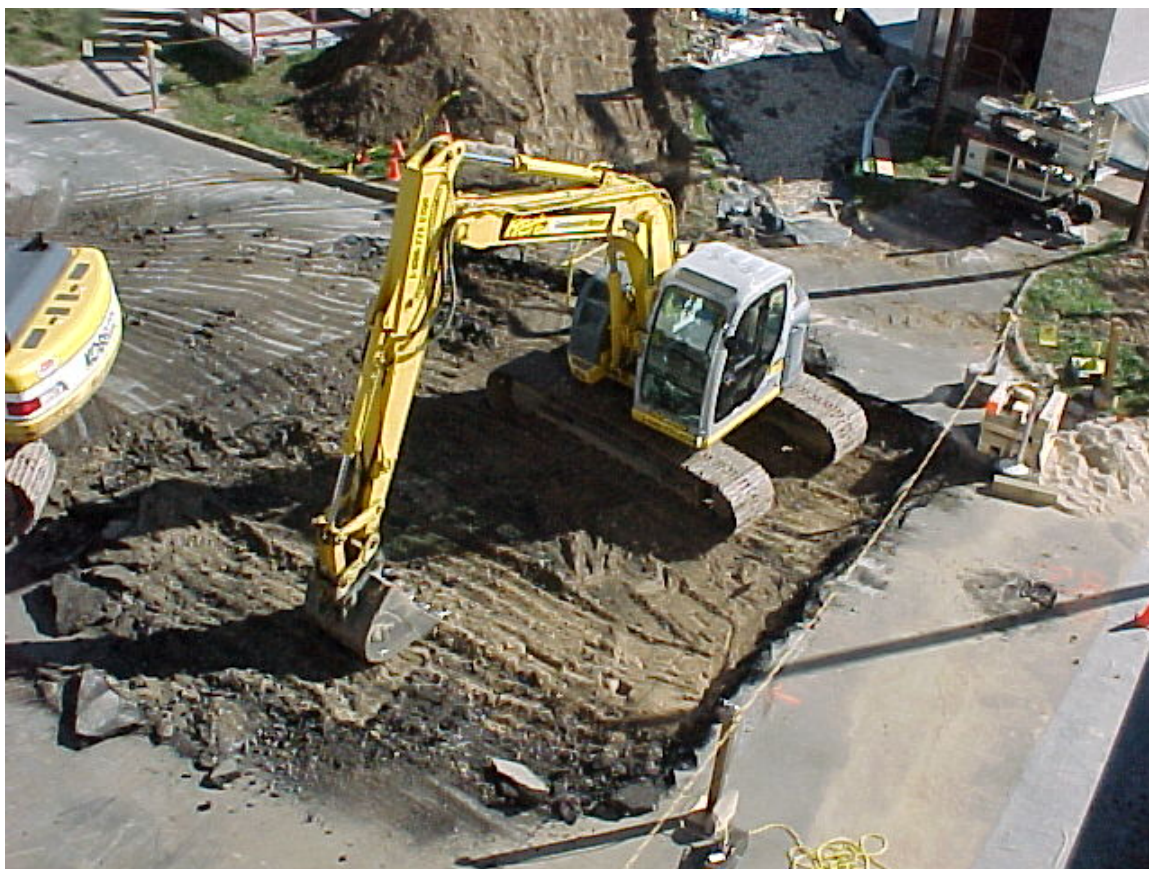
Photo taken from the southeast corner of Building 701 shows the beginning of the excavation of the asphalt and soils on the south side of the Canal area.

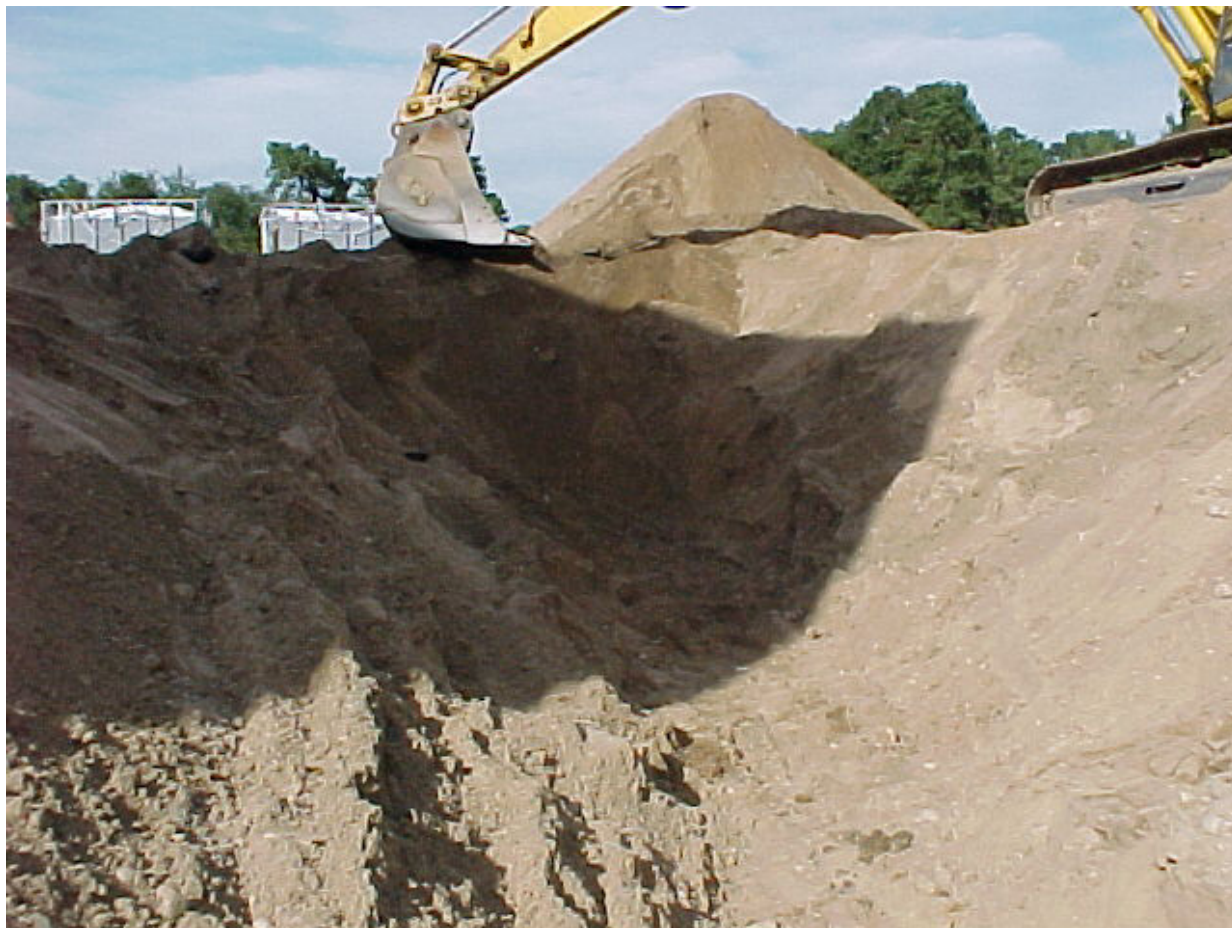
The excavation continued east of Building 703 and became much deeper to uncover the Canal's discharge line that ran east into the piping trench extending from Building 801 to Building 811. The discharge line in this area was approximately 12 feet below-grade.

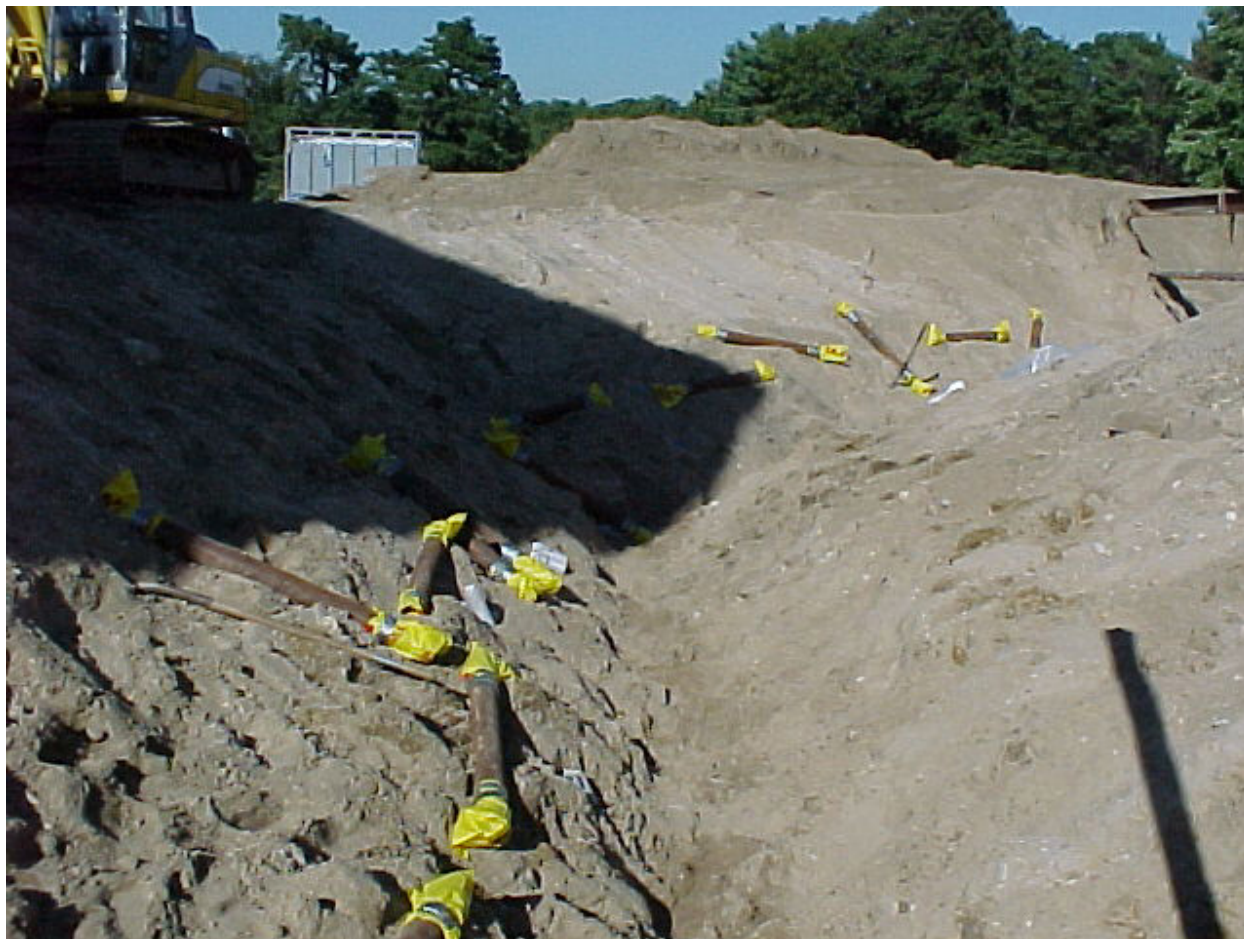
The Canal discharge line was removed in sections suitable for packaging. The covered sections of line were placed into disposal containers. The exteriors of the pipes were not contaminated.

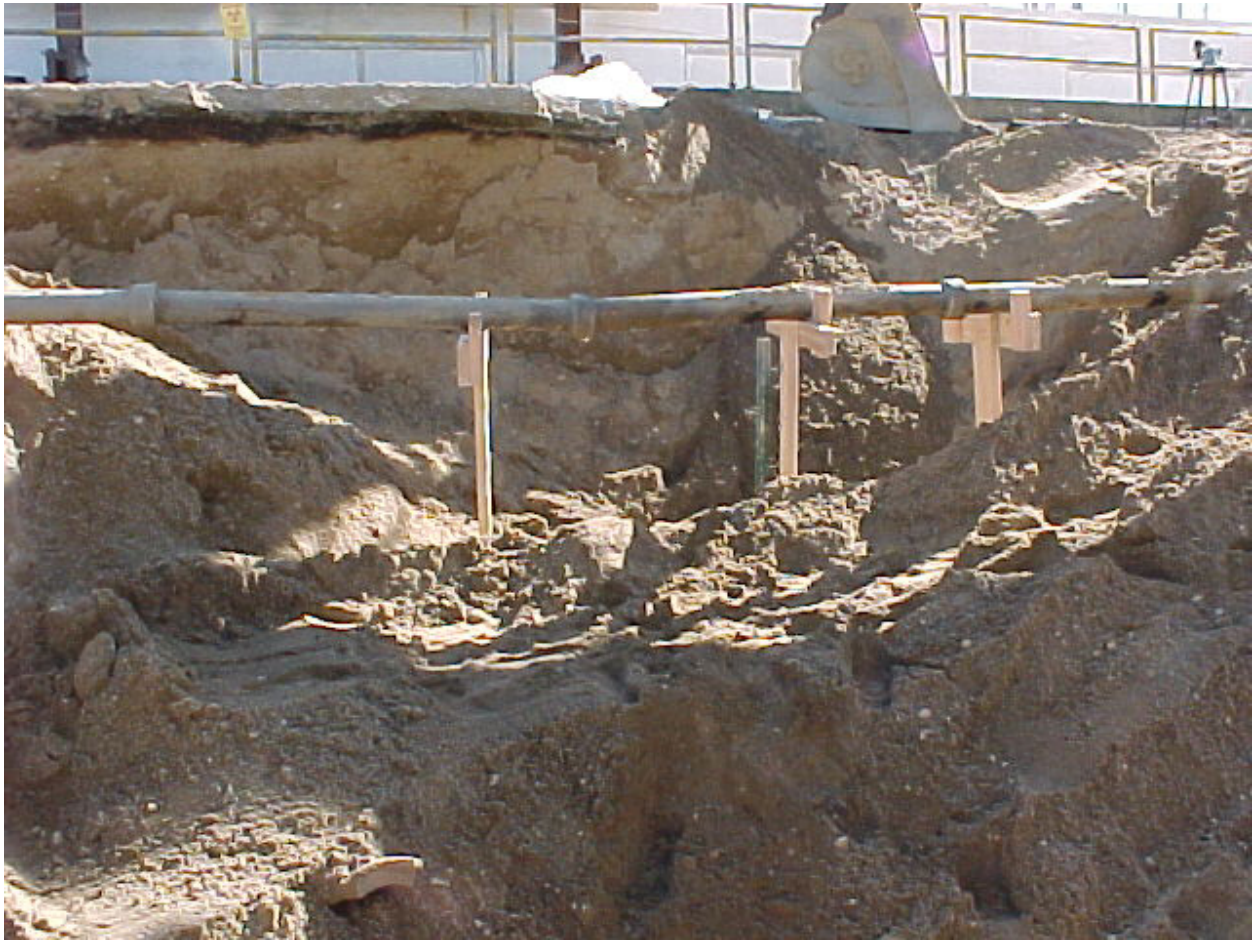
The sewer line was supported during the excavation for the deeper Canal discharge line. It had to be removed and replaced because it was close to the discharge line. The sewer line is a cooling-water discharge line from a laser device in Building 703. The Laser was not used for approximately two weeks to give the project enough time to remove the sewer line and gain access to the Canal discharge line. Once the Canal discharge line was taken out, the sewer line was replaced and the laser could be operated again.

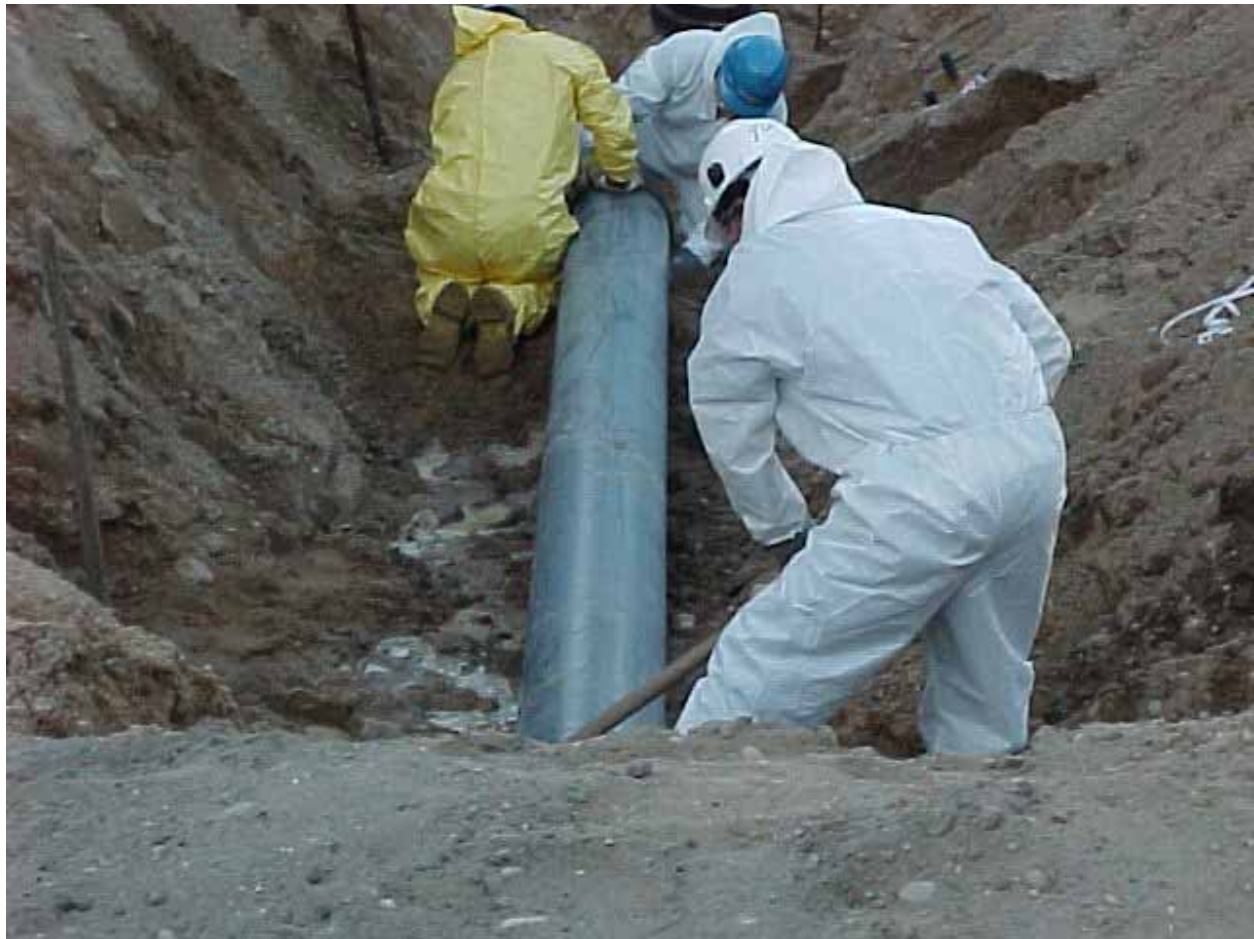
Once the area was cleared, the storm drain piping had to be replaced. The water in the trench is clean storm-drain water (rainwater run-off).

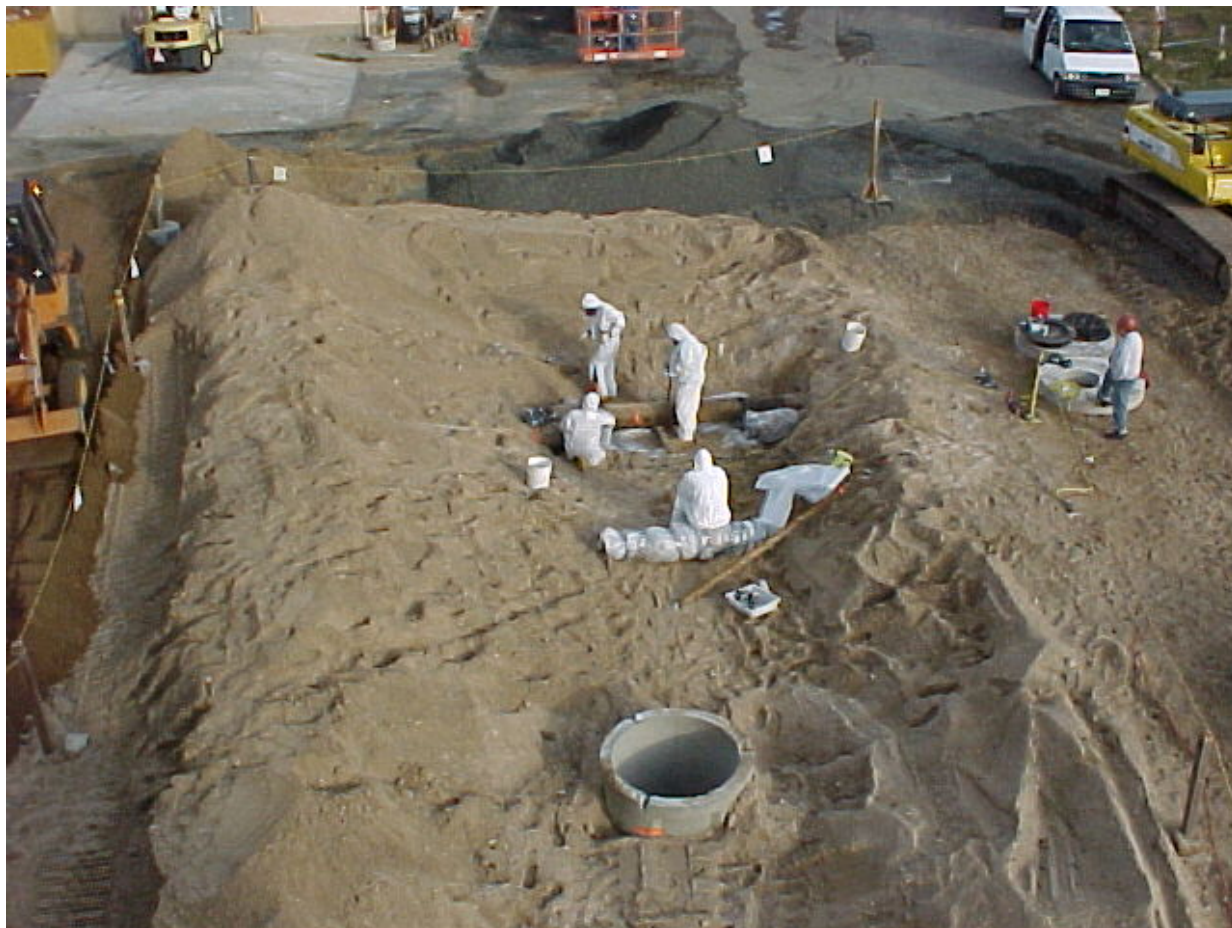
Looking east, of the abandoned chilled-water and air lines are moved from the new storm drain trench. Workers were protective clothing and respirators due to the pipes' asbestos coating and the potential for the piping to be internally contaminated. One of the new storm drain catch basins has been installed near the bottom of the picture.

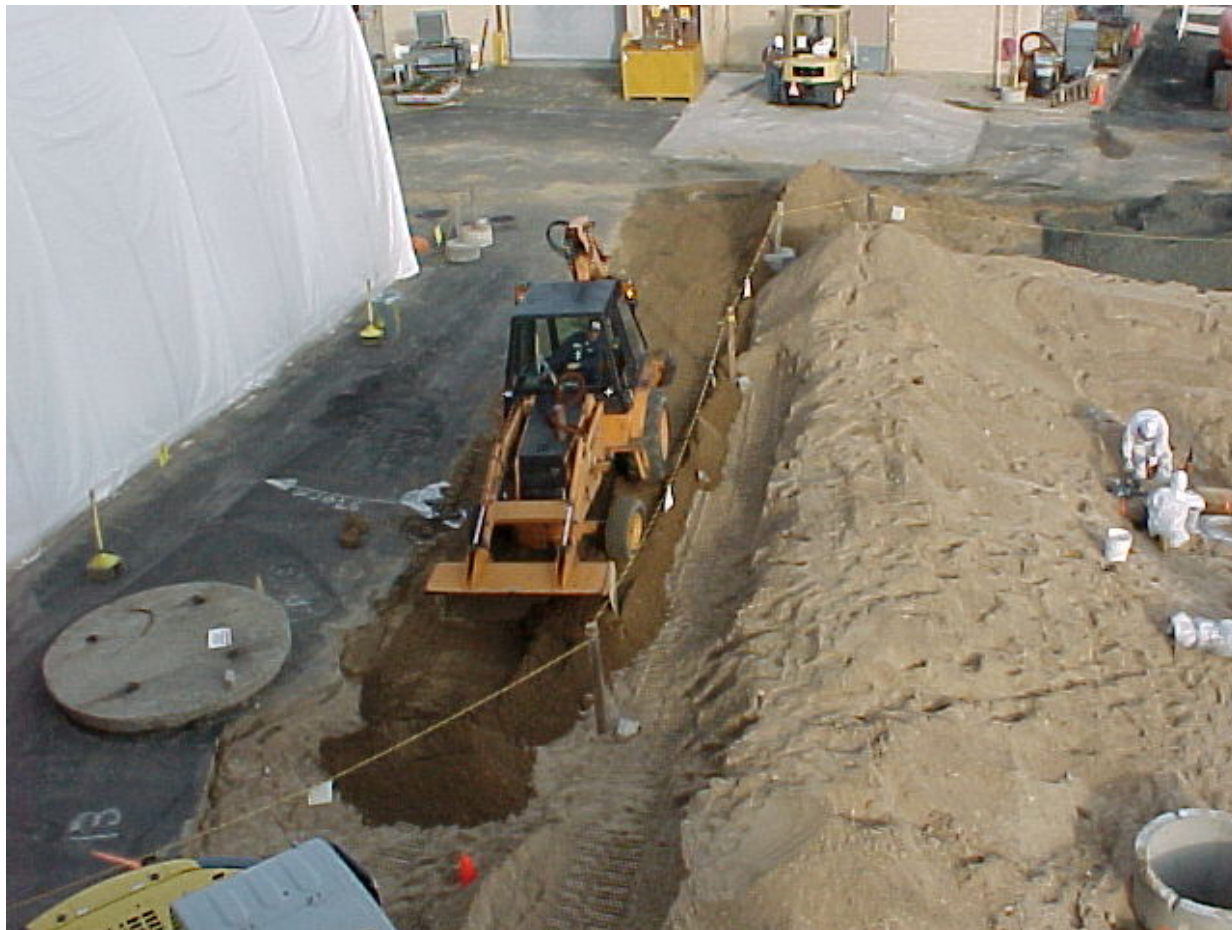
Back fill of the area near the south side of the large tent. A lift then was placed in this area to assist in the disassembling of the large tent.

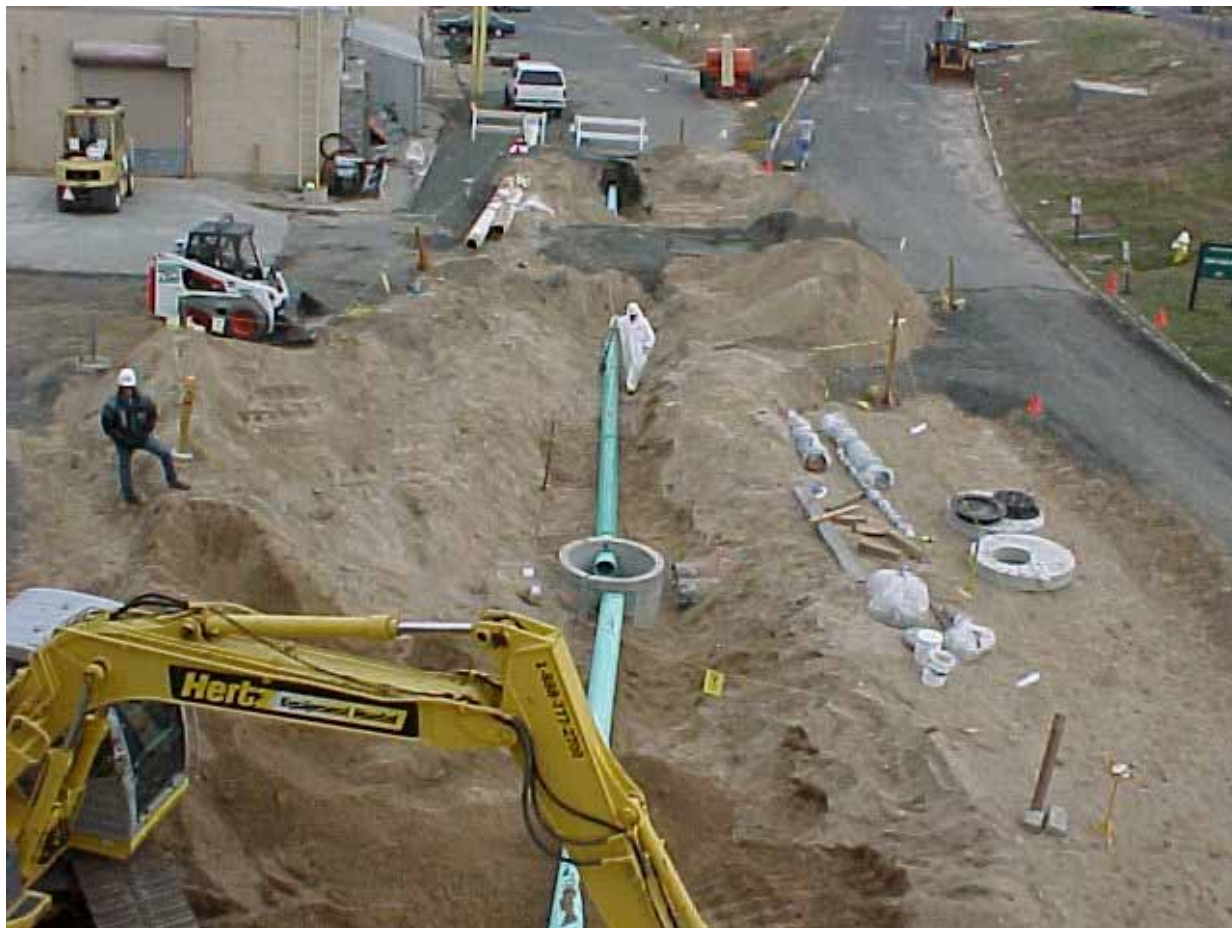
Installation of the new storm drain piping system. When this is completed, the storm drains will be connected to the new system. After of the new concrete storm-drain catch basin is finally in place, near the center of the picture, it will catch the surface rainwater run-off. This picture was taken from Building 701 looking east; the corner of Building 801 is visible in the back left.

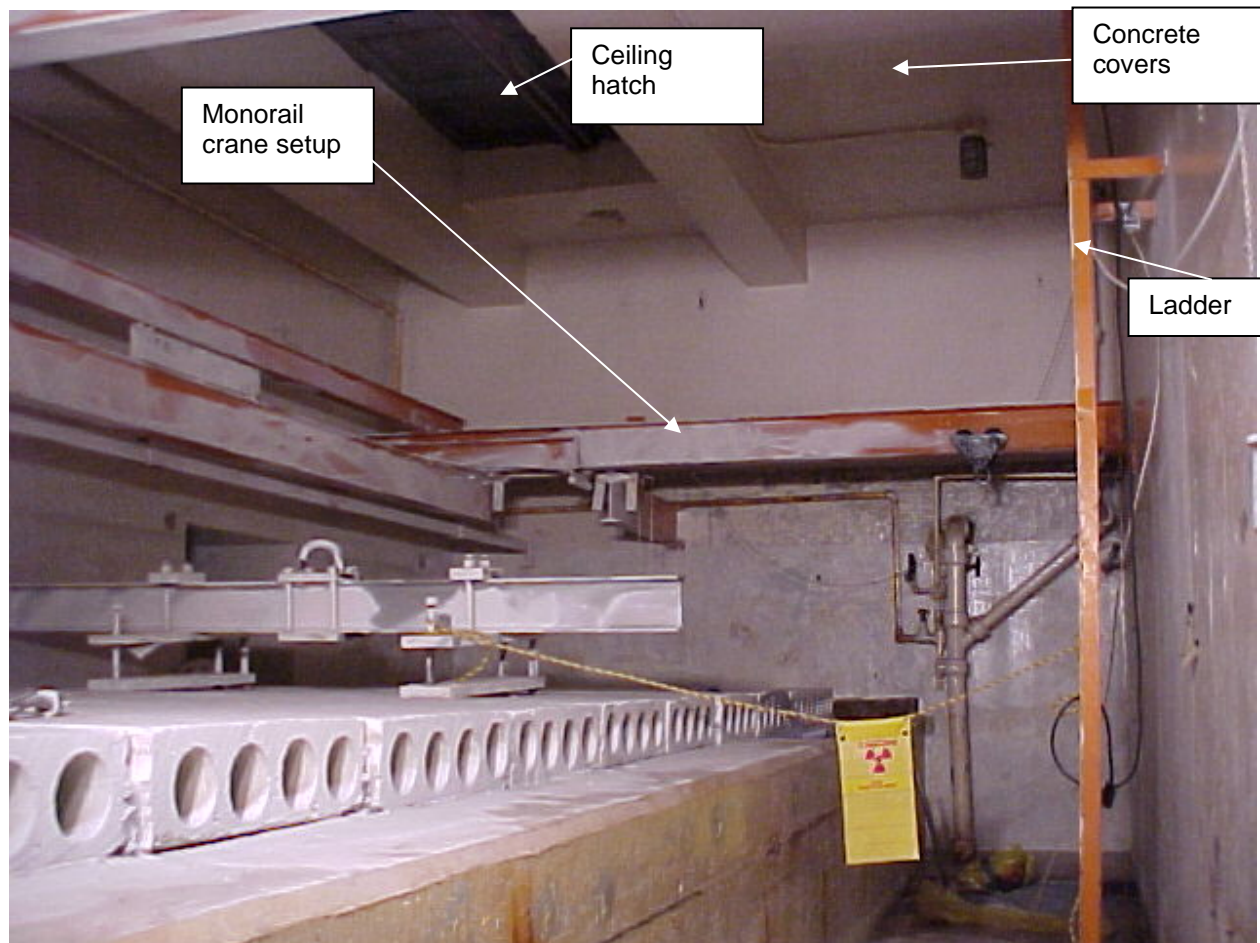
The east end of the lower Canal area. The ceiling contained the equipment hatch to the main floor of the Canal area; The ladder gave personnel access to and from the main floor. The concrete covers were still in place. The orange steel-framing was the monorail crane setup in the lower Canal area that to moved equipment and material from the deep pit on the west end of the Canal into and along it.

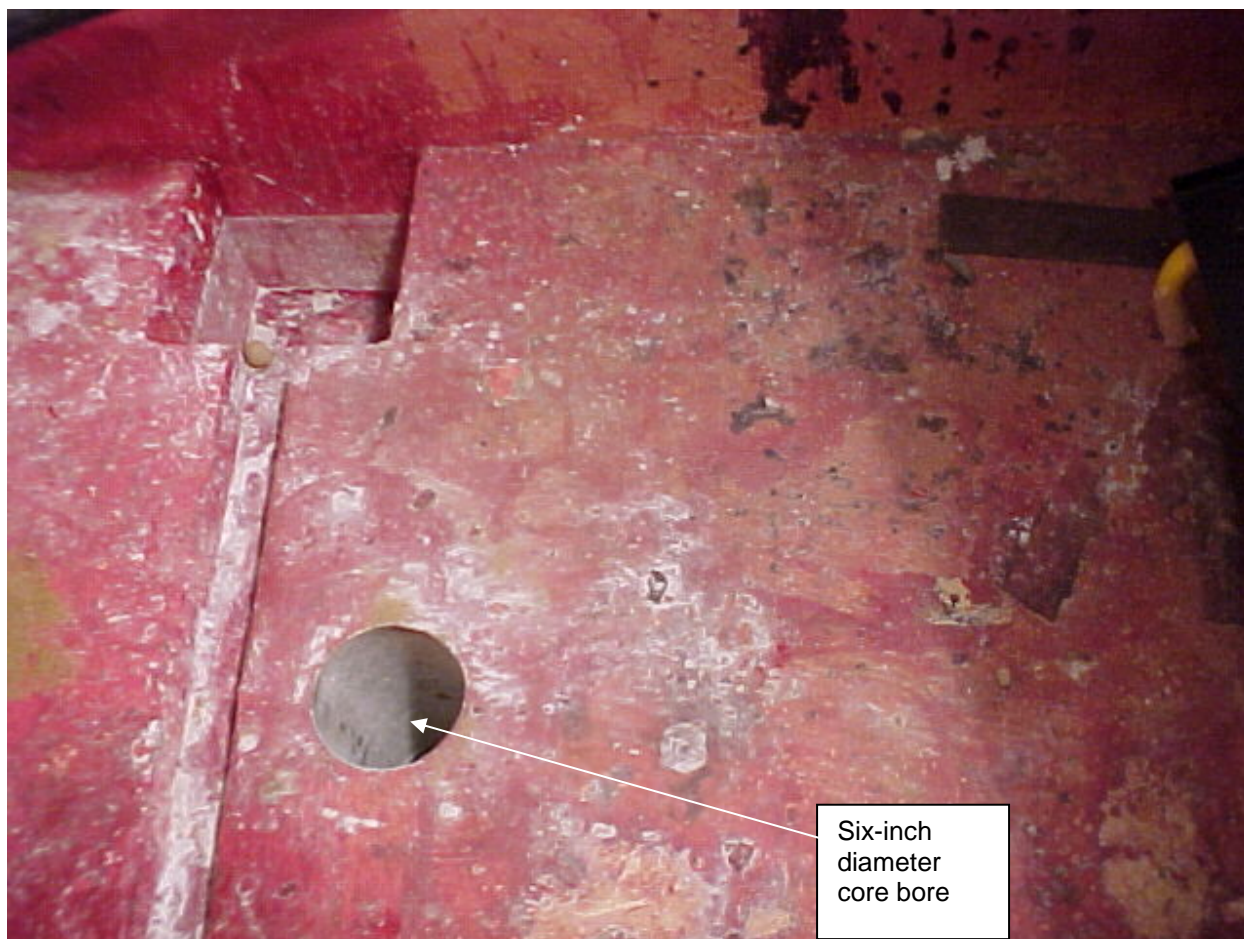
Characterization of the Canal and the soils below it required taking concrete core bores through the Canal floor at many locations. This shows a six-inch diameter core bore near one of the floor drain sumps. The concrete in this section is 2 feet thick.

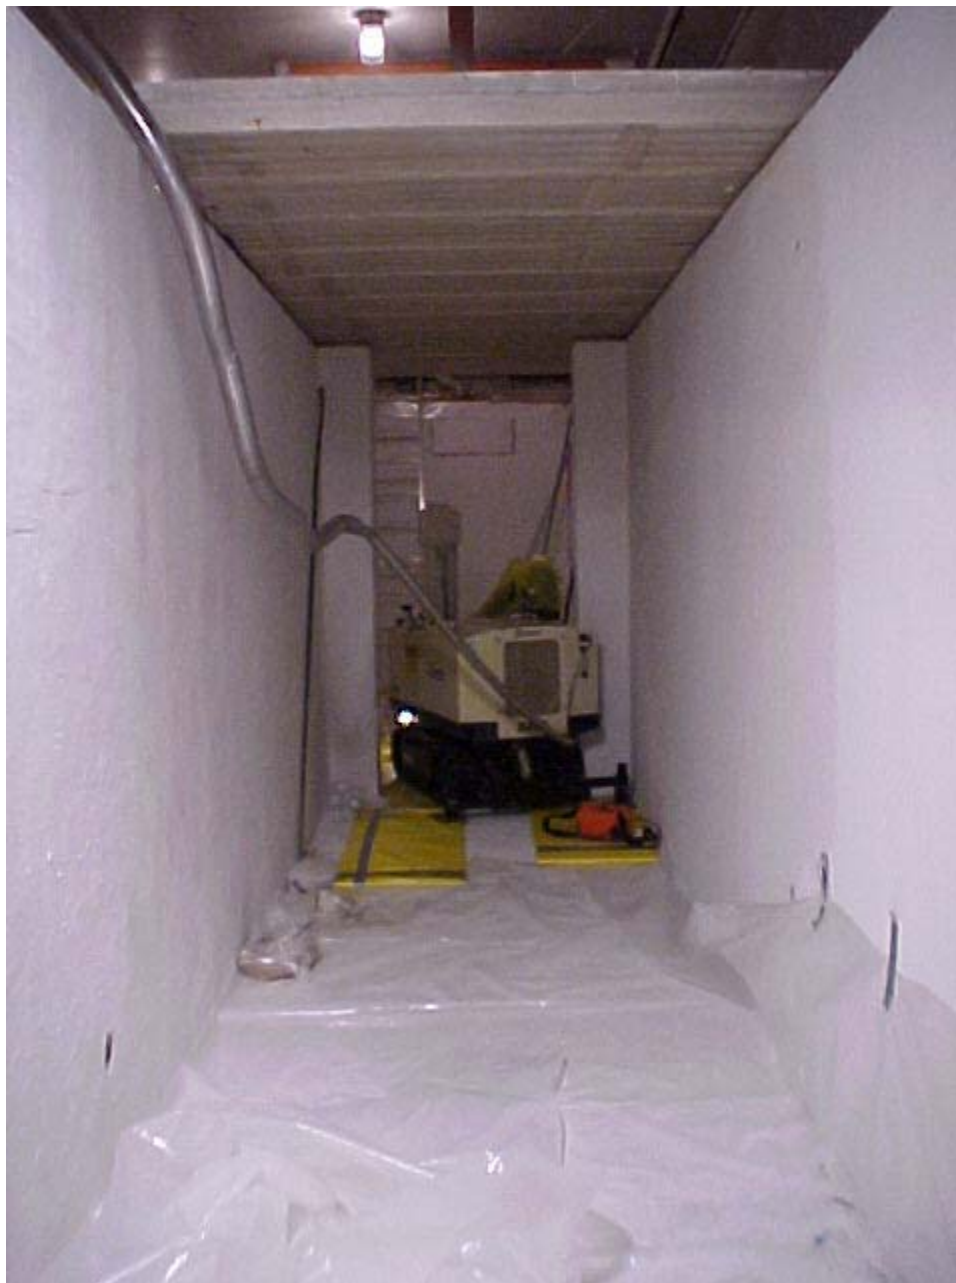
Following the initial core bores, more fixative was applied to the Canal area. This picture was taken from the Canal floor looking west. The small diesel-engine-driven Geoprobe, weighing 2,500 pounds, was lowered 18 feet from grade level to the floor of the 9-foot-deep Canal. The Geoprobe to extracted soil samples to ground water for characterization. The Canal's walls are 9 feet high and its floor is 6 feet wide. The concrete covers that sealed the top of the Canal were removed to provide access.

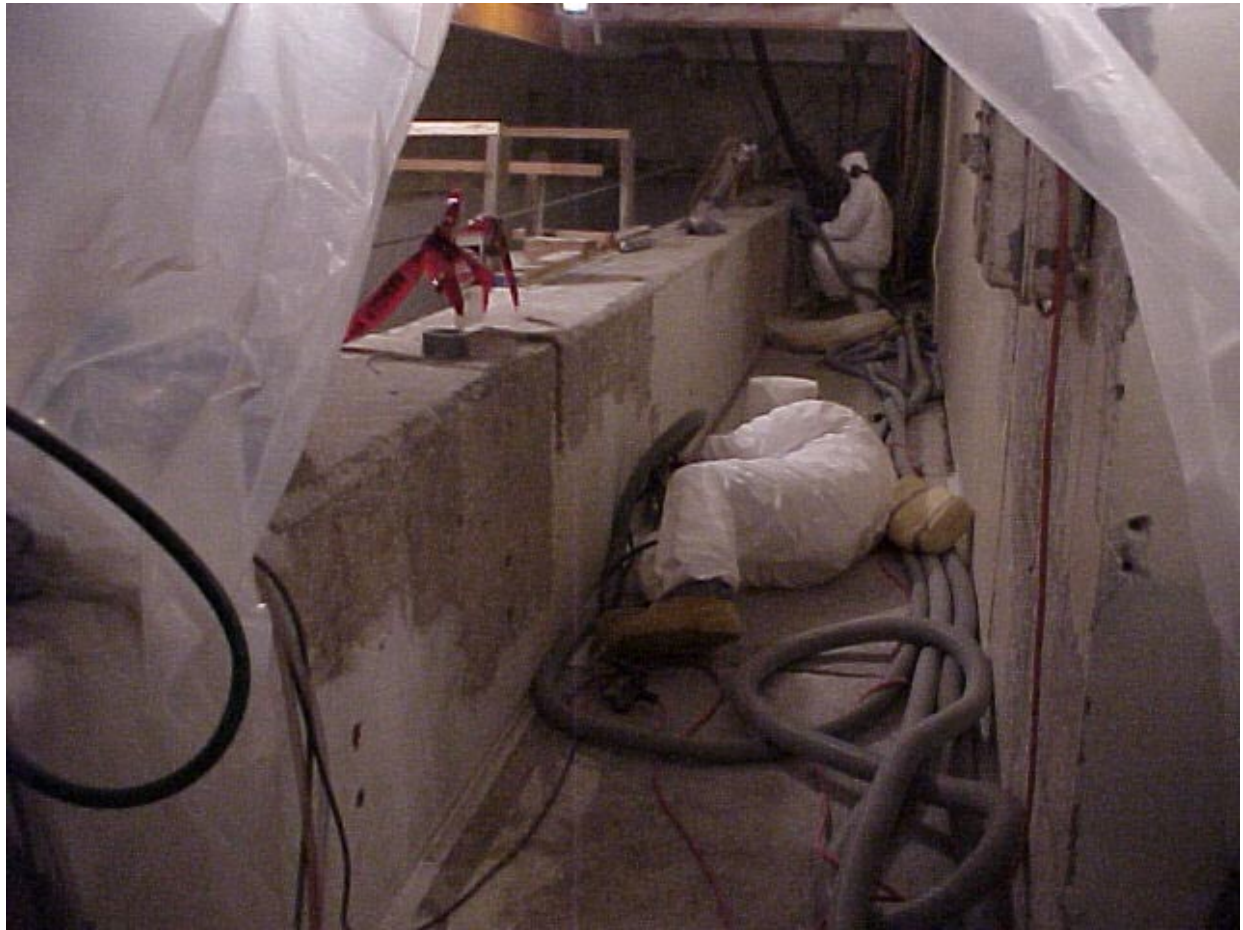
Workers using hand held scabbling equipment to clean the walls of the Canal's walkway. The workers wear protective clothing and use respirators.
