SITE WATER DISTRIBUTION ANALYSIS REPORT 2003

PREPARED BY MICHAEL KRETSCHMANN, PE

FIRE PROTECTION ENGINEERING GROUP

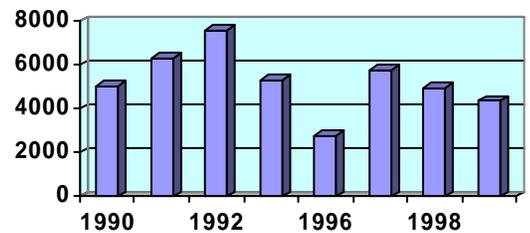
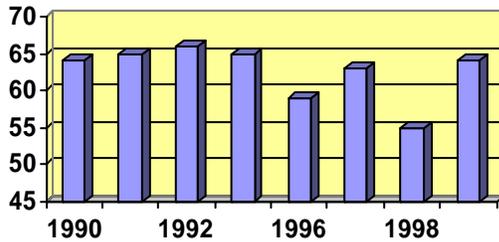
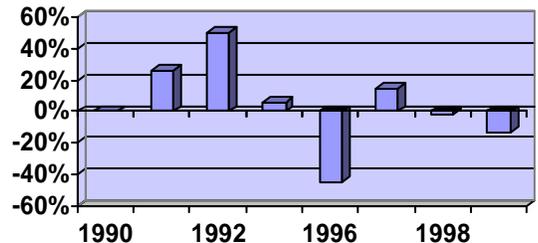
CALCULATED FLOW AT 20 PSI (GPM)

SUMMARY TABLE	OVERALL	10 YEAR	5 YEAR
STATIC PRESSURE AVERAGE	62.6 PSI	61.2 PSI	59.5 PSI
FLOW AVERAGE @ 20 PSI	5264 GPM	4641 GPM	4656 GPM
FLOW CHANGE FROM OVERALL	-	-13.4%	-13.1%

The pressure hydrant was H098 and the flow hydrant H097. The nearest water supply source (Water Treatment Facility) is about 2,150 feet away. The local mains are 10 inch. The piping in this area has not been altered since the first relevant flow test in 1990 and is over 60 years old. The piping in this area is Cement Lined Ductile Iron.

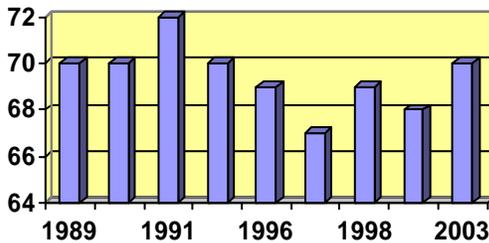
PERCENT FLOW CHANGE FROM 2001

Static pressures have remained relatively consistent (~69 PSI). These constant static pressure readings cannot be explained by apparent changes in either piping condition or day to day water demands. Further investigation by means of a hydraulic flow model study is required to understand the trend.

Piping Condition is rated "Poor" since the 6 inch looped piping was made into a dead end condition and the 2003 flow test result with respect to the MEFF demand.

Flow Capacity is rated as "Poor" because of the limited flow rate at current piping conditions.

Piping Network of water supplies is rated "Dead End" since this area can only get water via the small dead end pipe to the water sources.

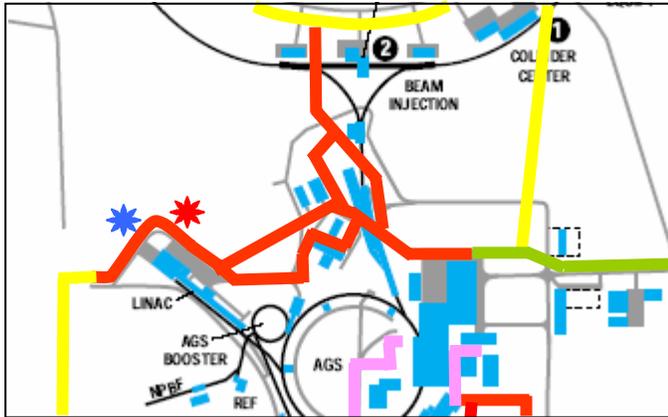
7.19 TEST POINT 19: WEST FIFTH AVENUE

MEFF 2,500 GPM	OCCUPANCY ORDINARY HAZARD	PIPING CONDITION POOR	FLOW CAPACITY GOOD	PIPING NETWORK MULTIPLE PATH
--------------------------	-------------------------------------	---------------------------------	------------------------------	--

The pressure hydrant was H202 and the flow hydrant H201. The nearest water supply source (Water Treatment Facility) is about 2,500 feet away. The local loop mains are 8 inch while the feed from the Water Treatment Facility is 10 inch. The piping in this area has not been altered since the first relevant flow test in 1990 and is about 40 years old. The piping is Transite Cement Lined and Black Steel.

Occupancy is rated "Ordinary Hazard" due to non combustible buildings with combustible contents, cable trays.

Piping Condition is rated "Poor" due to a decrease in available flow by 8% in the last 13 years.

Piping Network of water supplies is rated "Multiple Path" since this area can easily get water from multiple sources around the site.

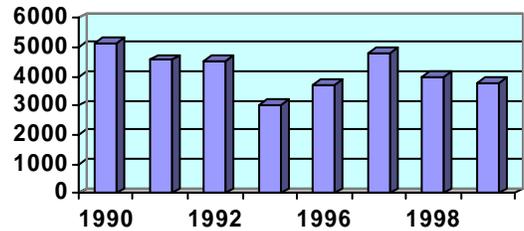
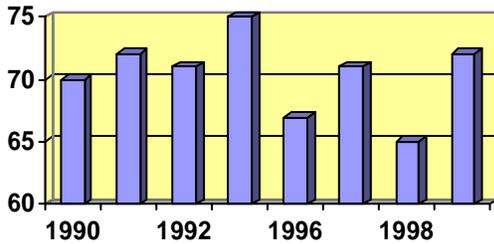
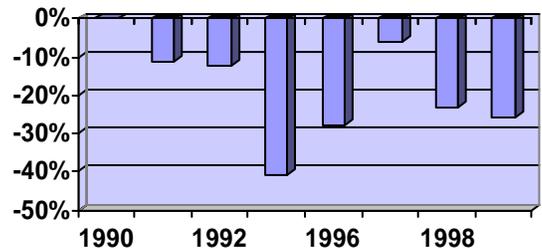
SUMMARY TABLE	OVERALL	10 YEAR	5 YEAR
STATIC PRESSURE AVERAGE	70.4 PSI	70.0 PSI	68.5 PSI
FLOW AVERAGE @ 20 PSI	4187 GPM	3858 GPM	3870 GPM
FLOW CHANGE FROM OVERALL	-	-8.5%	-8.2%

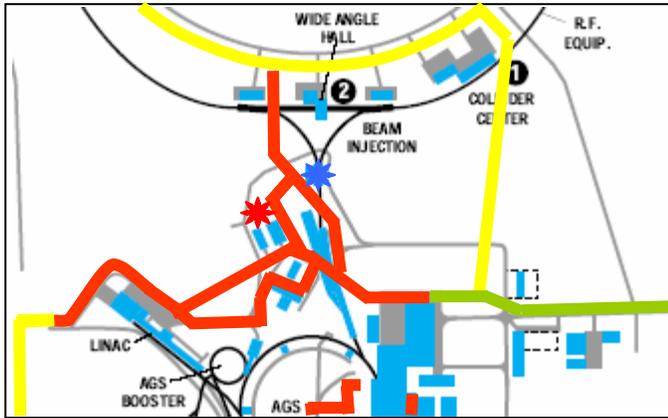
7.20 TEST POINT 20: THOMPSON AVENUE

MEFF 2,500 GPM	OCCUPANCY ORDINARY HAZARD	PIPING CONDITION FAIR	FLOW CAPACITY GOOD	PIPING NETWORK MULTIPLE PATH
--------------------------	-------------------------------------	---------------------------------	------------------------------	--

The pressure hydrant was H234 and the flow hydrant H211. The nearest water supply source (Well 10) is about 2,600 feet away. The local mains are 8 inch. The piping has not been altered since the first relevant flow test in 1990 and is about 40 years old. The piping is Transite Cement Lined and Cast Iron.

Occupancy is rated "Ordinary Hazard" due to non combustible buildings with combustible contents.

Piping Condition is rated "Fair" due to a decrease in available flow by 4% in the last 13 years.

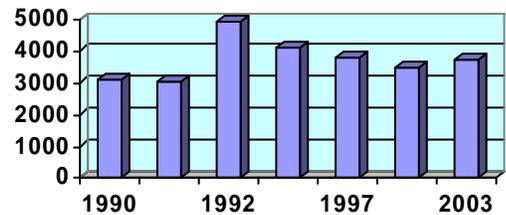
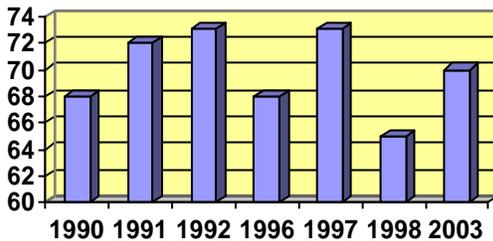
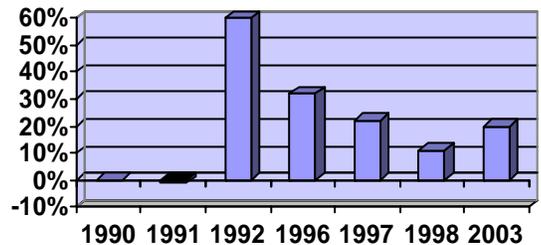
SUMMARY TABLE	OVERALL	10 YEAR	5 YEAR
STATIC PRESSURE AVERAGE	69.9 PSI	69.0 PSI	67.5 PSI
FLOW AVERAGE @ 20 PSI	3722 GPM	3746 GPM	3571 GPM
FLOW CHANGE FROM OVERALL	-	0.6%	-4.2%

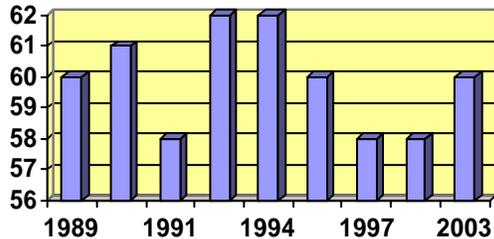
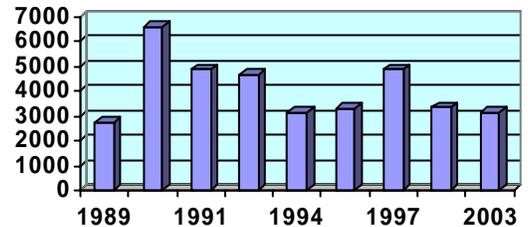
The pressure hydrant was H027 and the flow hydrant H026. The nearest water supply source (300K Tank) is about 1,600 feet away. The local loop mains are 8 inch. The piping in this area has not been altered since the first relevant flow test in 1989 and is over 60 years old. The piping is Transite Cement Lined.

Occupancy is rated "Ordinary Hazard" due to the wood frame buildings with flammable liquids, but low importance to BNL programs.

Piping Condition is rated "Poor" due to a decrease in available flow by 25% in the last 14 years.

Piping Network of water supplies is rated "Dead End" since all water must enter via the isolated 8 inch loop. The two six inch feeds have to be investigated by hydraulic modeling to see if can support the area by themselves.

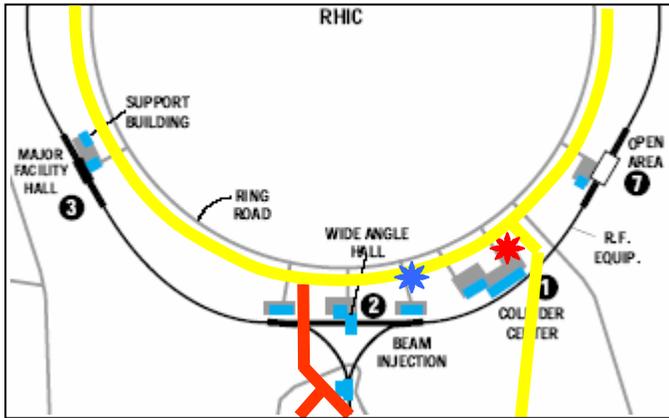
7.22 TEST POINT 22: RHIC RING – EAST FEEDER

MEFF 2,500 GPM	OCCUPANCY ORDINARY HAZARD	PIPING CONDITION GOOD	FLOW CAPACITY GOOD	PIPING NETWORK MULTIPLE PATH
--------------------------	-------------------------------------	---------------------------------	------------------------------	--

The pressure hydrant was H226 and the flow hydrant H225. The nearest water supply source (Well 10) is about 2,700 feet away. The local loop mains and feeder are 10 inch. The piping in this area has not been altered since the first relevant flow test in 1990 and is about 15 years old. The loop piping is Cement Lined Ductile Iron and the feeder is Cast Iron.

Occupancy is rated "Ordinary Hazard" due to non-combustible facilities with high programmatic contents.

Piping Condition is rated "Good" due to an increase in available flow by 11% in the last 13 years.

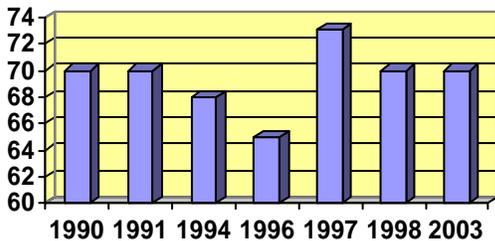
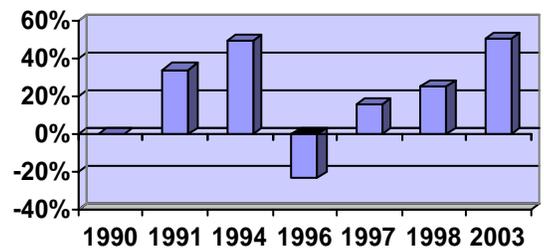
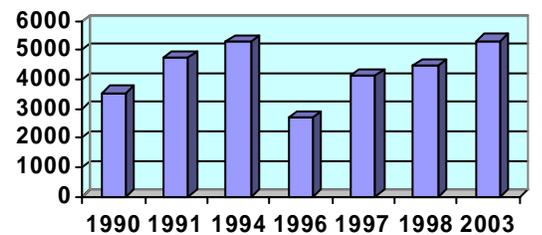
SUMMARY TABLE	OVERALL	10 YEAR	5 YEAR
STATIC PRESSURE AVERAGE	69.4 PSI	69.2 PSI	70.0 PSI
FLOW AVERAGE @ 20 PSI	4310 GPM	4376 GPM	4888 GPM
FLOW CHANGE FROM OVERALL	-	1.5%	11.8%

The average available flow is now about 4,900 GPM. Average flow rate from 1990 has increased by up to 11.8%. This flow rate increase cannot be explained by apparent changes in either piping condition or day to day water demands. Further investigation by means of a hydraulic flow model study is required to understand the increase.

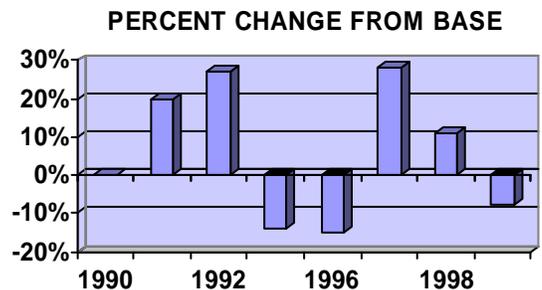
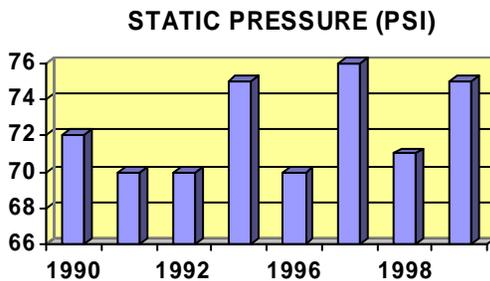
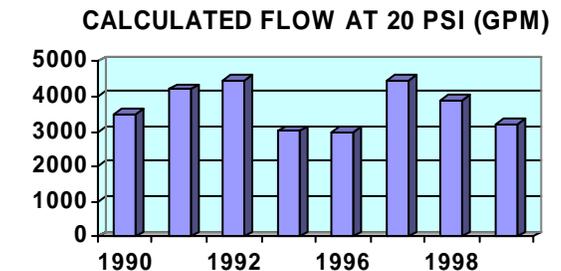
SUMMARY TABLE	OVERALL	10 YEAR	5 YEAR
STATIC PRESSURE AVERAGE	72.4 PSI	73.4 PSI	73.0 PSI
FLOW AVERAGE @ 20 PSI	3716 GPM	3515 GPM	3557 GPM
FLOW CHANGE FROM OVERALL	-	-5.7%	-4.5%

The pressure hydrant was H230 and the flow hydrant H219. The nearest water supply source (Well 10) is about 5,000 feet away. The local loop mains are 10 inch. The piping in this area has not been altered since the first relevant flow test in 1990 and is about 20 years old. The piping is Cement Lined Ductile Iron. . .

The average available flow is now about 4,650 GPM. Average flow rate from 1990 has decreased by 4.5%. This flow rate decrease cannot be explained by apparent changes in either piping condition or day to day water demands. Further investigation by means of a hydraulic flow model study is required to understand the decrease.

Occupancy is rated "High Hazard" due to the densely populated wood frame construction buildings.

Piping Condition is rated "Fair" due to a decrease in available flow by 4% in the last 13 years.
