Brookhaven National
Laboratory

Fire in the Debris Soil Pile DST-2, Chemical
and Glass Holes Project:
The Investigation Report

Brookhaven National Laboratory
Upton, New York

March 11, 2000

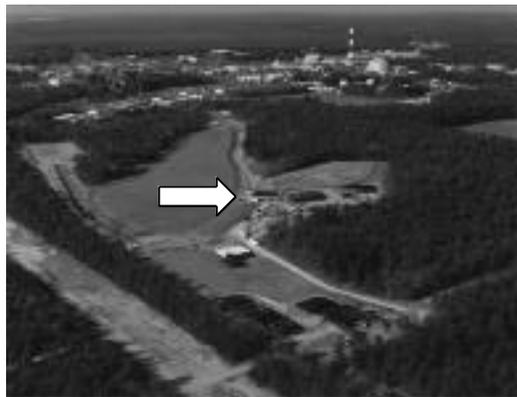
Aerial view of Project.
View looking Northwest toward center of site.
Arrow points to DTS-2 pile.

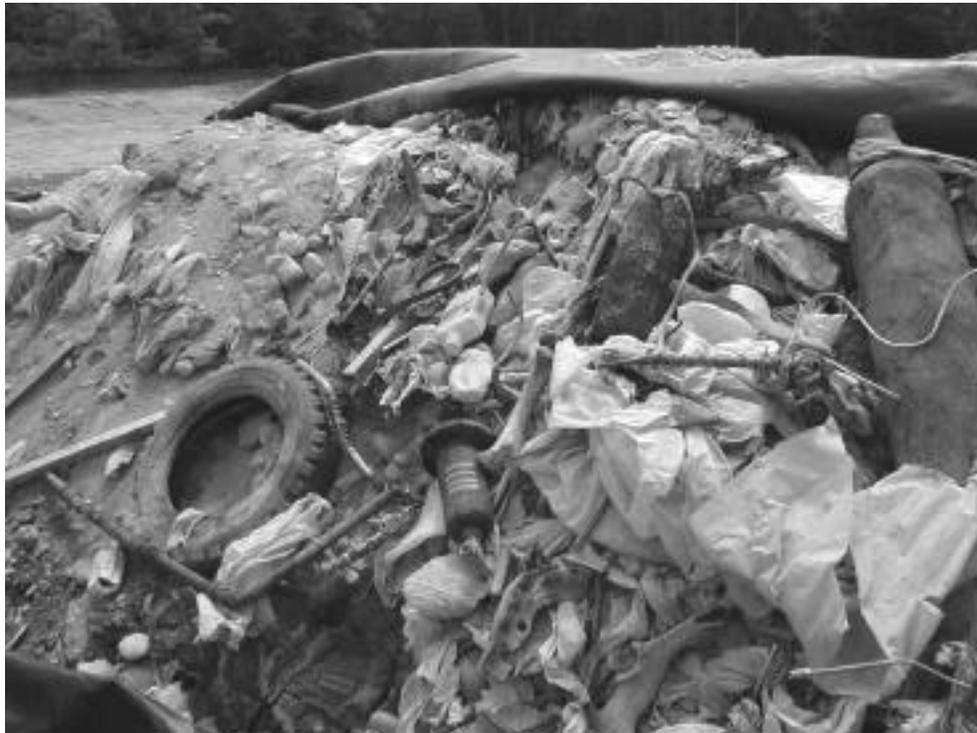
Assorted materials removed from Chemical/Glass Holes after 1997 sorting operation.

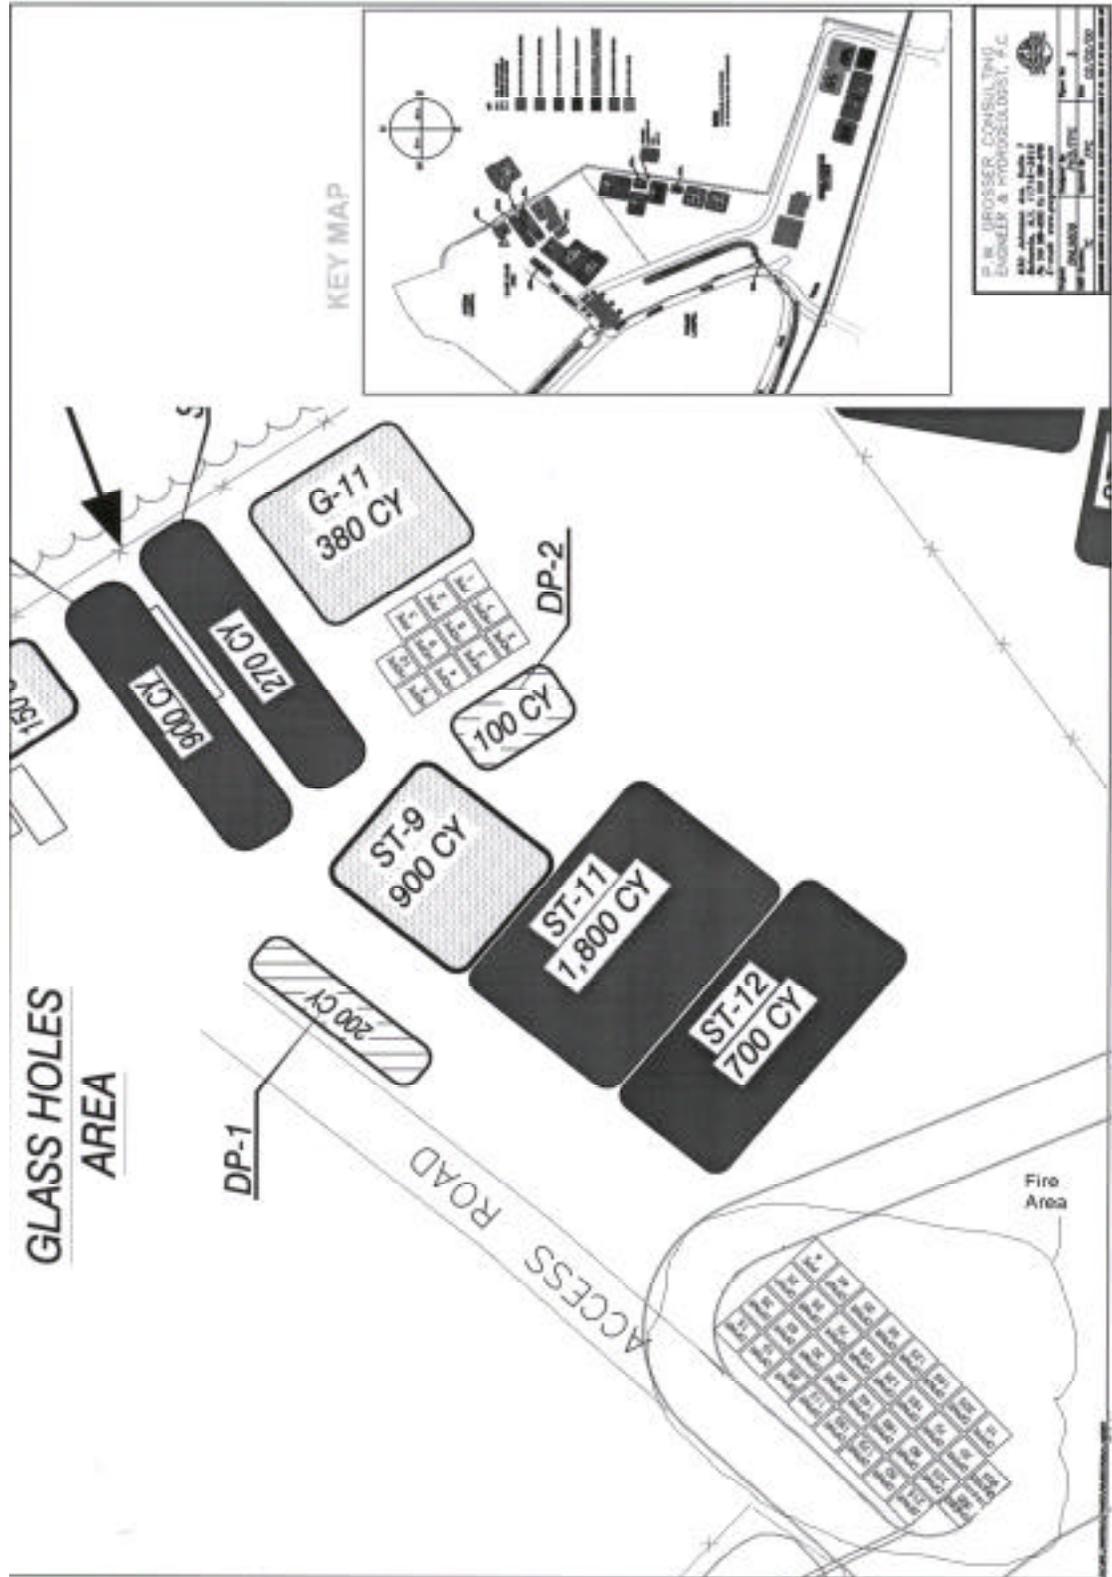
Plan view of the area with DST-2 in the lower right corner. South is left and North is right.

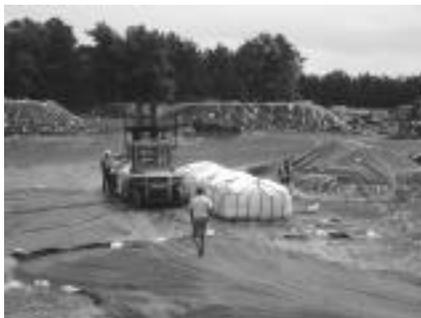
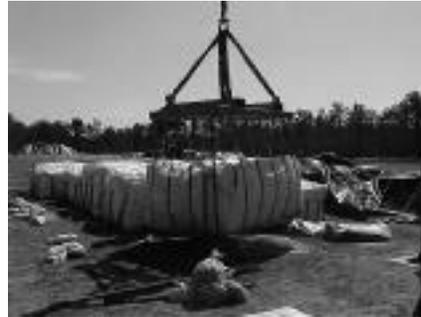
Rigging of a soft sided lift liner waste container system, and its placement on plastic liner.

In the original work plan, the container system was described by performance criteria (such as compliance with DOT, 12 months storage). The hazard of using combustible lift liners was not evaluated, nor was that of using combustible padding. The hazard of introducing large pieces of baled straw into the combustible containers was not evaluated.

DOE prepared an extensive report on the soft-sided lift liner system. However, this report did not identify the combustibility of the plastic lift liners as a new hazard in its comparison with metal containers. No information was given in the DOE report on the ease of igniting the lift liner system.

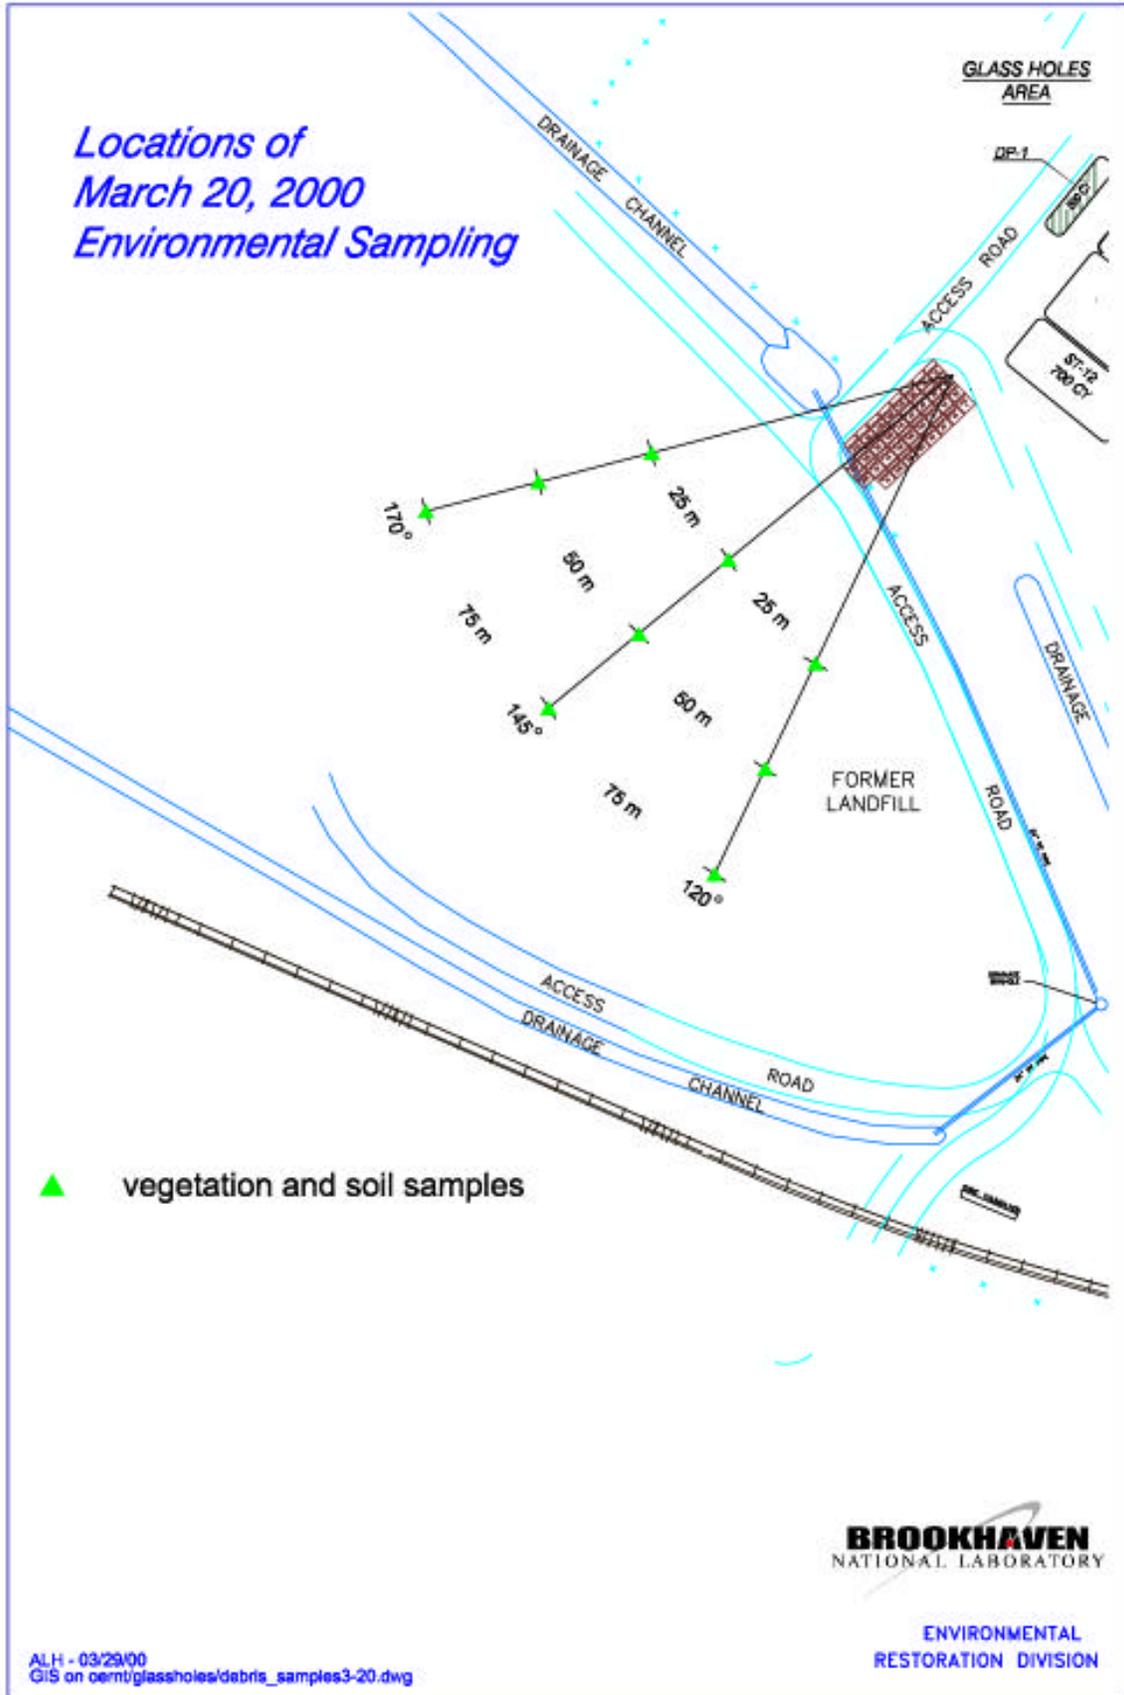
Follow up samples were collected at twelve locations around the perimeter of the debris piles on March 13, 2000 (COC 20031314). The samples were composited into North, South, East and West samples. See the figure titled "Locations of March 13, 2000 Environmental Sampling" on the following page for the locations. The results were non-detect for ^{241}Am and ^{60}Co and normal ambient background ^{137}Cs in all four locations.

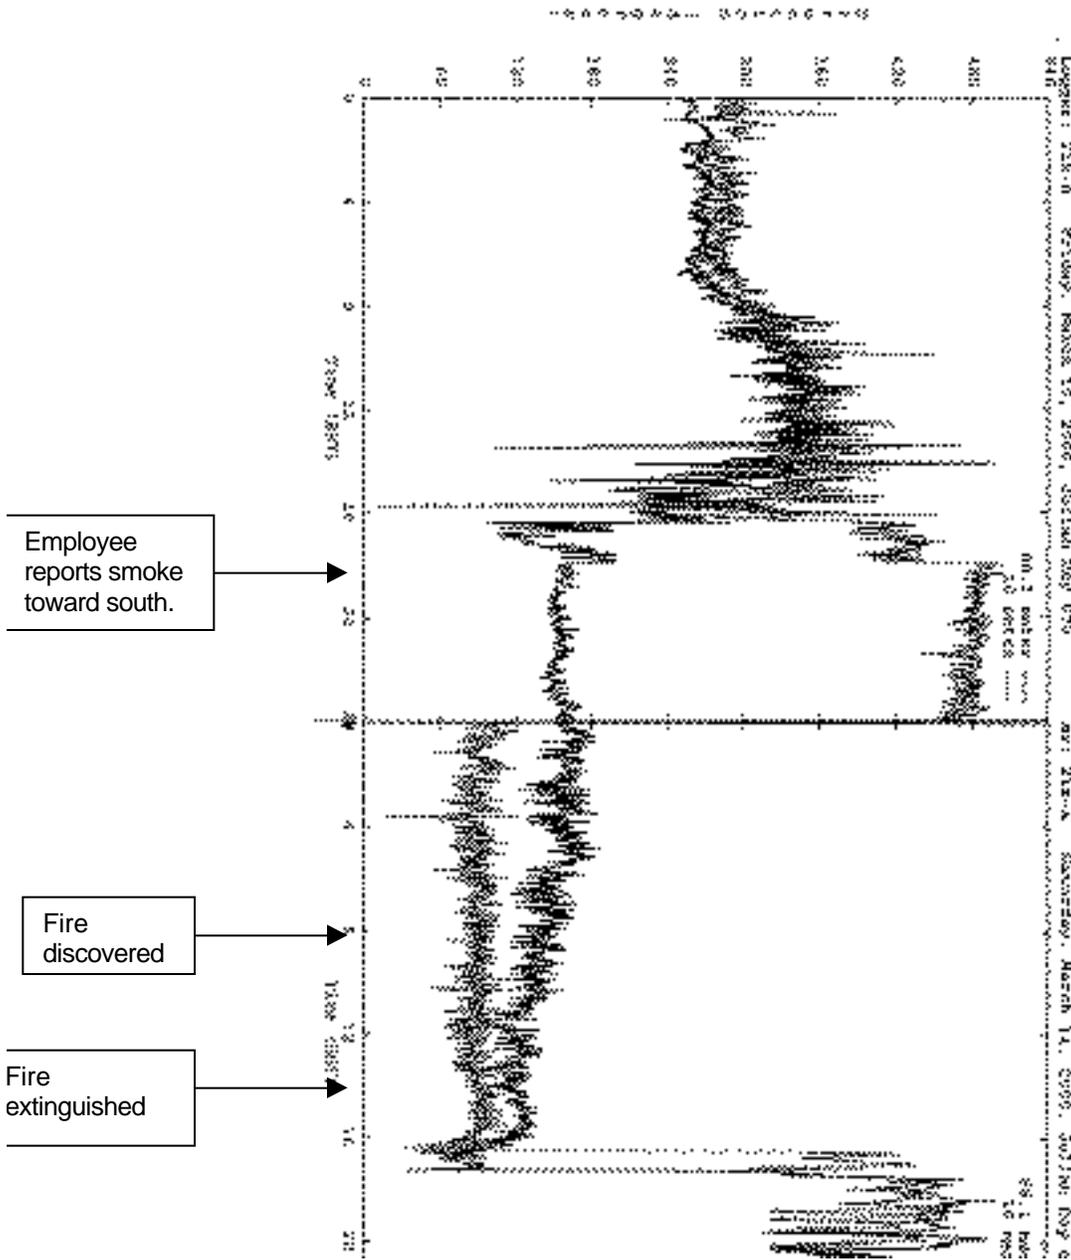
On Friday, March 10, 2000, a steady wind started to blow to the south at 4 PM. A BNL employee leaving work at 5:30 PM reported smoke coming from the southern part of the site. An investigation by the BNL Fire/Rescue Group did not find a source. There were two large brush fires in the immediate vicinity of BNL. One fire was located to the south in Manorville and one to the north in Ridge. (Several Plant Engineering employees working in the center of the site also reported smelling burning "plastic" the Monday after the fire. Wind direction was to the south and they were up wind - see Attachment E. Some turbulence could have resulted in brief northerly airflow).

Chart shows wind direction from the Meteorological tower located by Bldg. 51 for March 10th to March 11th.
