INVESTIGATION REPORT

LANL Investigation of a Laser Eye Injury

Submitted to: G. Peter Nanos
Director, Los Alamos National Laboratory

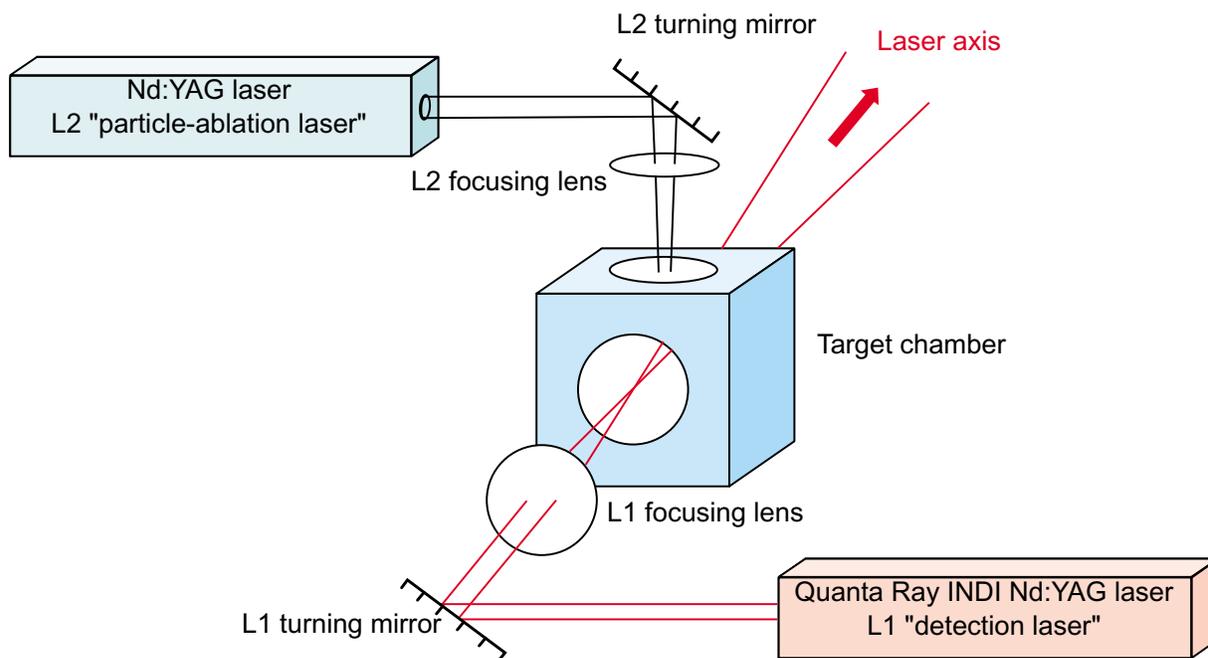
Figure 2.6. A diagram of the experimental system setup, showing the beam path along the L1 axis, through the target chamber, and out the chamber's rear window.

On July 13, 2004, the PI set up a new target chamber (an environmental chamber with a rear viewing window) and a second laser (an ablation laser to ablate and suspend particles). The experimental setup then involved two lasers: the original INDI detection laser, L1, and the newly introduced ablation laser, L2. Laser radiation from L1 and L2 is invisible, at an infrared wavelength of 1064 nm. The PI directed the laser paths of both lasers through the chamber with the use of turning mirrors and focusing lenses. See Figure 2.6.

Using two lasers, viewing particles in the chamber, and using L1's flash lamps for illumination were not described, evaluated, or authorized by the LIBS HCP. The Team found no record of a laser registration, Form #1552, for LI. Nor could the team find the associated hazard analysis.

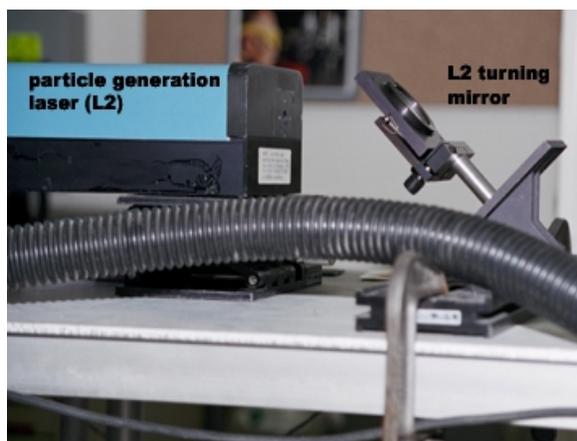
Figure 2.8. L2 was mounted on a table built onto and raised above the optics table. L2 was positioned above the target chamber. Neither the optics table nor the chamber are shown here.

A top window on the chamber allowed L2's beam (also directed through the use of a turning mirror and focusing lens) to enter the chamber to strike and suspend particles of a powdered sample held in a cup. Figure 2.8 shows L2's position above the chamber. The chamber's rear window, used for viewing, was along the beam axis at the "back" of the chamber beyond the sample's location. A removable beam stop behind the rear window served to stop the beam from propagating beyond the optics table.

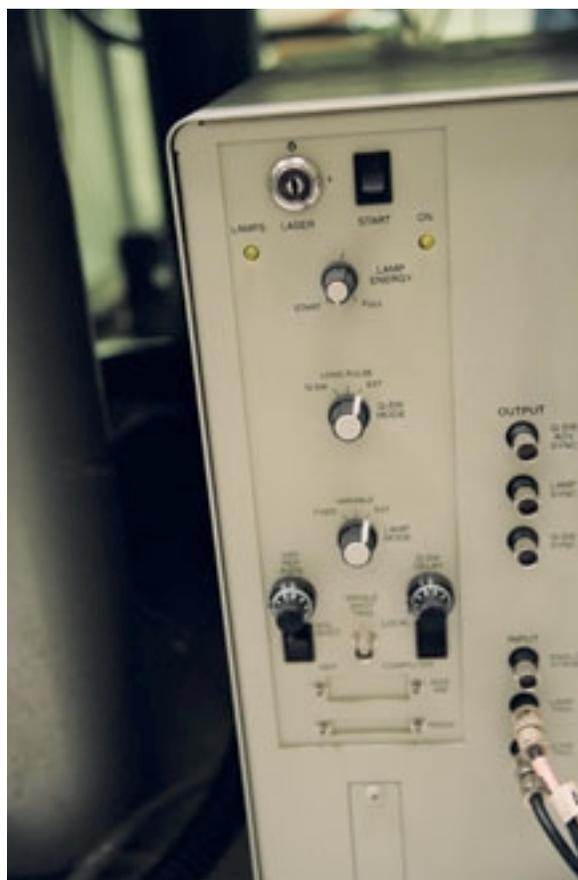
Figure 4.1. The front of the laser power supply.

supply was configured to operate in long-pulse mode. See Fig. 4.1 for a view of the switches on the front of the power supply.

3. With the flash-lamp trigger cable connected and the Q-switch trigger disconnected, the Q-switch mode-selector switch on the front of the power supply was configured to operate in Q-switch mode.

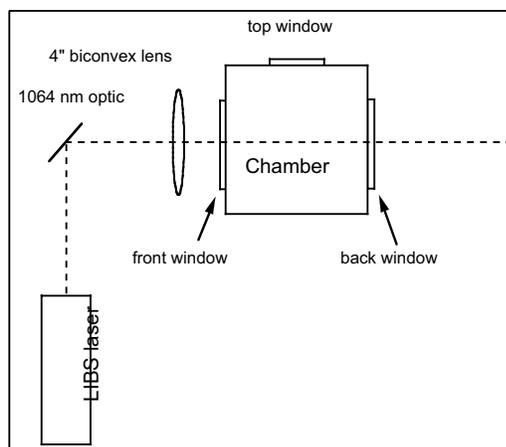
Figure 2: Schematic of the designed optical path and chamber.

A schematic of the designed optical path and chamber is shown in Fig. 2. The definitions of the components are also shown. We first observed what looked like damage from the laser on the input and output windows of the target chamber, see Figs. 3 and 4. There was dust on the top chamber window but no damage, see Fig. 5. The turning mirror for the LIBS laser was clean and intact. The lens in front of the chamber had some dust but no damage.

The optical path of the laser conformed to the designed path, being turned first by what appeared to be a 1064 nm dichroic optic (from the efficiency with which it turned the laser). The laser then passed low through the lens and out the back side of the chamber.

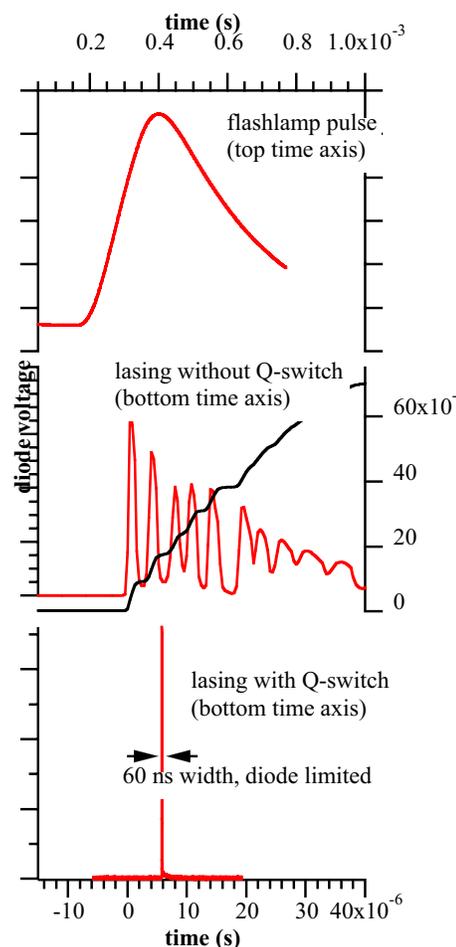
Figure 7: The temporal shapes of all conditions. The measured Q-switch pulse width is limited by the photodiode response time.

The three modes of emission by the LIBS laser are shown in Fig. 7. The data were taken on a Tektronics 740 oscilloscope, recording the voltage from a Si photodiode. The data are plotted as the voltage as a function of time. The signals from the three traces are not directly comparable in this graph. The bottom trace is the voltage recorded from a pulse obtained with the Q-switch trigger selection set to Q-switch (the mode in which the Q-switch is internally triggered). The second trace is the voltage from a free-running pulse obtained with the Q-switch trigger selection set to long pulse (the mode in which the Q-switch is held open for the duration of the flashlamp pulse). Both traces are plotted against time on the bottom axis. The pulse width of the traces in this graph are broadened due to saturation of the photodiode. The quoted width of the Q-switched pulse is 5 to 8 ns. A more-careful measurement of the individual pulse width in long-pulse mode yielded a width of 440 ns (a lower limit, as the photodiode could still be broadening the measured pulse). The top trace is voltage obtained with the Q-switch trigger selection set to EXT, without an external Q-switch trigger pulse. The laser flashlamp trigger selection was set to EXT for all measurements, with a TTL trigger applied from a Stanford Research Systems (SRS) delay generator. The top trace is plotted as a function of

The total energy in this mode is comparable to the energy in Q-switch mode ($\sim 20\%$ higher at the same flashlamp setting) but, as shown in Fig. 7, is distributed in a series of sub-microsecond pulses (laser free running). The beam diameter at the laser is 5 mm, as measured with the Tokin SHG-type IR card.

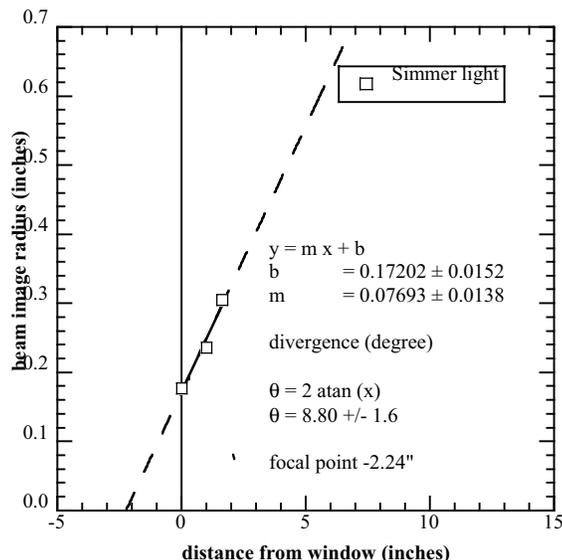
Figure 8: Far field divergence in the simmer pulse.

the same within our measurement uncertainties. The beam radius was measured in the far field for both the Q-switched and long pulses by exposing photographic paper with the beam. The image radius measured in this way for both modes is shown in Fig. 8. The beam image radius in Fig. 8 is plotted as a function of the distance from the external surface of the back window on the chamber, with the image radius on the window surface plotted at 0. When plotted in this way, fitting the data to a line yields the divergence and focal point. If the slope, m , and intercept, b , are determined from $y = mx + b$, where y is the beam image radius and x the distance from the chamber window, then the divergence angle is given by $\theta = 2 \operatorname{atan}(x)$, and the focal point, x_0 , by $x_0 = -b/m$. The solid and dashed lines of Fig. 8 are the resulting fit to the data, and the parameters are shown in the figure as well. The beam divergence for a lasing pulse in the far field is determined to be $\theta = 4^\circ \pm 0.3^\circ$ and the focal point $x_0 = -2.92''$. The negative value for the focal point places the laser focus approximately 3 inches into the chamber, from the external surface of the back window, or near the front half of the chamber.

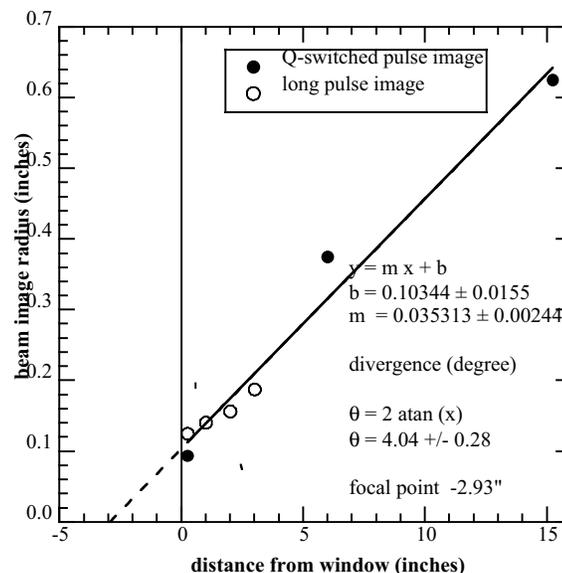
Figure 9: Far field divergence in the laser pulse.

The image radius measured in this way is shown in Fig. 9. The beam image radius in Fig. 9 is plotted as a function of the distance from the external surface of the back window on the chamber, with the image radius on the window surface plotted at 0, as in Fig. 8. The solid and dashed lines of Fig. 9 are the resulting linear fit to the data, as done for Fig. 8, and the parameters are shown in the figure as well. The beam divergence for a lasing pulse in the far field is determined to be $\theta = 8.8^\circ \pm 1.6^\circ$ and the focal point $x_0 = -2.2''$.

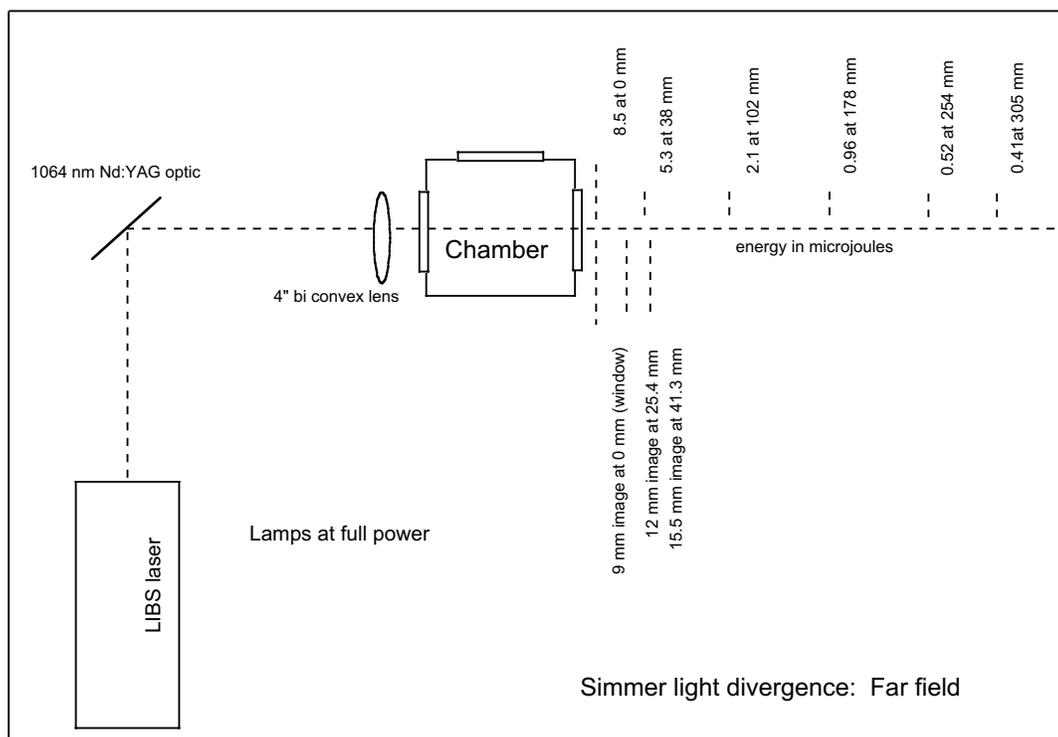
Figure 10: Position index of energy measurements made on the simmer pulse.

the energy measurements was set to full. A position index of the energy measurements made for the simmer pulse is shown in Fig. 10. These data were then divided by the aperture area of the energy meter used, or 0.95 cm^2 , to yield the energy density as a function of position past the back chamber window. The data are plotted in Fig. 11 as a function of distance behind the back chamber window, with the external window surface at $x = 0$, as before. The solid line is a calculation of the energy density, E , as a function of the same distance from the back chamber window, r , using $E = E_0 (r_0/r)$, where E_0 is the energy density at the external surface of the window, with image radius r_0 .

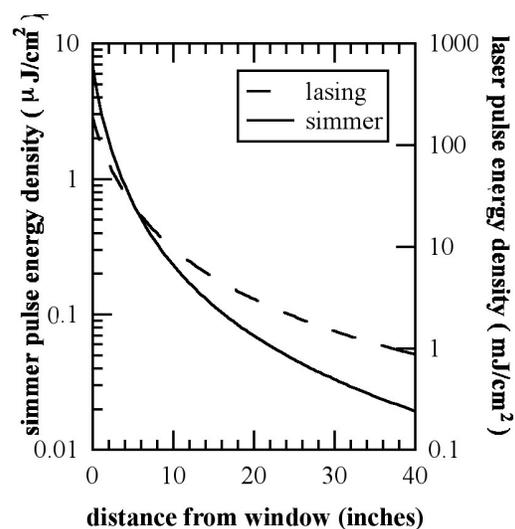
Figure 12: Calculated energy density as a function of distance from the back chamber window for both simmer and laser pulses.

The calculated energy density as a function of position is shown in Fig. 12 for both lasing and simmer modes. The distance scale is referenced to $x = 0$ at the external surface of the back chamber window, as before. The calculation is for threshold emission, with the flashlamp voltage set at the minimum threshold to produce a laser pulse (as indicated on the laser with a pencil mark).

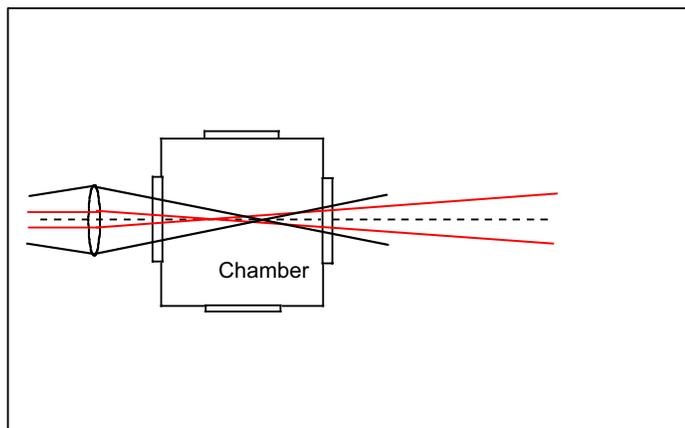
Figure 13: Schematic of the beam divergence in the far field. The red lines depict the laser beam path and the black lines the simmer light.

The divergence of the simmer and laser beams is shown schematically in Fig. 13. The height of the center of the beams was measured to be 48" at the back chamber window and 59" at the back wall, which is 83" horizontally from the back chamber window.

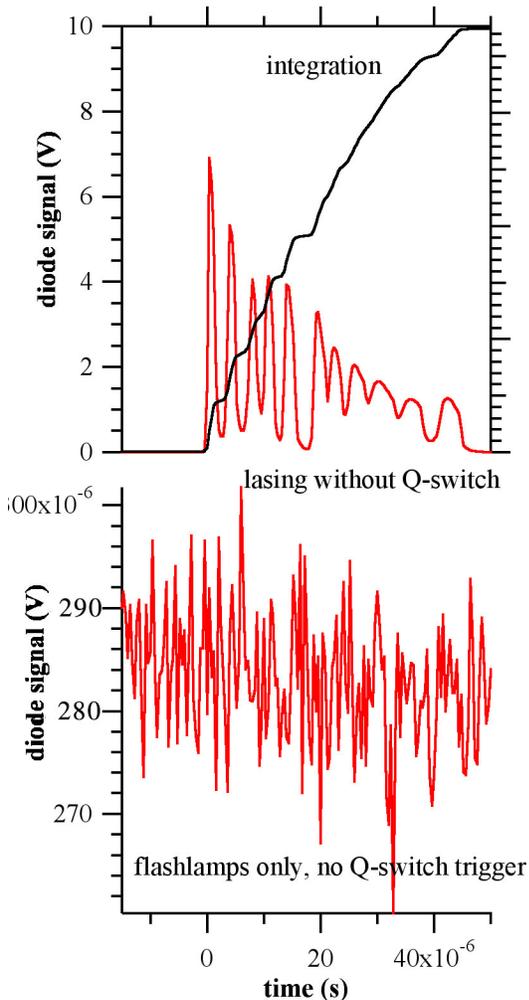
7 V was measured while using a long pass filter, RG 850, as well as the 1064 nm dichroic turning mirror in order to discriminate against the simmer light and optimize the sensitivity to measuring a laser pulse. The Q-switch trigger selection was then set to EXT, and measurements of the baseline were made. No laser pulse was observed in this manner over the entire time period of the laser duty cycle and particularly not during the duration of a flashlamp pulse. The two experiments are shown in Fig. 14. Using an integrated intensity for the long-pulse-mode laser pulse of 40 mJ and noting that the leading pulse in the long pulse train is approximately 10% of the energy leads to a value of 4 mJ for the energy of a single pulse in long-pulse mode or a conversion factor of 6×10^{-4} J/V. The measured baseline in Fig. 14, obtained under the same conditions as the long-pulse data, gives a baseline sensitivity of 10 μ V or an upper limit to any laser pulse present of 5 nJ.

Figure 14: The long pulse signal on a Si photodiode is shown in red. The signal is plotted in volts. The black line is the integration of the signal. The zero amplitude measurement made in search of a lasing condition is shown in the bottom panel.

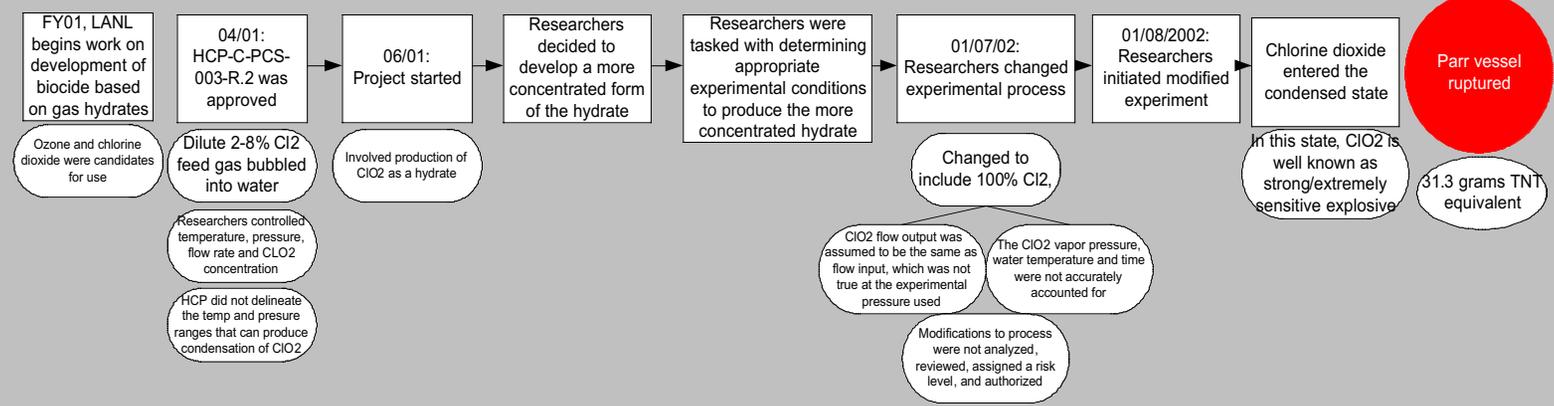
Event and Causal Factor Chart

Ozone and chlorine dioxide were candidates for use

Dilute 2-8% Cl₂ feed gas bubbled into water

31.3 grams TNT equivalent

1. Involved Group stood down ops. Review of SWP with supervisors. Reviewed quality of hazard analysis (HA) documentation and how to improve HA. Closed 5/31/02
