# Cryogenic Summary - Testing D2L106 in MAGCOOL, Part 1 100 K Cooldown and Failure of Joint on Heat Shield Line

K. C. Wu  
6/19/03

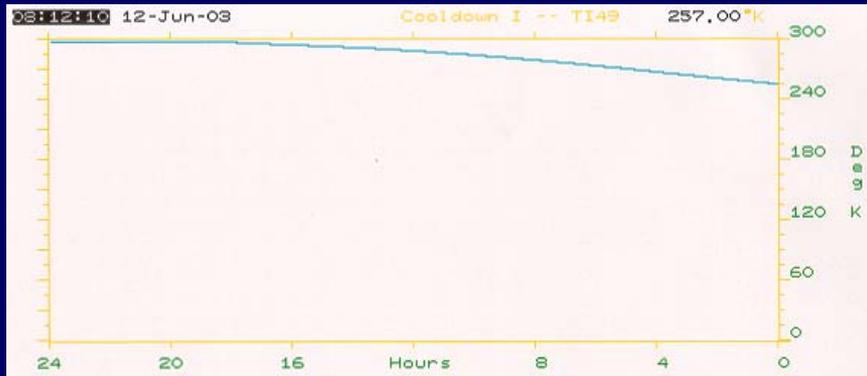
# Cooldown from 300 – 100 K for D2L106 (6/11 – 6/14/03)

- Cooldown rate:

- ~ 2.5 K/hour 300 – 210 K

- ~ 5 K/hour 210 – 150 K

- ~ 1.5 K/hour 150 – 140 K

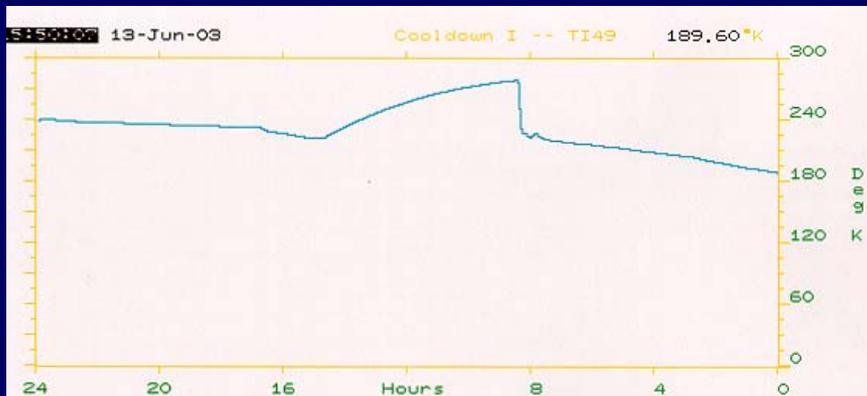
- Cooldown compressor CS5 tripped midnight 6/13. Resume CS5 and CDI at 8 AM.

- 100 K Cooldown was terminated in the morning of 6/14 due to significant frosting on the Feed Can, Vacuum Bellow and End Can.
