Critique of Incident

"Omission of Lead glass cover from View Port on X-12C"

Issued: March 27, 2002

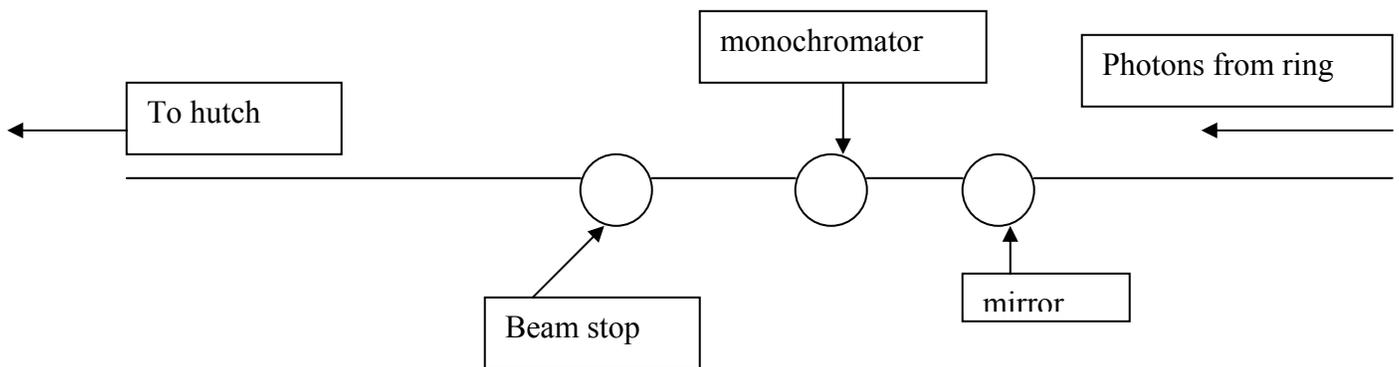
Figure 1
Conceptual Schematic of X-12C Beam Line
Not to scale

- During the first 8 hour run, difficulties in transmitting the photon beam through the monochromator were encountered (See figures 1 and 2 for conceptual schematics of beam line and monochromator lay-out). This prompted the installation of a view port to help align the monochromator crystal. A steel flange on the beam line port was removed and replaced with a glass view port. In hard x-ray beam lines, view ports that are conventional glass are always required to be shielded with a lead glass cover¹. However, the view port and its lead glass cover were not added to the beam line checklist following this change in the beam line configuration.
