***Restoring a Damaged 16-Year-Old Insulating
Polymer Concrete Dike Overlay: Repair Materials
and Technologies***

Toshifumi Sugama

September 2006

**Final Report
(February 2002-July 2006)**

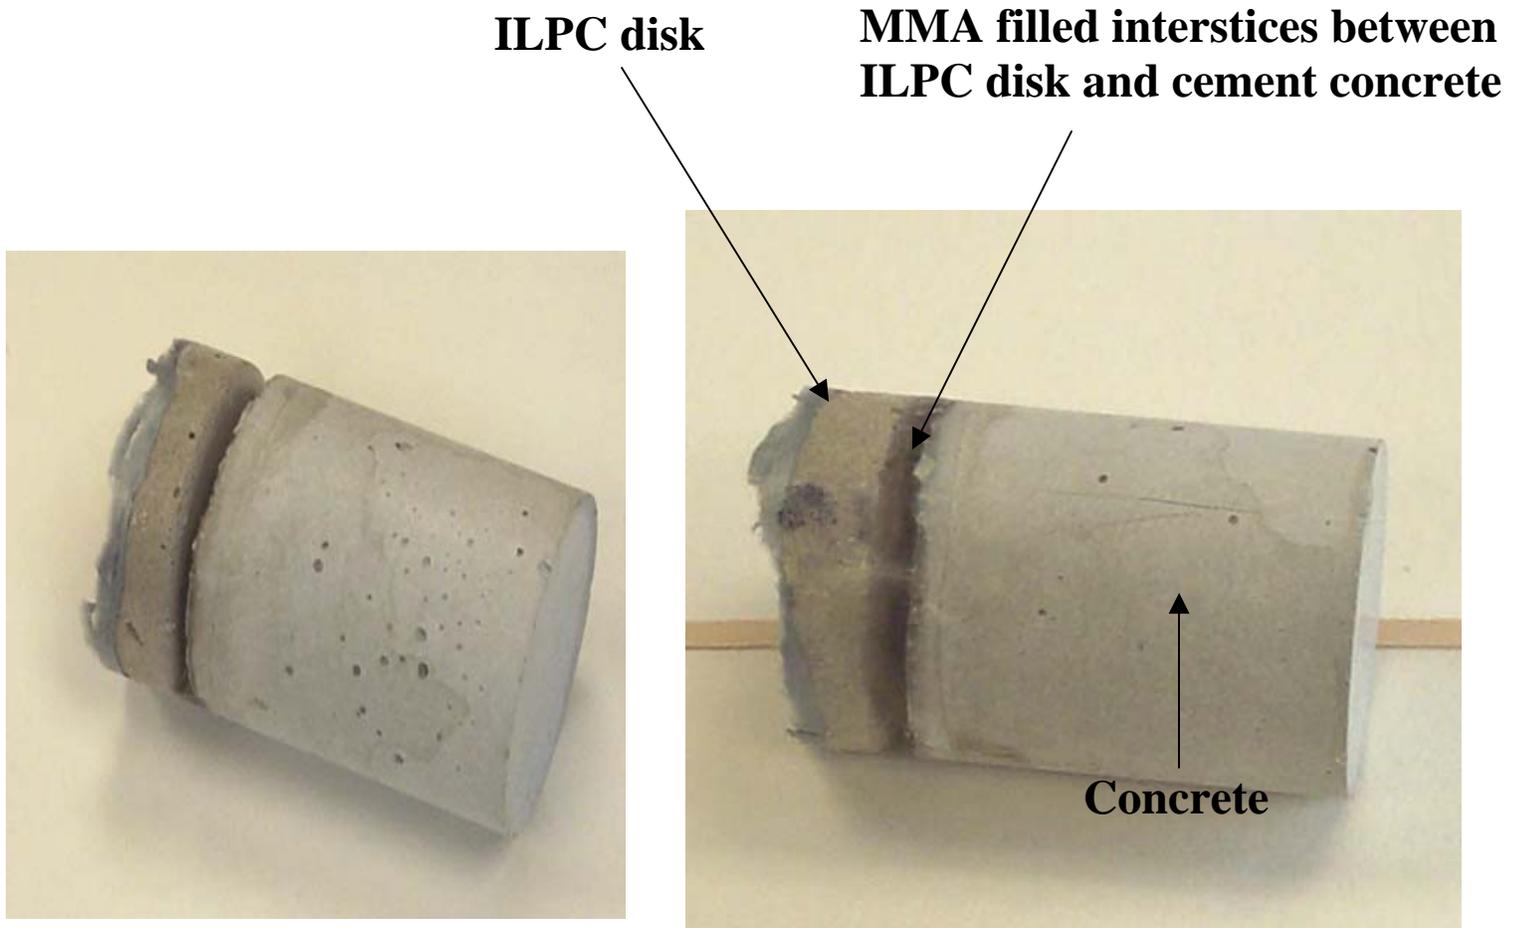
Vacuum	Range of crack's width, in.	Penetration of MMA	Filling activity of MMA in the interstices between ILPC disk and concrete
Yes	0.003-0.007	Excellent	Fully filled (Figure 15)
Yes	0.009-0.013	Excellent	Fully filled
Yes	0.021-0.025	Excellent	Fully filled
No	0.003-0.007	No penetration	No filling
No	0.009-0.023	Some penetration	No filling
No	0.021-0.0025	Good	Partially filled

Figure 15. Non-bonded ILPC disk with concrete (left) before impregnation of MMA and the ILPC disk linked to concrete after its impregnation (right).

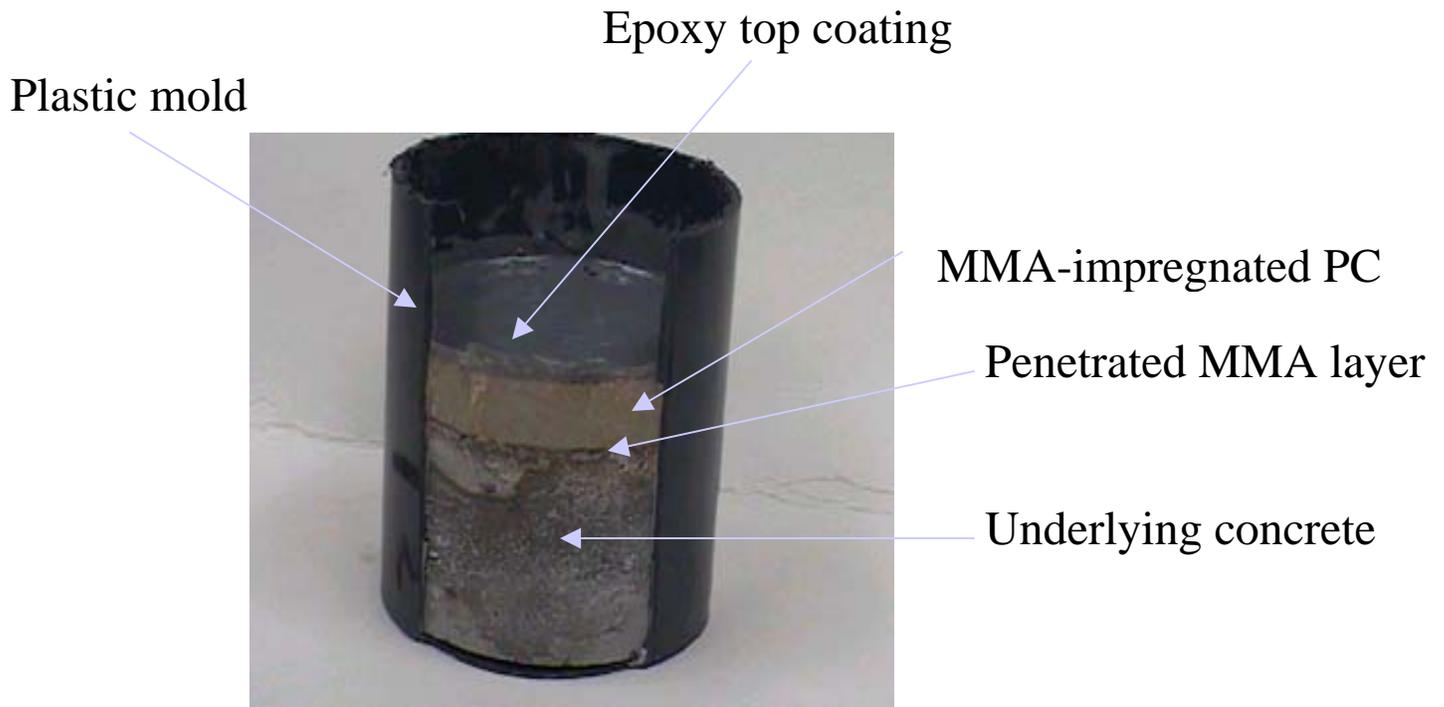
Since the lifted and delaminated ILPC dikes would be repaired by a two-step route involving MMA impregnation, and a non-flammable, anti-oxidant epoxy overlay, the principal structure of repaired ILPC dike would consist of four different layers: 1) Cement concrete as an underlying layer; 2) a penetrated MMA layer adhering to the underlying concrete; 3) an MMA-impregnated old-failed ILPC layer; and, 4) an epoxy top coating layer. Thus, we used samples made under the four different conditions (see Table 12) for the LN spilling test. Table 13 gives the formulation for each of concrete, impregnating, and coating materials. The samples were prepared in a cylindrical mold (3.0 in. diam. x 3.5 in. high), and then were placed in a Styrofoam insulating box (Figure 25). The LN was directly spilled over the coatings' surfaces. As soon as LN came in contact with the warm coatings' surfaces, an oxygen deficient vapor cloud rapidly formed, thereby obscuring all visibility (Figure 26). About 3 min after spilling, the vapor cloud was dispersed by the prevailing air flow (Figure 27). Most of the \sim one inch deep LN pool over the coatings was dissipated within 10 min. The samples were left for 24 hours at room temperature before visually observing their surface and cross-sectional profiles. As shown (Figure 28), neither delaminations nor blisters were seen on the coating's surfaces of all the samples, underscoring that although the surfaces of ILPC dike repaired with MMA were wet, the BNL-formulated epoxy coating strongly adhered to the wet MMA. More importantly, the entire structure remained intact. The cryogenic LN did not cause any separation and segregation of the layers (Figure 29). From this encouraging result, we believe that the ILPC dikes repaired with this technology will withstand a LNG spill.

Figure 29. Cross-sectional profiling of repaired PC dike after a spill of LN.

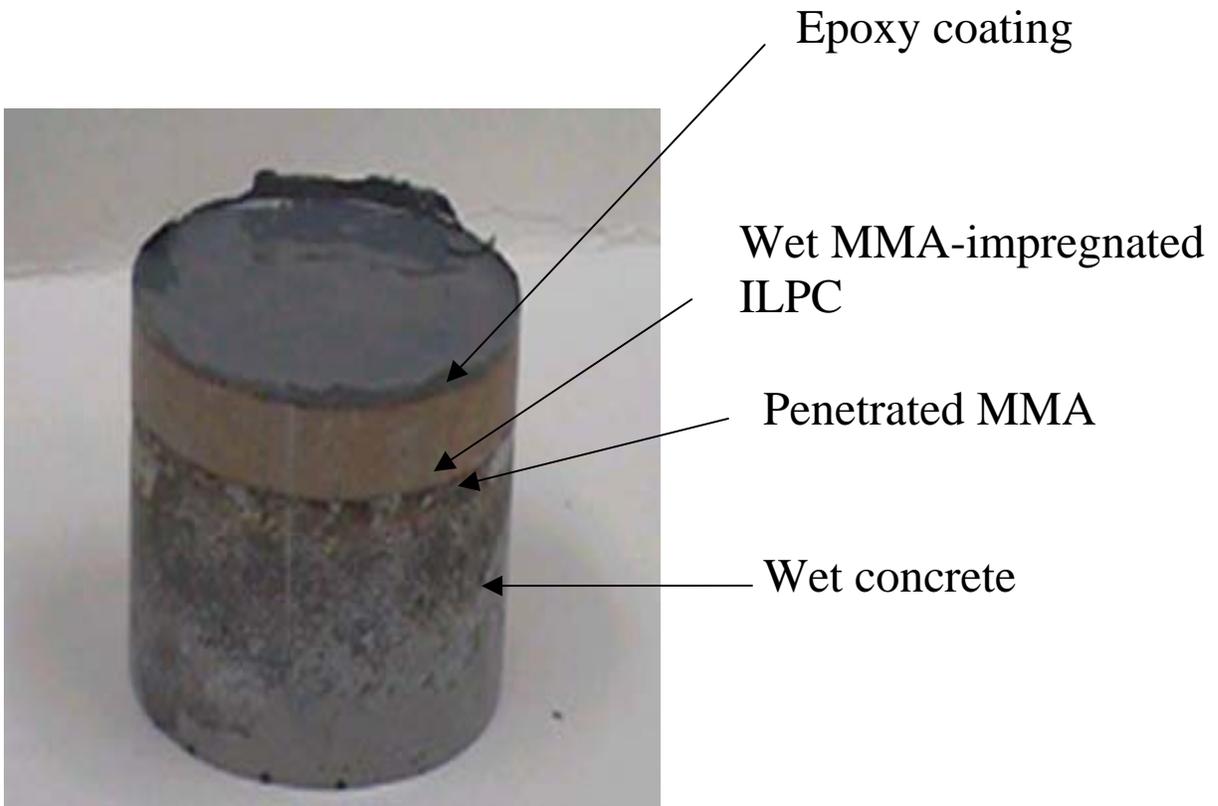
Although the repaired ILPC dike withstood a cryogenic temperature, another concern to be addressed was its freeze-thaw durability; in particular, the bond durability at the interfacial joints between the underlying concrete and MMA-impregnated old ILPC dike and between the MMA-impregnated ILPC dike and the epoxy top coating. In response to this question, we prepared the specimens similar to those made for the previous LN spilling test. The specimens were submerged in water in the freeze-thaw cycling chamber as per ASTM C666 Test, and were subjected to a series of 6 cycles per 24 hours period based upon a one cycling temperature between 0 and 50°F. Specimens were removed from the freeze-thaw chamber after 10, 20, 30, 50, 100, and 200 cycles, and then their appearances were observed to obtain information on whether failure and disbandment at the joints had taken place. After 200 cycles, all specimens exhibited no changes in appearance; reflecting no delamination of the top coating layer, despite the wet concrete and wet MMA-impregnated ILPC in this joint system (see the sample I.D. 4 in Table 12). Further, we saw no separation at any joints on examining the cross-sectional profile (Figure 30), confirming the excellent durability of these bonded joints in the 200 freeze-thawing cycles.

Figure 30. Cross-sectional profile of the wet concrete/penetrated MMA/wet MMA-impregnated ILPC/epoxy coating joint system after 200 freeze-thaw cycles.

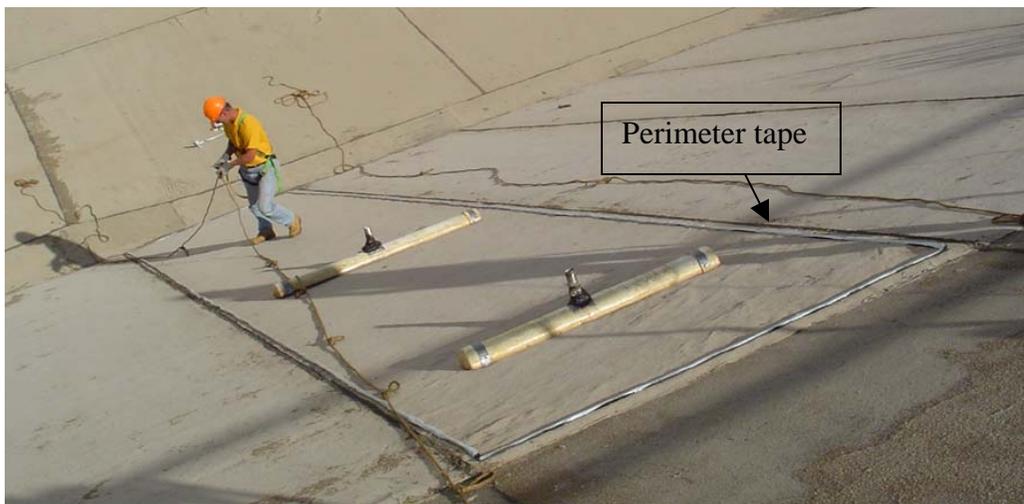
Figure 32. Extremely sticky double-sided perimeter tape adhering to test panel's surface.

The vacuuming-impregnation operation in the first step was conducted in the following sequences: 1) A strip of extremely sticky double-sided tape was applied three inches inside the perimeter of the panel (Figure 32); 2) two one inch mesh fabric nets were evenly laid out within this tape border; 3) three inverted troughs (six-in. diam. x approximately 5-ft.long) with closed ends and a two inch pipe nipple coming out the top were evenly spaced on the panel (Figure 33); 4) the ends of five clear plastic tubes ($\frac{1}{2}$ in. inside diameter) then were placed within the area to be impregnated at various locations and the other ends of the tubes were run to the top of the dike; 5) the latter were sealed to prevent vacuum leakage; 6) the tubes were crossed with sticky tape to hold them in place and another layer of tape was applied over the tube; 7) a six mil sheet of reinforced polyethylene was placed over the slab and carefully sealed to the sticky perimeter tape (Figure 34); 8) gaps for the three, two inch pipe nipples coming out of the top of the troughs were cut through the polyethylene sheet, and then this sheet was sealed around them; 9) two inch diameter hoses were connected from these nipples to a valved manifold connected to the vacuum pump at the top of the dike (Figure 35); 10) the vacuum pump was turned on and the valves opened; the polyethylene sheet immediately sucked in tight to the panel (Figure 36); 11) the MMA monomer was mixed with the BPO catalyst (Figure 37); 12) after vacuuming for 40 minutes, the ends of the five sealed tubes that were previously run to the top of the dike were opened and inserted into a five gallon can of MMA (Figure 38); 13) the MMA monomer was immediately drawn out from the container and was observed to rapidly spread out under the polyethylene sheet covering about 45% of the surface (Figures 39 and 40), while the vacuum continued to run; 14) during this 12 minute impregnation, ~ 14 gallons of MMA were consumed to fill the cracks in the panels' surfaces; 15) the polyethylene sheet was peeled off from the panel (Figure 41); 16) of the total area of panel, about 95 % was wetted by MMA (Figure 42); and finally, 17) additional MMA was poured on the remaining ~ 5 % non-wetted areas and rolled into the surface until it ran off (Figure 43).

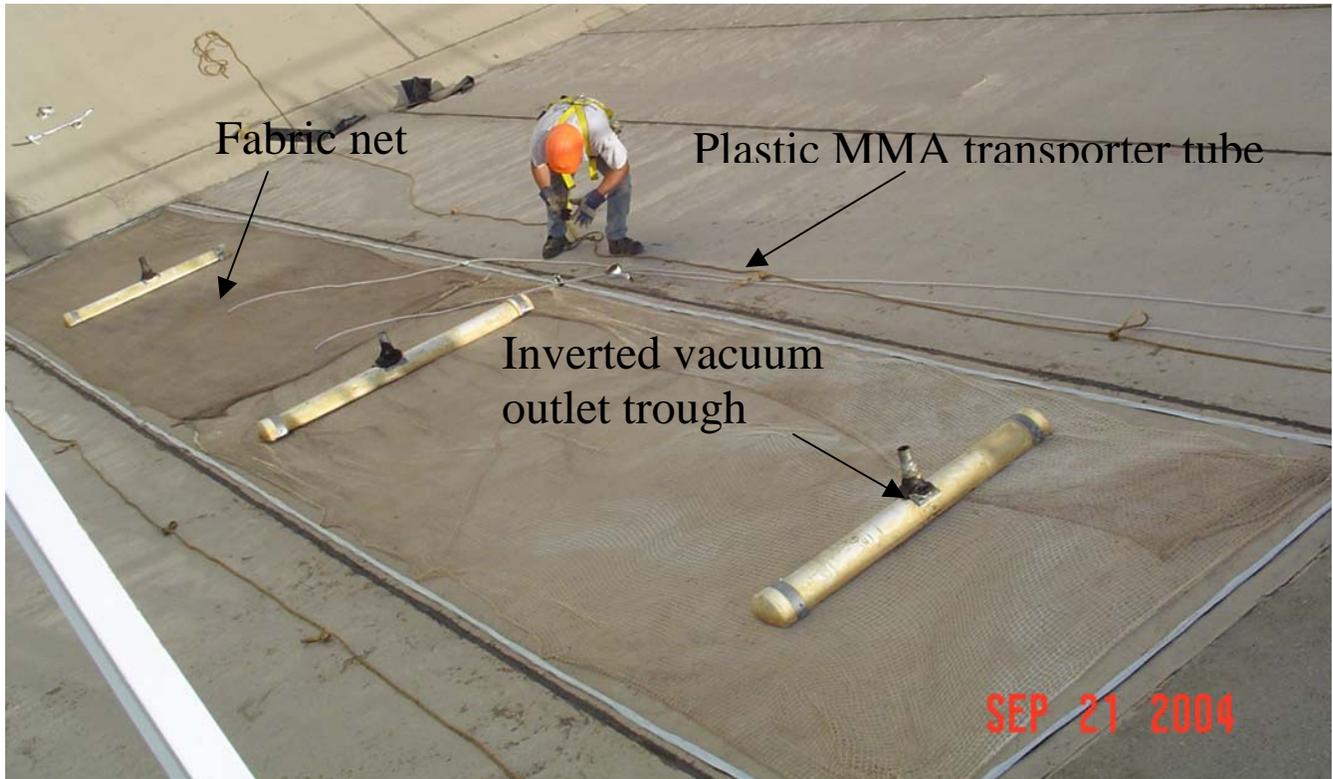
Figure 33. One inch mesh fabric nets were laid down within perimeter tape border. The closed end-inverted troughs attached to 2-in. vacuum outlet pipe nipple were then deployed on fabric nets. The ½ in. inside diam. clear plastic tubes, which transport MMA monomer, were sited in the areas to be impregnated.

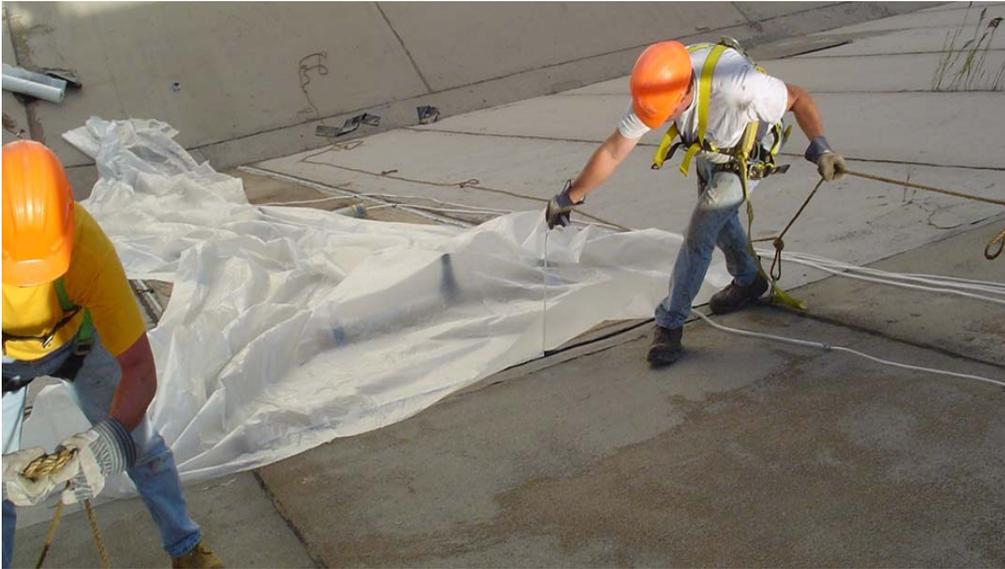
Figure 34. Six mil-thick polyethylene sheet was placed over the panel, and then it was pressed to the sticky tape at the perimeter to seal a vacuum-impregnation area.

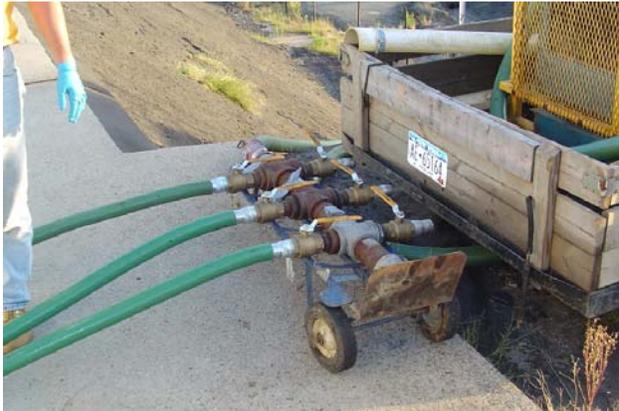
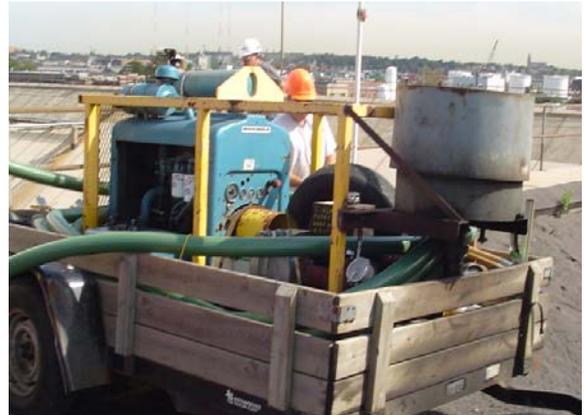
Figure 35. 2-in. diam. hoses (left) were connected between the pipe nipples that were attached to troughs and the vacuum pump (right).

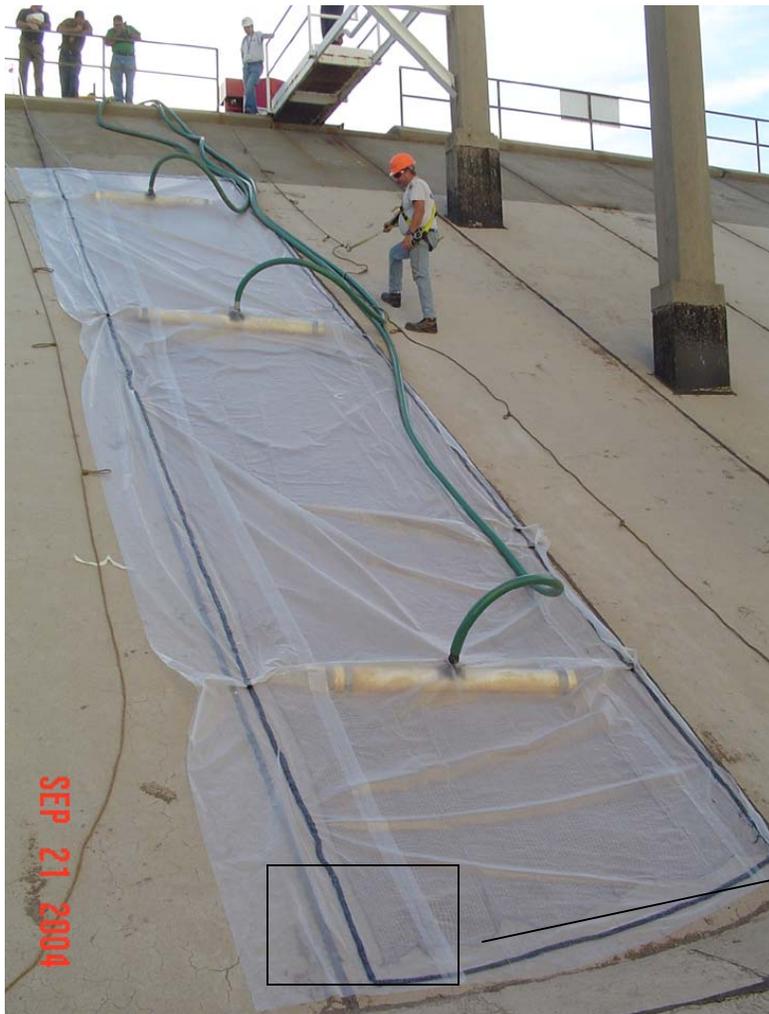
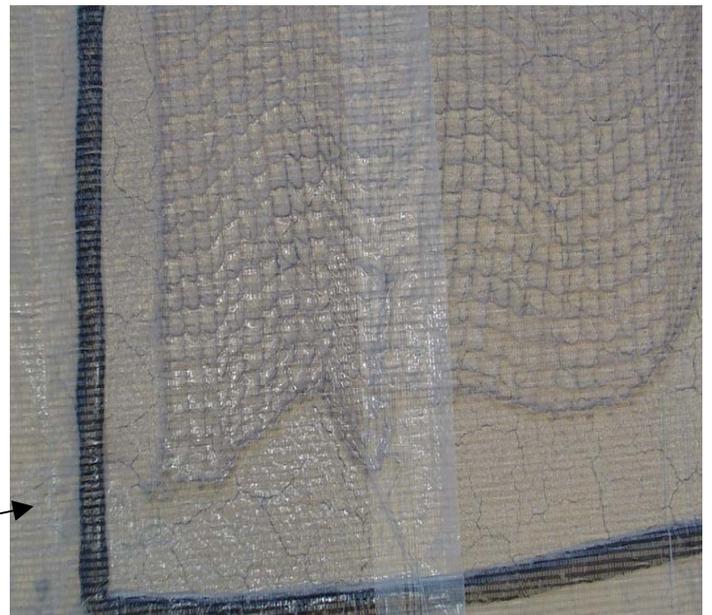
Figure 36. Polyethylene sheet was immediately sucked down after vacuuming, demonstrating that the perimeter sticky tape had tightly sealed the area (enlarged area, right photo).

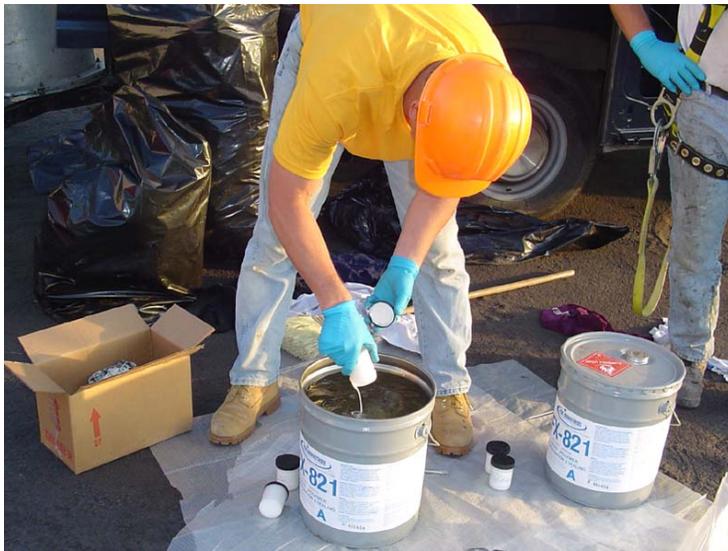
Figure 37. BPO catalyst was added to a 5 gallon MMA monomer container.

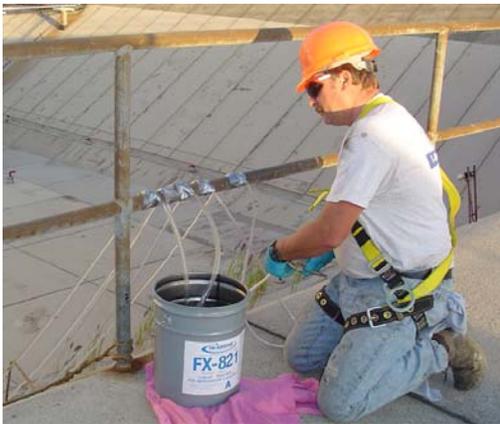
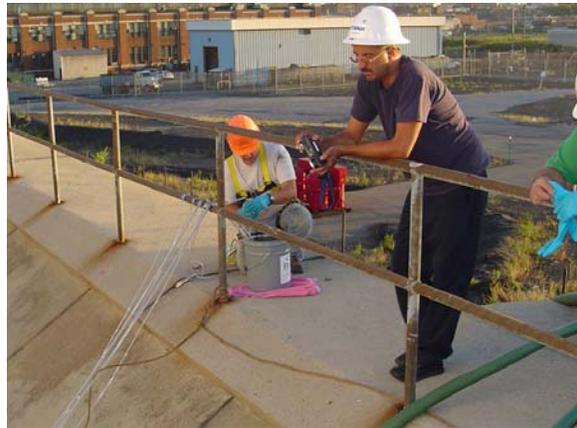
Figure 38. Five clear plastic MMA transporter tubes were immersed in a 5 gallon MMA container.

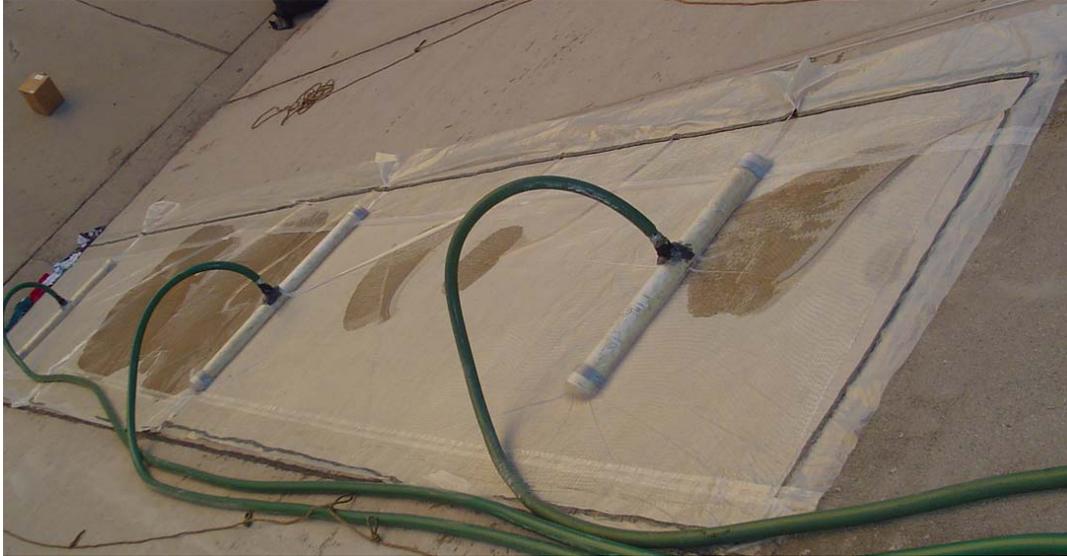
Figure 39. After vacuuming for 40 min, MMA was dispersed on the test panel underneath the polyethylene sheet, while continuously running the vacuum pump.

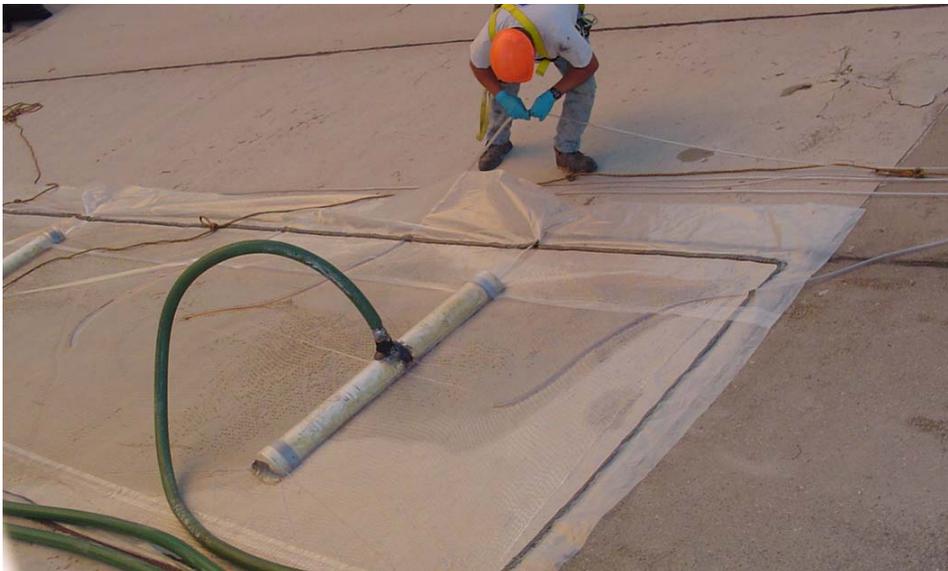
Figure 40. Vacuuming- MMA impregnation operation of damaged ILPC panel sealed with polyethylene sheet.

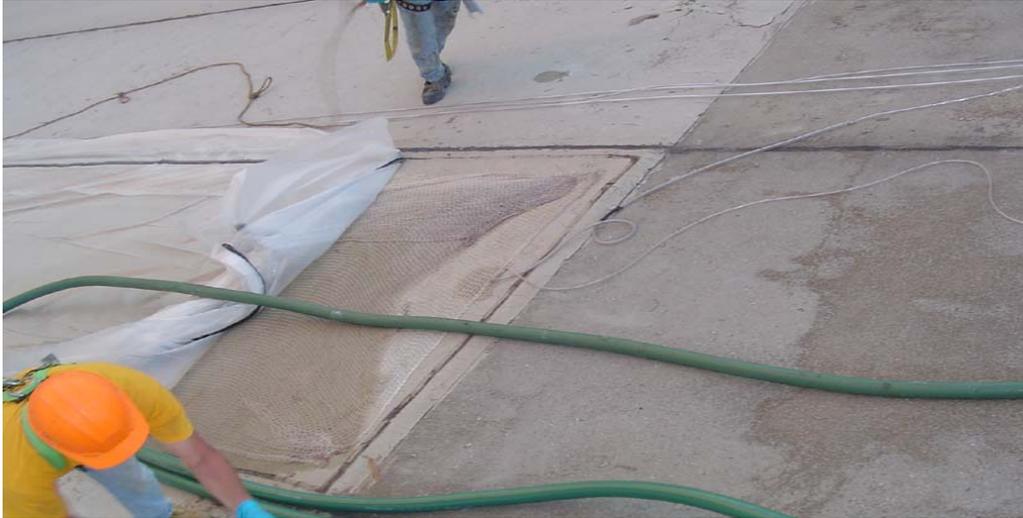
Figure 41. After completing MMA impregnation, the vacuum pump was turned off, and the polyethylene sheet peeled off from the adhesive tape.

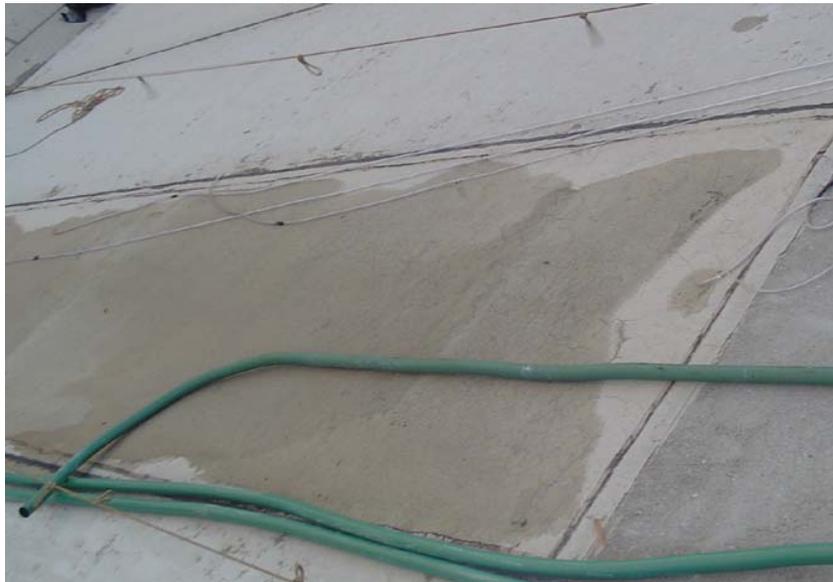
Figure 42. About 95% of total surface area of panels was wetted by MMA, and ~ 14 gallons of MMA was used in this operation.

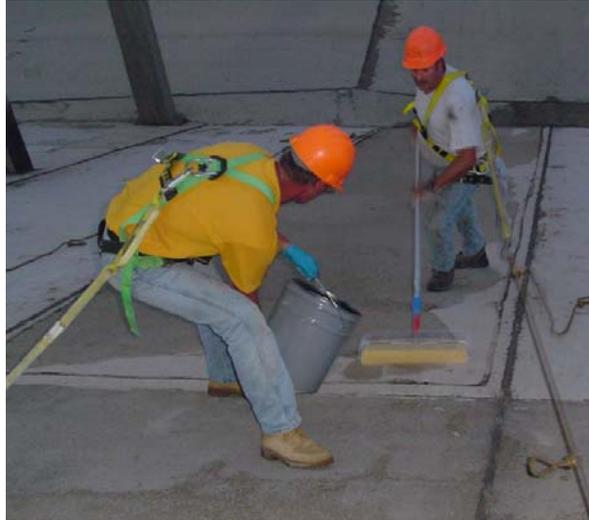
Figure 43. Using a roller, the remaining non-wetted portions, representing about 5 %, were covered with additional MMA.

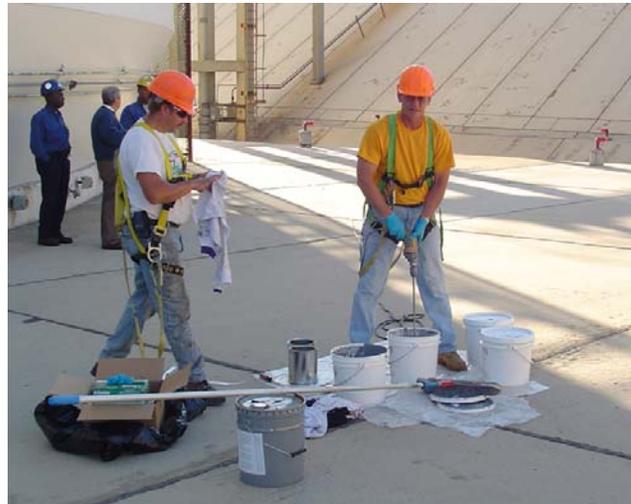
Figure 44. Preparation of epoxy top coating.

consisting of two parts, first, appropriate amounts of the three additives, the fire retardant, anti-oxidant and silane coupling reagent, were added to three gallons of epoxy (designated as part A), and this mixture was stirred with a motorized mixer (Figure 44); second, the one gallon can of part B was added to it, followed by mixing. The prepared epoxy resin was poured on the panel from the top downward, spread with a squeegee and then rolled with a paint roller into the surface (Figure 45). All 4.5 gallons of the epoxy was used for the first coating layer. The epoxy coating was cured within four hours. Afterward, a second epoxy coating totaling three gallons was applied in a similar fashion to the first layer's surface (Figure 46). A graded sand mixture was broadcast over the top layer before it gelled to provide a skid resistant surface. Figure 47 compares the appearance of the repaired and non-repaired ILPC dikes' surfaces.

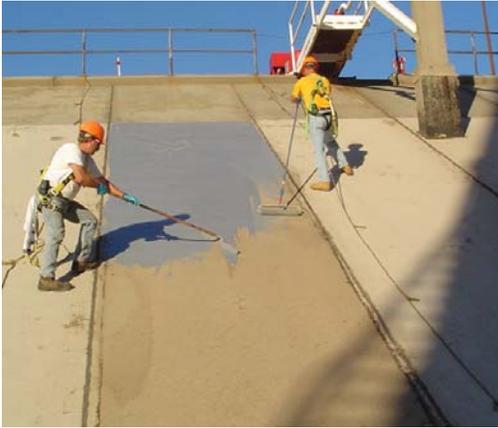
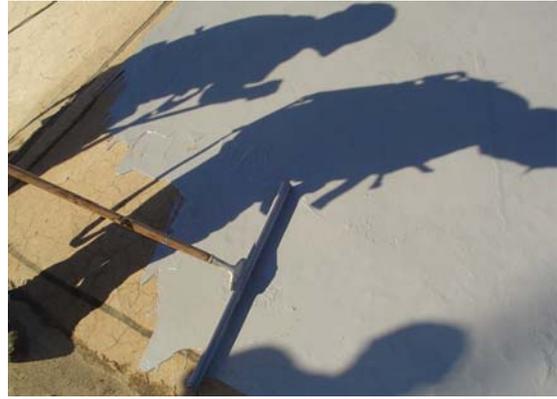
Figure 45. Using 4.5 gallons of epoxy coating, the first layer was applied by roller on the MMA-impregnated ILPC panel.

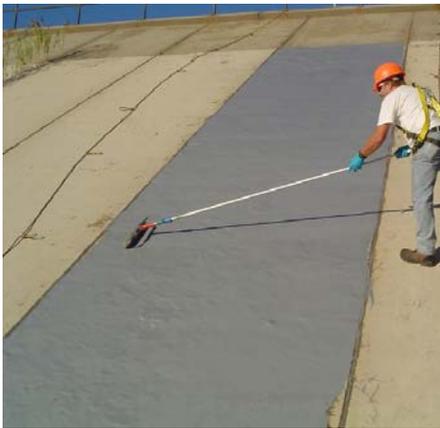
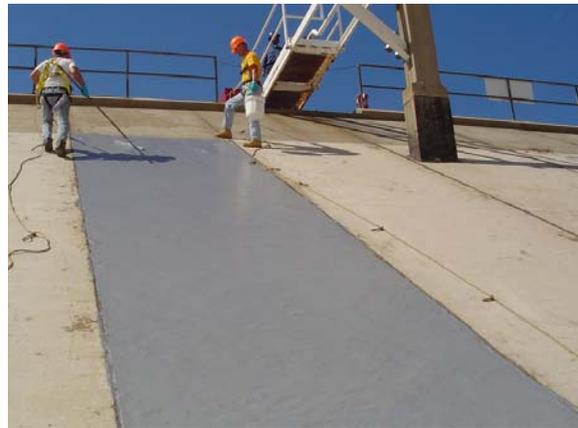
Figure 46. Three gallons of epoxy were used to fabricate a second coating layer over the first layer.

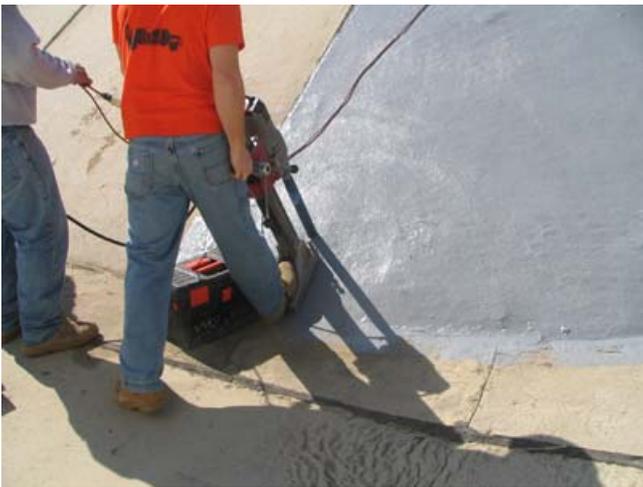
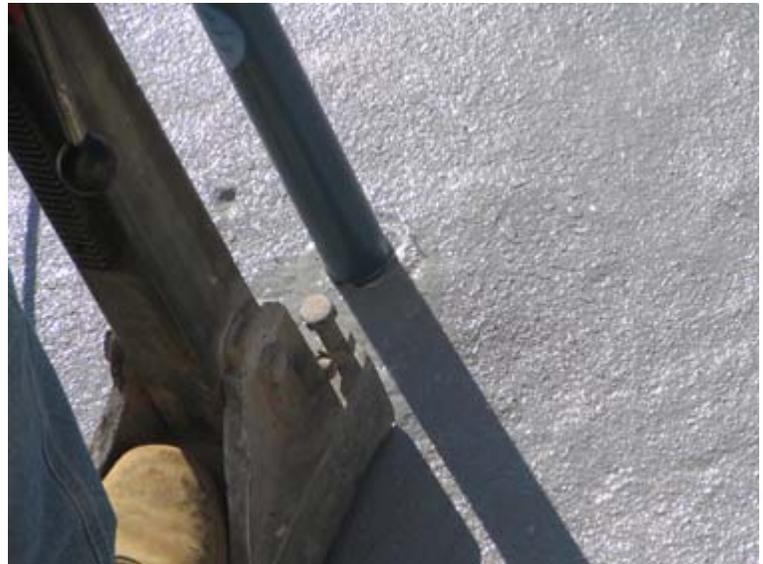
Nearly two weeks after being repaired, a core sample, ~ 2 in. diam. by ~ 3.5 in. long, was taken from a location of ~ 2 ft. away from the bottom edge of the repaired 8-ft.-wide x 30-ft.-length ILPC-overlay slop panel using a drilling bit (Figure 48). The core sample (Figure 49) was brought to BNL to conduct the post-demonstration analyses, to provide us with pivotal information on whether the vacuuming-impregnation repairing technology and subsequent deposition of a top coating layer has the potential and reliability for restoring a 16-year-old damaged ILPC overlay. As revealed by the cross-sectional area, the corrected core sample was composed of four layers; the epoxy top coating, MMA-impregnated old ILPC, MMA layer linked between impregnated ILPC and underlying concrete, and the concrete. For comparison purpose, we took a reference core sample from the non-repaired ILPC overlay (Figure 50). The post-demonstration analyses focused on assessing the reconstitution and restoration of damaged ILPC overlay by this repairing technology. They involved classifying the failure modes by the tensile splitting test and identifying the chemical states by FT-IR. Figure 51 shows photographs of the failure modes for the repaired and non-repaired core samples after the tensile splitting test. In the repaired core sample (Figure 51, left), most of the splitting breakage took place in the underlying concrete layer, except for a remnant of ~ ½ in. thick concrete layer attached to the ILPC. No conspicuous feature of destruction was

Figure 48. Collection of a core sample from the repaired ILPC panel with a drilling bit.

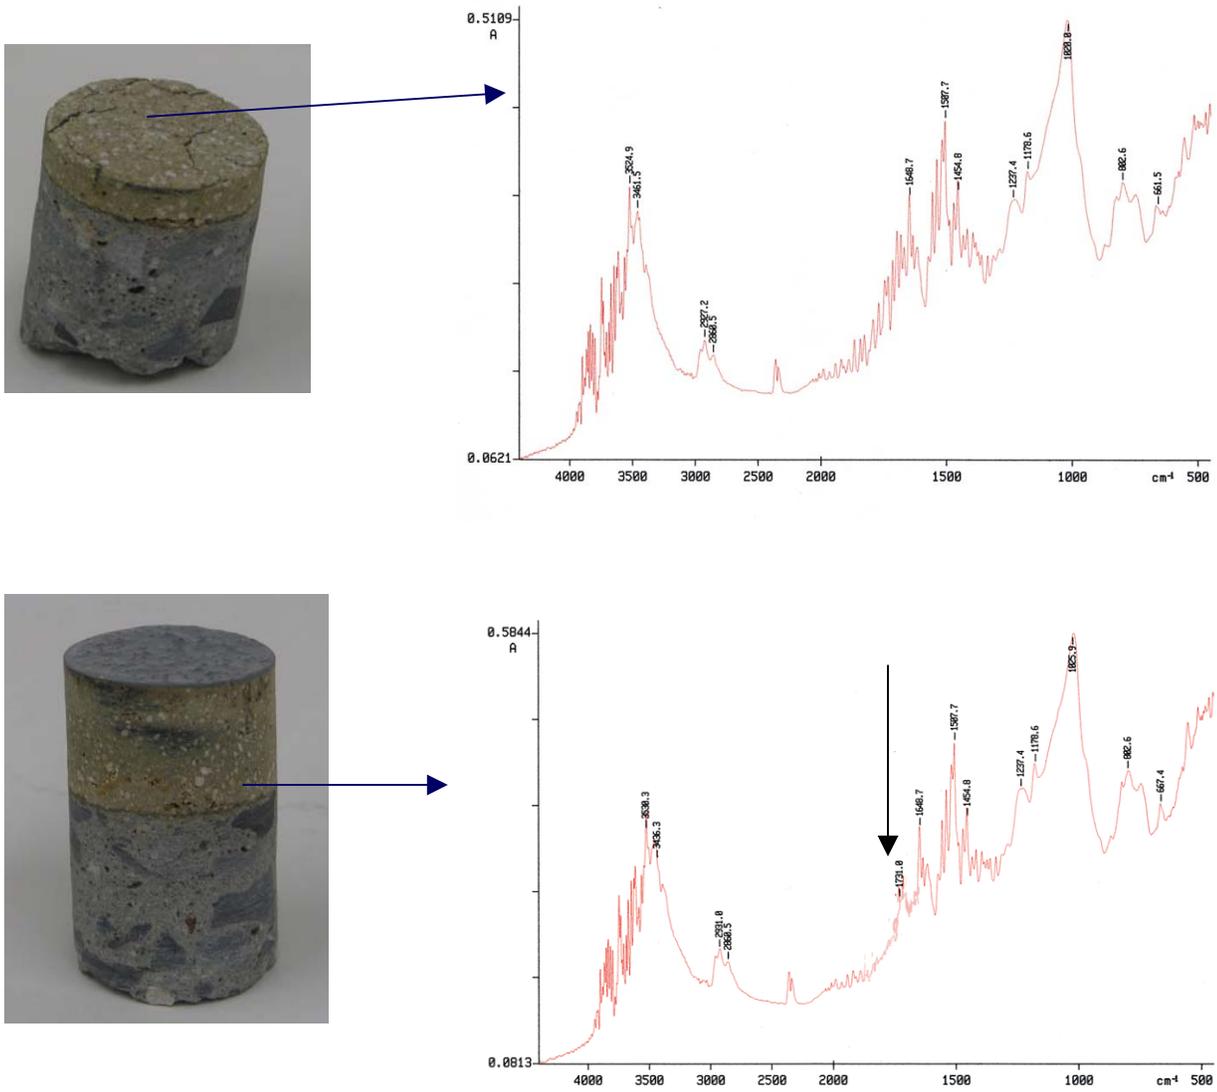
Figure 52 shows the FT-IR spectra for the samples taken from the non-impregnated (top) and MMA-impregnated (bottom) ILPC layers. The FT-IR spectrum of former included absorption bands at 3524.9, 3461.5, 2927.2, 2860.5, 1648.7, 1507.7, 1454.8, 1237.4, 1178.6, 1020.0, 802.6, and 661.5 cm^{-1} . The bands at 3524.9 and 3461.5 cm^{-1} were attributed to the O-H stretching vibration in moisture. Correspondingly, the band at 1648.7 cm^{-1} belonged to the H-O-H bending vibration in moisture. The three bands at 2927.2, 2860.5, and 1454.8 cm^{-1} were assignable to the stretching mode of $-\text{CH}_2-$ within the polyester binder. Considerable attention is concentrated on the bands at 1507.7 cm^{-1} originating from the carboxylate anion group, $-\text{COO}^-$. No ester group ($-\text{CO}-\text{O}-$)-related band at ~ 1730 cm^{-1} was found in this spectrum, strongly suggesting that the ester groups in the original polyester binder were transformed into the carboxylate anion groups during a long period of 16 years. Thus, it is possible to rationalize that the ester groups in polyester polymer structure underwent the UV-promoted saponification and were converted into the carboxylate groups, implying that the polyester-based binder in the ILPC was degraded. This degradation might cause some shrinkage of ILPC that would be reflected in the generation of numerous cracks. All remaining bands of the spectrum were associated with the aluminum silicate microsphere fillers used as the thermal insulator of ILPC. Compared with that of the non-impregnated ILPC layer, the spectrum of the impregnated layer was characterized by the incorporation of an additional band at 1731 cm^{-1} (see arrow), attributed to the ester groups ($-\text{CO}-\text{O}-\text{CH}_3$) in MMA,

Figure 52. FT-IR spectra for MMA-impregnated (bottom) and non-impregnated (top) old ILPC layers.

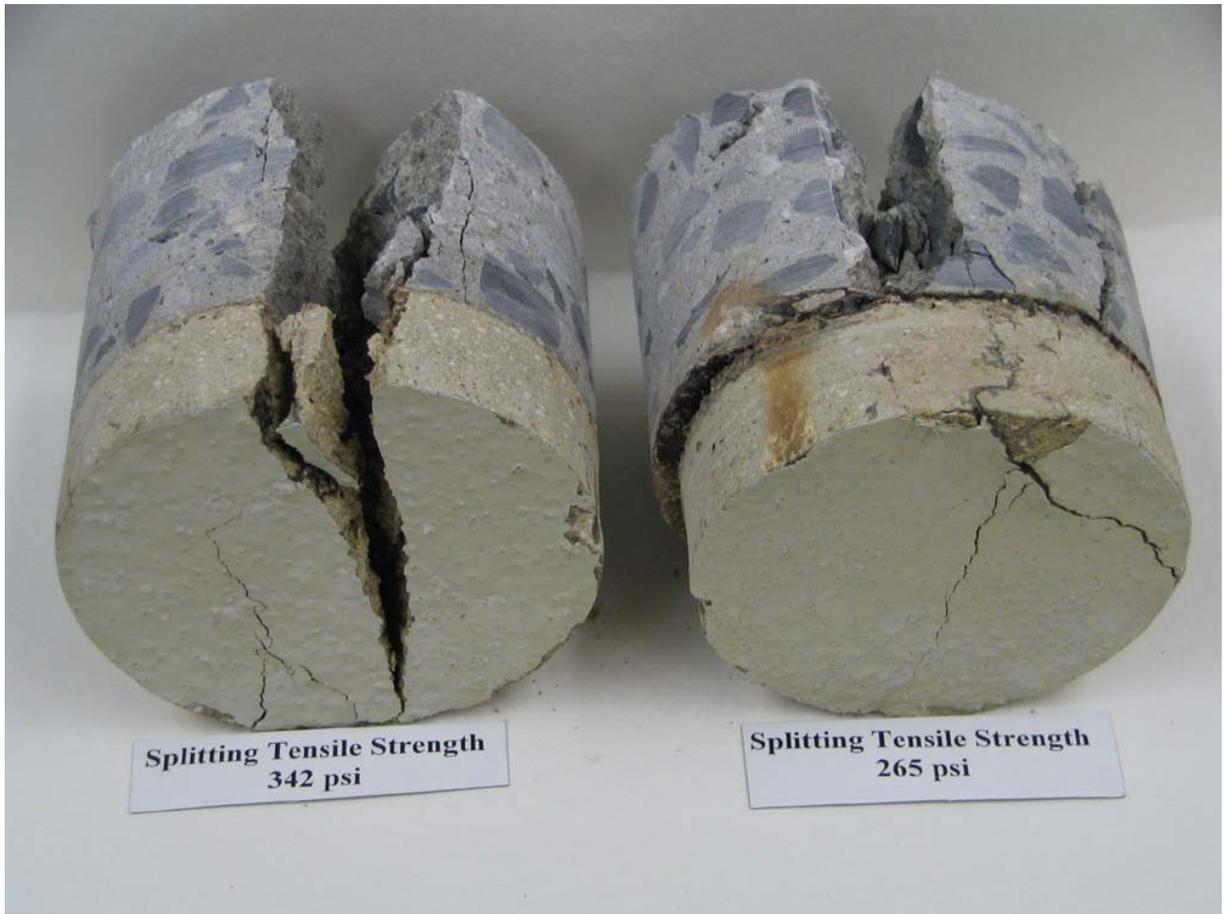
To identify how strongly the impregnated MMA cross-links between the repaired ILPC and concrete, we determined the splitting tensile strength for these core specimens (Figure 56). The test results showed that a well adhered second core specimen (left) had the splitting tensile strength of 342 psi, and the splitting breakage occurred through an entire core specimen, clearly demonstrating that the delaminated ILPC layer was strongly linked by impregnated MMA to the underlying concrete. In contrast, for the first core specimen involving two undesirable factors, a poor filling effect of MMA in the interspaces and a elastic behavior of cured MMA, the feature of its splitting breakage (right) was quite different from that of the second core specimen; the breakage only took place in the underlying concrete, but not the repaired ILPC. This failure mode clearly verified that these undesirable factors weakened a coupling effect of impregnated MMA in cross-linking structure between repaired ILPC and concrete, thereby resulting in ~ 23 % lower splitting tensile strength than that of the second core specimen.

Figure 56. Splitting tensile strength test for these core specimens.
