1 Scope:

This procedure describes the methods for repairing damage to the Kapton cable insulation that occasionally occurs during the winding, curing, measuring or handling of a coil.

RHIC-MAG-R-7337-A

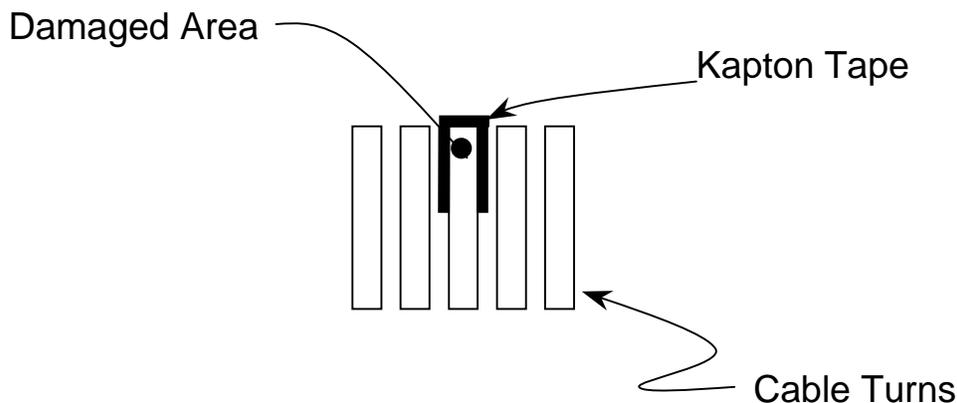
3.2.3.2 Damage prior to curing - Separate the turns and form a cap with the Kapton tape over the turn with the damage as per the sketch below:

3.2.2 Typical insulation damage may be patched with a piece of Kapton tape such that the tape extends approximately .25" past the damage in all directions.
