DIRECT IMAGE PROCESSING OF CORRODING SURFACES APPLIED TO FRICTION STIR WELDING

¹H. S. Isaacs, ²A. Haughton, ²A. M. Shipley, ³H. Popenoe, ³E. Karplus, ⁴J. B. Lumsden

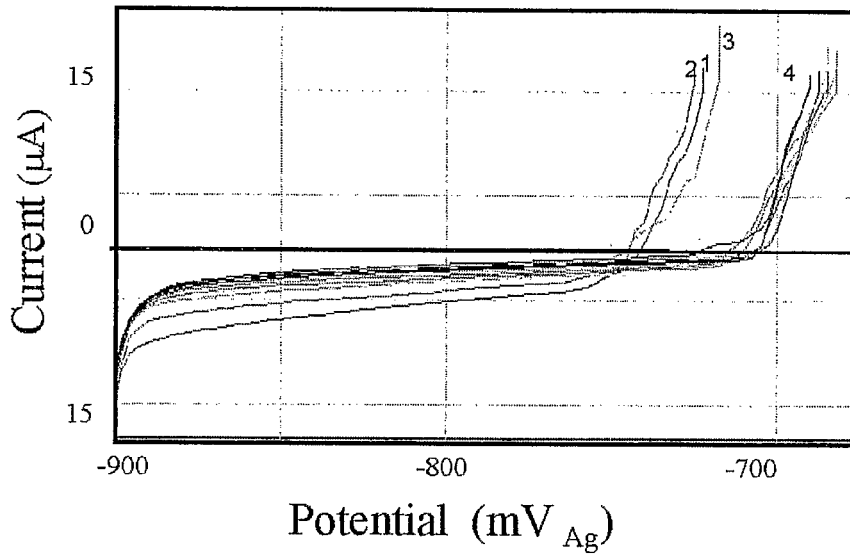
Figure 3. Repeated polarization scans at 1mV/sof the weld region shown in Figure 1 in 0.05 M NaCl.

Figure 3 shows a series of pitting potential measurements. The first five scans show a clear trend of increasing pitting potential indicating decreasing corrosion susceptibility. The fifth to tenth scans show very similar pitting potentials. This behavior suggests that the location of corrosion could be significantly different if the exposure conditions were different. A single continuous exposure would initiate at the more susceptible sites and corrosion could continue at these sites once initiated. However, if exposed to a periodically aggressive environment the location or number of the sites would change. The traditional approach of relying on single tests followed by post test observations would make it extremely difficult to assess the susceptibility of the different corrosion sites. In addition, in situ imaging has suggested a rather unexpected cause for the increased apparent susceptibility.
