## Shielding Re-Evaluation for the Linac to Booster Transfer Line at the CLS Mo Benmerrouche and Kerry Babcock

RadSynch13 Workshop  
BNL May 9, 2013

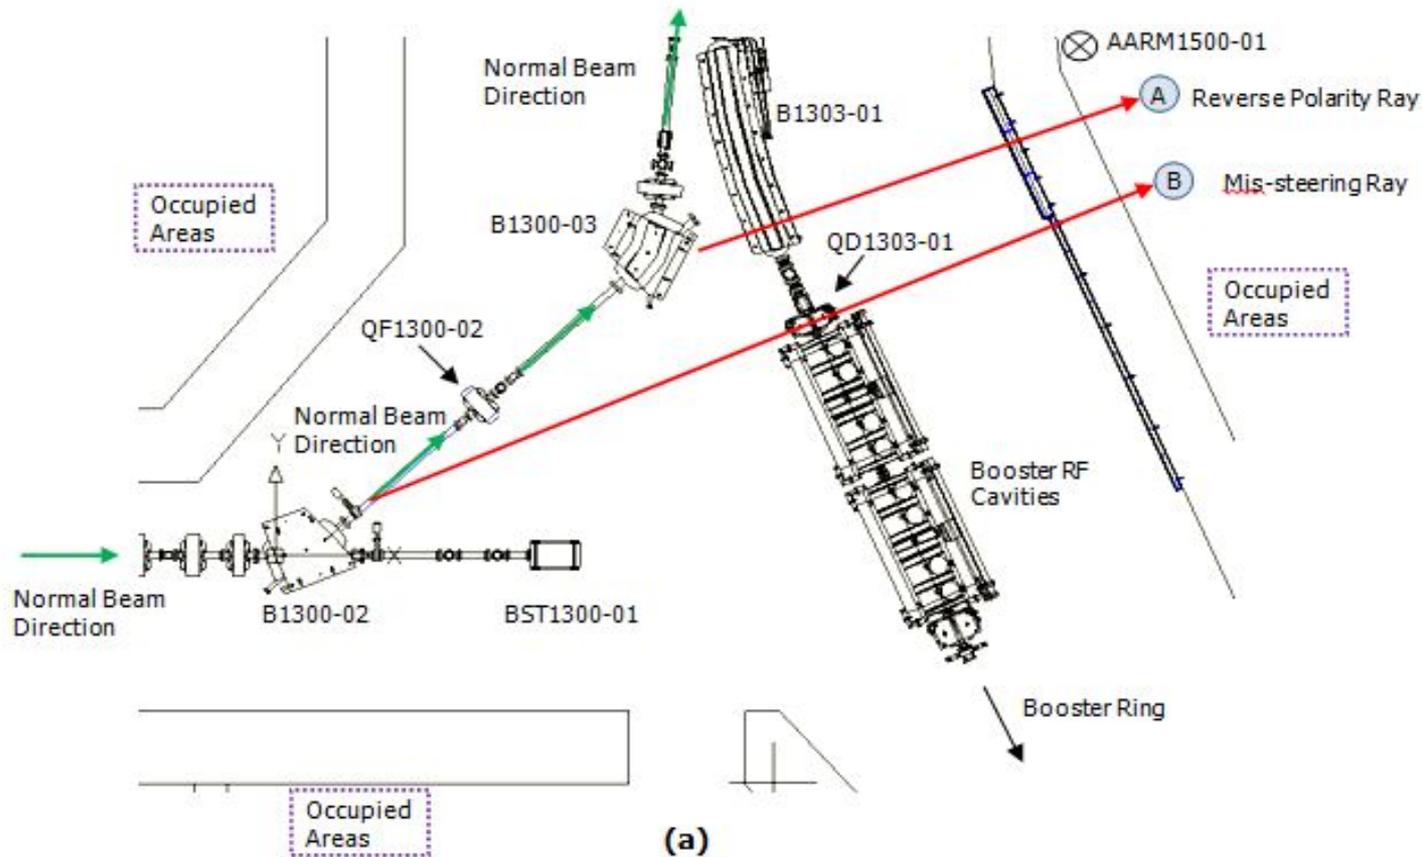
# Linac to Booster Transfer Line between Dipoles B1300-02 and B1300-03

A layout of the Linac-to-Booster (LTB) transfer area extracted from CAD drawing. Arrows represent the normal path of the beam, the reverse polarity and mis-steering events. Occupied areas are also labeled.

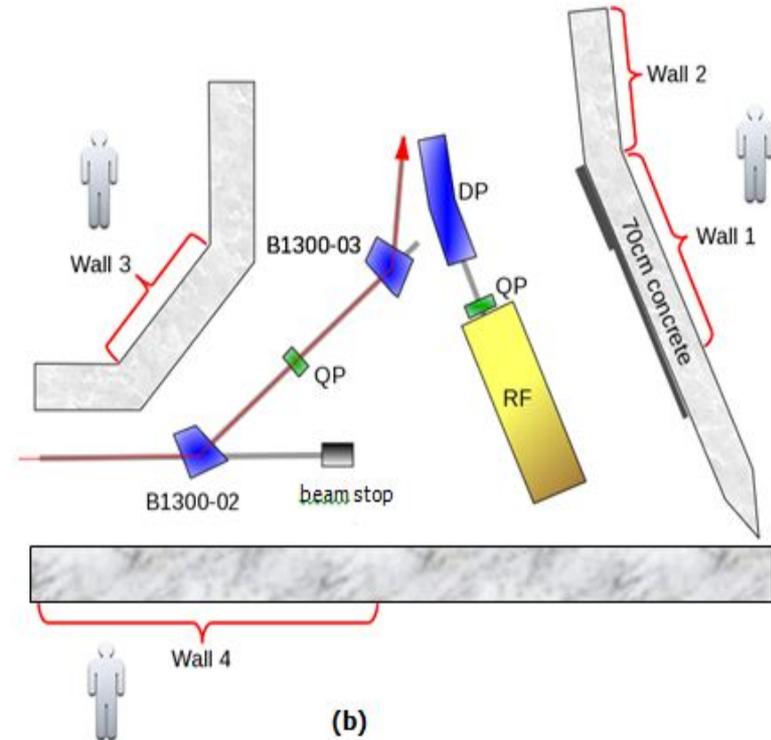
# LTB Area

- Along the LTB transfer line, there are two dipole bending magnets that steer the 250 MeV electron beam into the booster ring.
- These dipoles are designated B1300-02 and B1300-03 respectively. Between the two magnets is a quadrupole (QF1300-02). Between the two dipoles is a steel pipe which is 3.175cm in radius and 1.6mm in thickness.

- Also in the figure are components of the booster ring, namely a booster dipole (B1303-01), quadrupole (QD1303-01), and RF cavities.
- The LTB transfer area is enclosed by several shielding walls labeled 1 through 4 in figure 1(b). Wall 1 consists of 70cm of concrete with a strip section of lead shielding with two discrete thicknesses (5 and 10cm). The strip section of lead is centered at beam height (140cm off the ground) and is 60cm tall. Wall 2 is 70cm of concrete while walls 3 and 4 are 80cm concrete. The roof is 60cm concrete. The concrete shielding has a density of  $2.35\text{g/cm}^3$ .

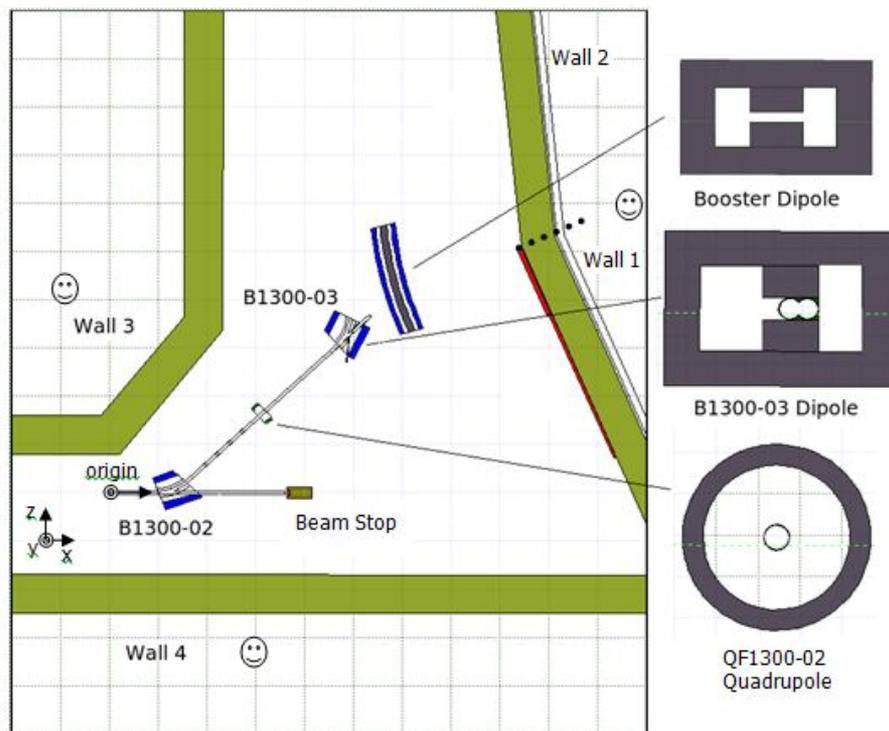
- The beam pipe, dipoles and quadrupole, were comprised of iron.
- The beam stop was comprised of an aluminum cylinder with a tungsten cylindrical insert.
- The walls were assigned  $2.35\text{g/cm}^3$  density concrete while the strip of shielding on Wall 2 was assigned lead.
- Subsequent shielding added to the model was also comprised of lead.
- The RF cavity was omitted because it was not in the direct path of the particle shower. Nevertheless, any shielding design will only be enhanced by the attenuation of the RF cavity

Figure 2: The Geometric Model of the LTB transfer area. Walls 1-4 are labeled. The smiling faces represent the viewing perspective for the 4 walls when looking at graphs in this document. The dotted line represents the divider between walls 1 and 2.

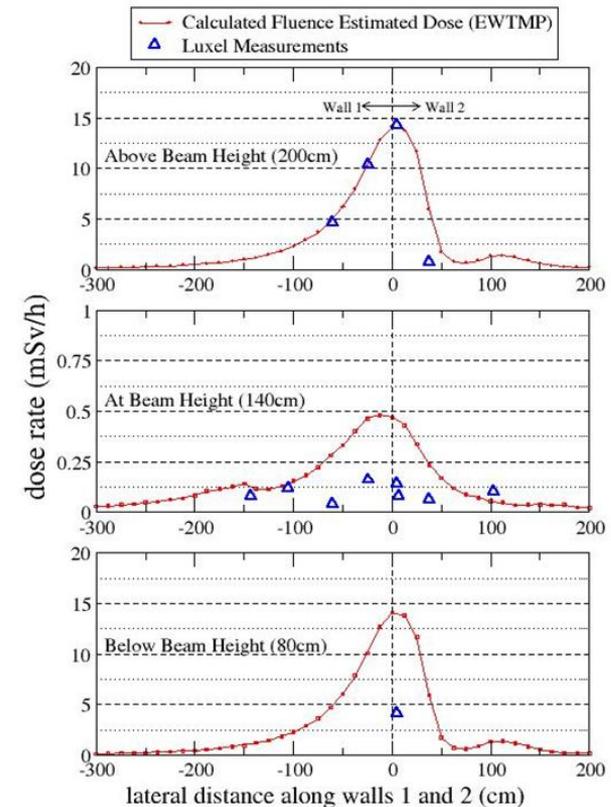
- Figure presents the calculated and measured dose rates on walls 1 and 2 for the conditions of Experiment 4.
- For measurements taken at or below beam height, the simulation tended to over-estimate dose. This was expected as the model did not include all attenuating structures such as the RF cavity, or the structures that support the beam line components.
- Above beam height, the agreement between measurement and simulation was satisfactory.
- A similar comparison between simulation and measurement was carried out for neutron dose rates. In both measurement and simulation, the neutron dose contribution was found to be negligible for all experimental setups.

Figure 3: Comparison of measured Luxel gamma dose rate measurements to FLUKA simulation with 95.5% field strength for the B1300-02 dipole. In the figure EWTMP refers to the "worst case" effective dose rate calculated from the particle (photon) fluence.

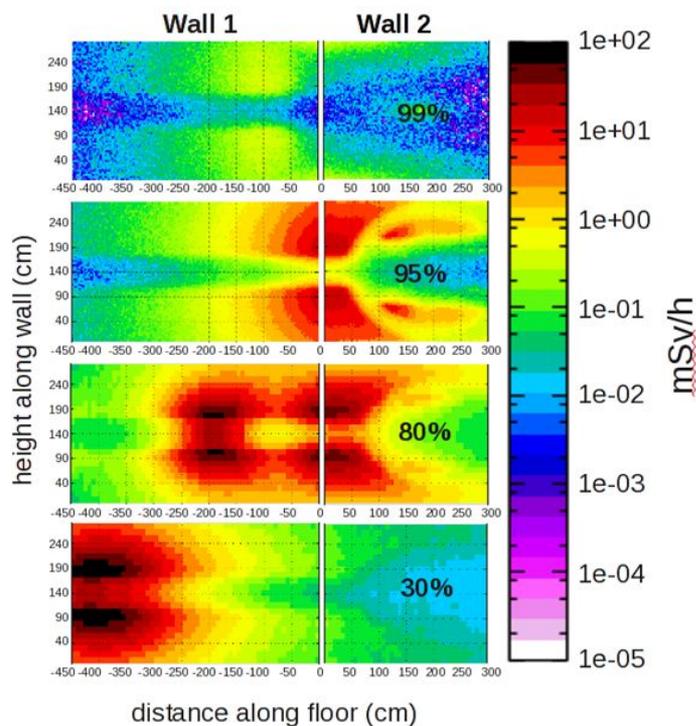
Figure 4: Photon dose rate map for walls 1 and 2 - B1300-02 at 99, 95, 80 and 30% field strength.

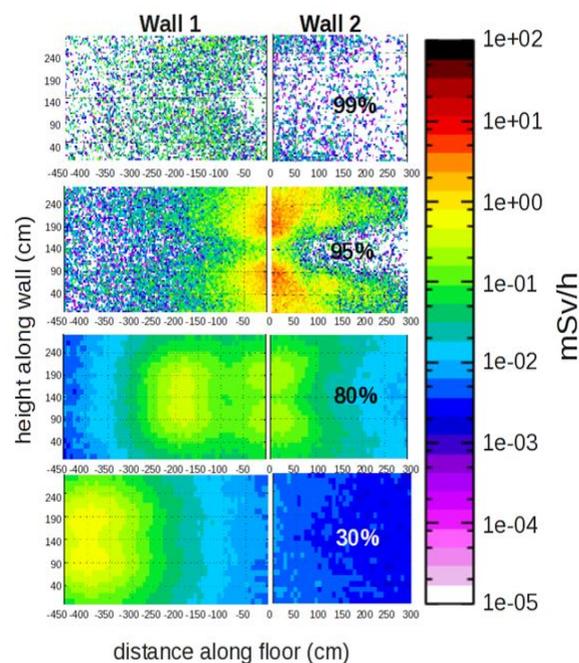
Figure 5: Neutron dose rate map for walls 1 and 2 - B1300-02 at 30, 80 and 95% field strength

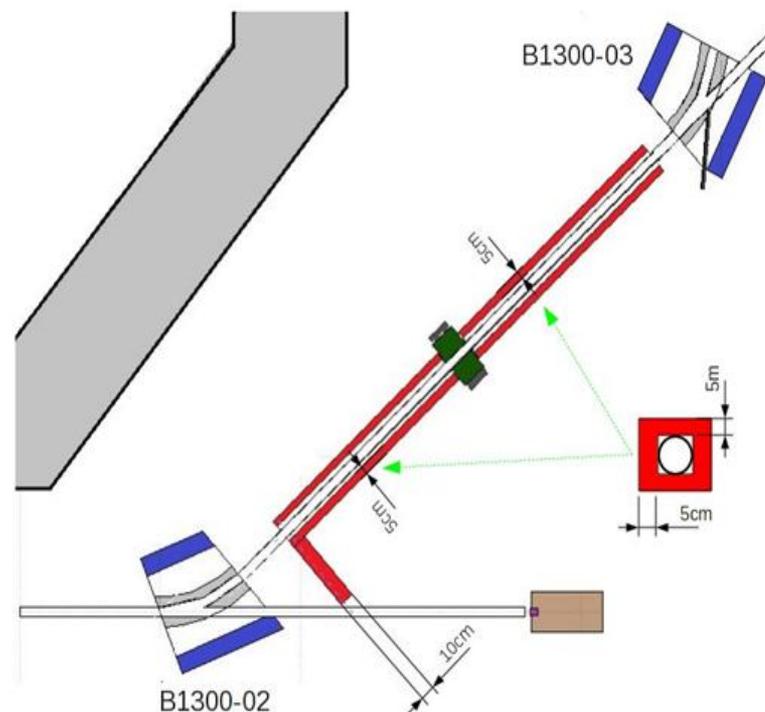
Figure 6: The shielding design. The design consists of a 5cm thick column of lead (red) that runs along the beam pipe. For large angle mis-steering, a right angle wall is placed near the B1300-02 dipole. The wall is 10cm thick and 60cm in height (centered at beam height).

- To contain the shower at any point along the beam pipe connecting B1300-02 and B1300-03, a lead box, 5cm thick on all four sides, was simulated around the pipe.
- For smaller mis-steering angles (corresponding to a B1300-02 field strength  $> 90\%$  of nominal value) the local shielding is sufficient to reduce the dose rates below  $0.100\text{mSv/h}$ .
- For larger mis-steering angles (corresponding B1300-02  $< 90\%$  of nominal value) an additional shielding wall (10cm thick, 60cm in height) is required between the beam pipe and beam stop.

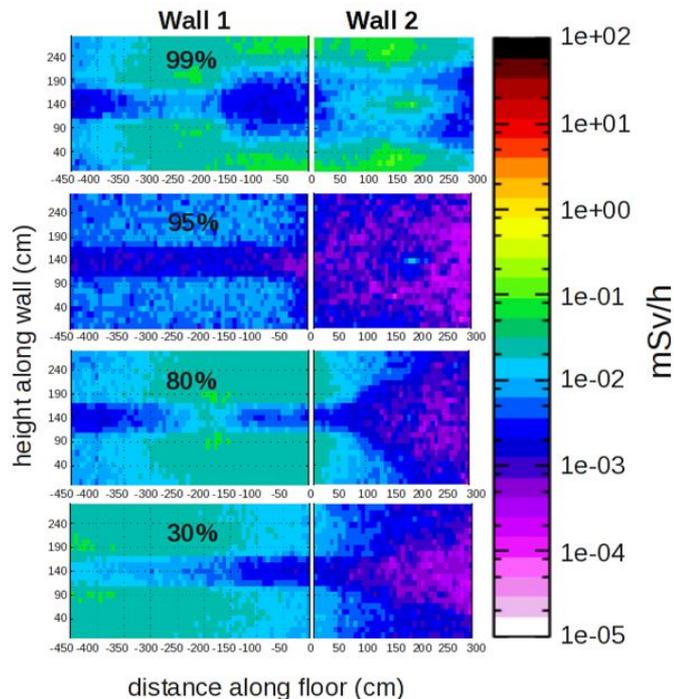
Figure 7: Photon effective dose rate map for walls 1 and 2 with additional shielding

For all walls and the roof, the dose rates do not exceed 0.100 mSv/h when the simulated shielding was in place !

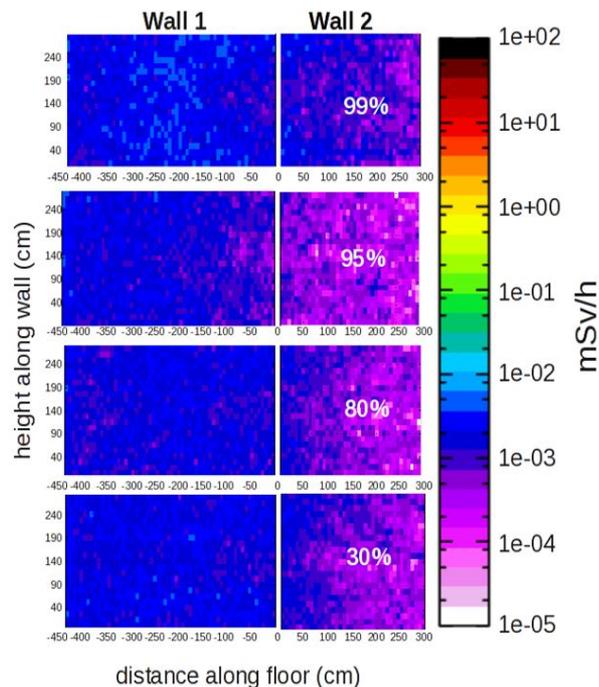
Figure 8: Neutron effective dose rate map for walls 1 and 2 with additional shielding

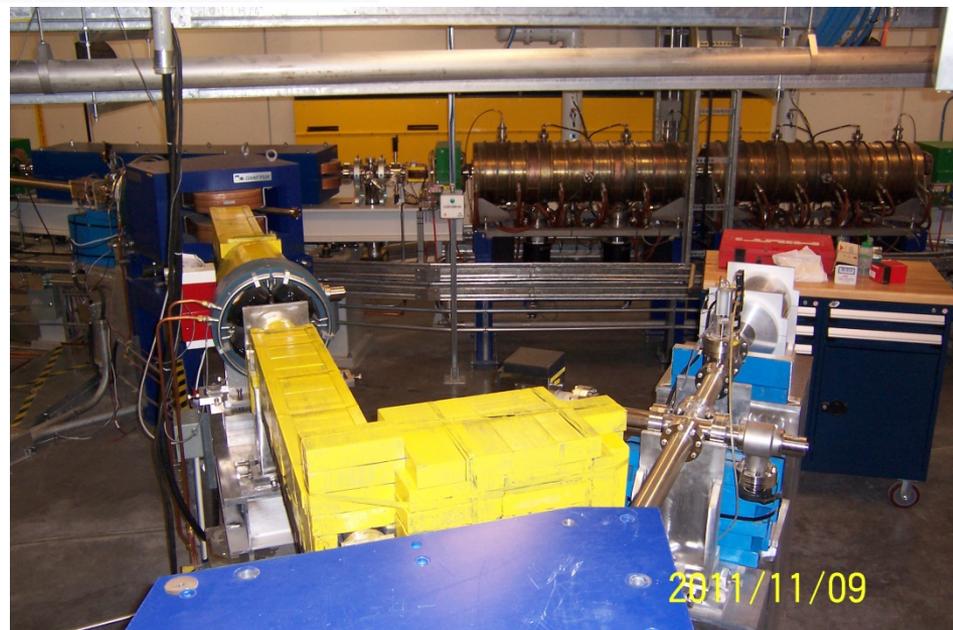
- In February and May of 2011 measurements were taken to validate the adequacy of local shielding.
- Generally, the measured and simulated dose rates are comparable.
